Milton Keynes Council

FLOOD RISK INVESTIGATION

Bletchley Section 19 Report

OUR REF. NO. 70082487-WSP-FRM-03-RP-CO-0001

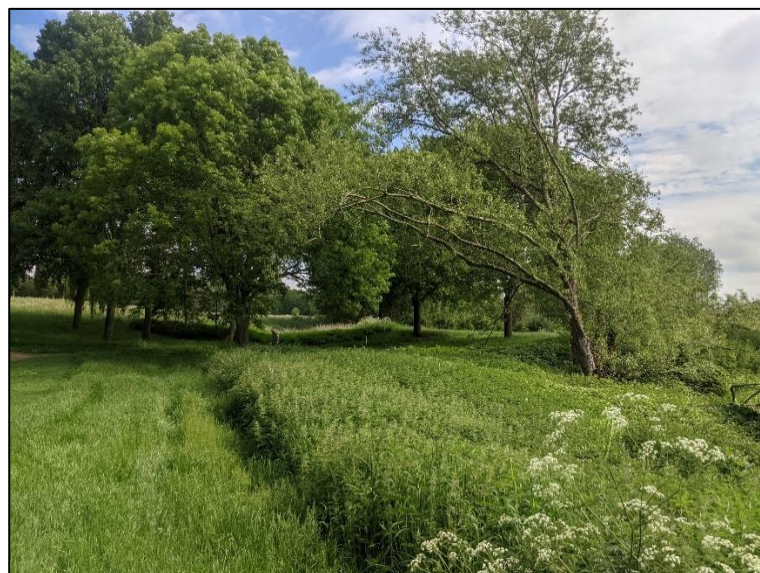
Figure 1-1 - Evidence of a low elevation in pathway located to the south of the property which could have been overtopped during the flood event. No evidence was found of a culvert being located beneath the pathway.

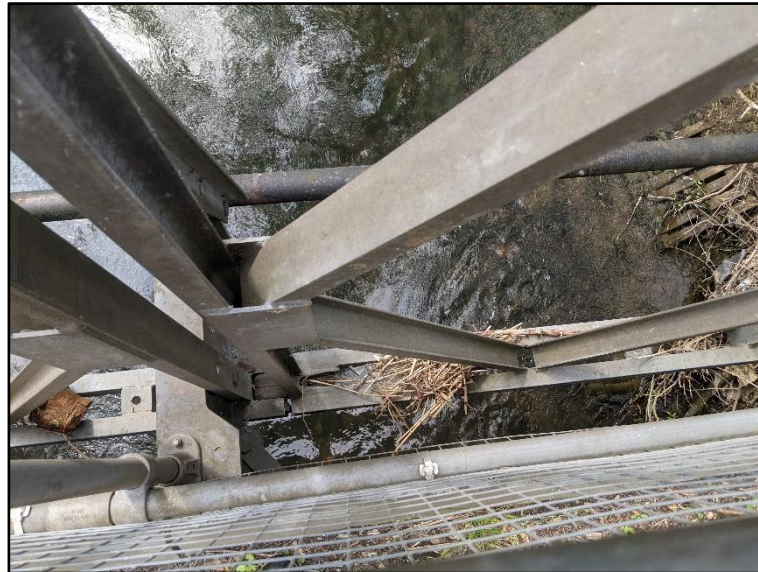
Figure 1-2 – Evidence of debris from a high flow event on a bridge downstream of the River Ouzel between the Bletchley Town Cricket Club and Watling Street.

- 4.1.3. At a site visit undertaken on 7th June, debris was found on the parapet of a bridge spanning the River Ouzel approximately 1km downstream of the flooded property. The debris were likely captured by the bridge during a high flow event. The structure may have constricted the flow of water downstream of the property leading to a backwater curve with heightened river levels at the property. In addition, vegetation on the banks of the Ouzel downstream of the flood event was unmaintained at the time of the flood, as shown in Figures 1-6 and 1-7, leading to reduced channel capacity. A side span of the bridge was partially blocked by vegetation which may have reduced the capacity of the bridge to convey river flows during extreme flood events. High water levels at the bridge are supported by the placement of sandbags adjacent to the river immediately upstream of the bridge, shown in Figure 1-3. Clearing works were undertaken during the month of May 2021 resulting in well-maintained and clean riverbanks in the River Ouzel running along Bletchley, depicted in Figures 1-5 to 1-7.

- 6.1.5. Evidence of high flows overtopping a bridge downstream of the flood has been found which may indicate flow constriction leading to a backwater curve. This theory is further supported by vegetation partially blocking a span of the bridge.

- 6.2.1. Recommendations and further work are suggested for the following key stakeholders.
- The *Lead Local Flood Authority* should support the community in the preparation of a Community Flood Plan, alongside the Environment Agency and other flood risk management authorities. The LLFA should also facilitate collaboration between key stakeholders to enhance current understanding of flood risk and flood mitigation measures at Bletchley to determine any potential improvement opportunities and constraints as well as investigate the flow capacity of the downstream bridge.

- The *Environment Agency* should investigate and consider further improvements to maintenance of floodplains and riverbanks around Mill Road and downstream at the bridge to increase discharge capacity of River Ouzel. The Environment Agency should also consider the improvement of maintenance of rainfall gauges located at Drayton Parslow and Birchmoor as well as support the community in the preparation of a Community Flood Plan, alongside MKC and other flood risk management authorities.

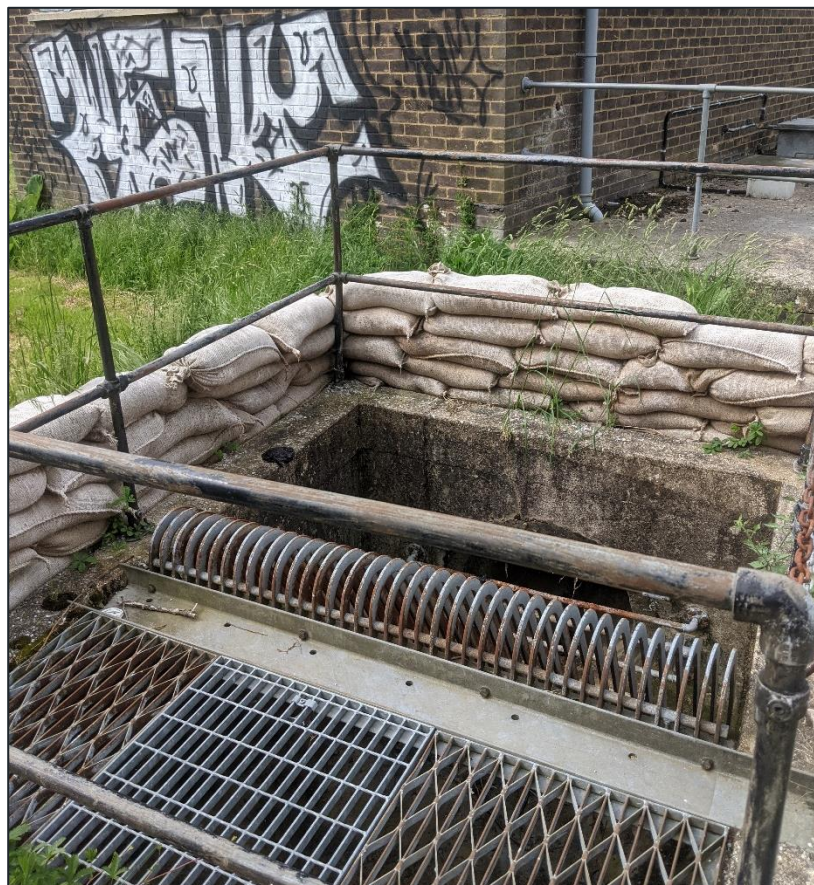
Figure 1-3 - Sandbags located between Bletchley Town Cricket Club and Watling Street, downstream of the River Ouzel.

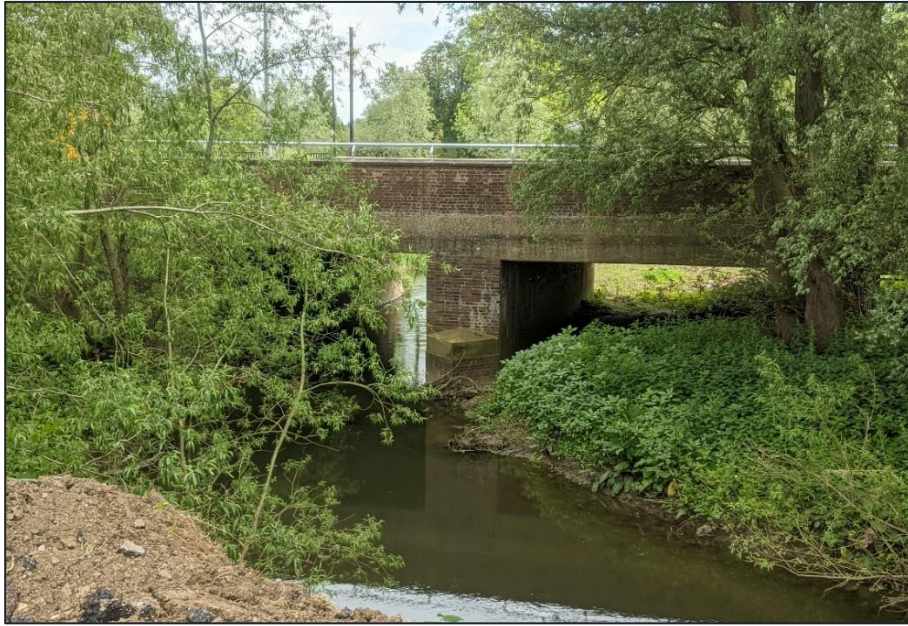
Figure 1-4 - Evidence of overgrown vegetation blocking one of the Watling Street bridge spans downstream of the River Ouzel. It might reduce the capacity of the bridge to convey river flows during extreme flood events.

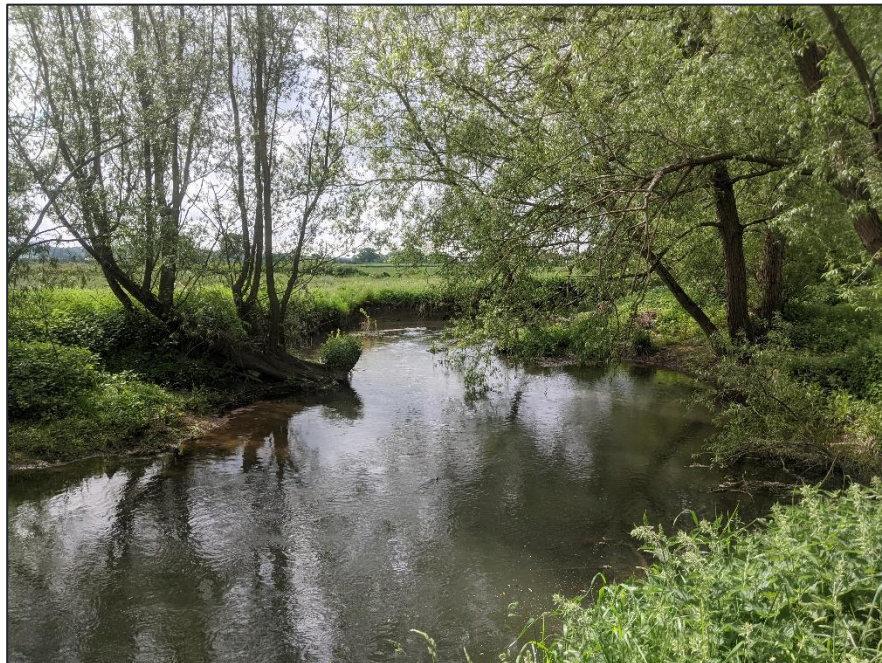
Figure 1-5 - Evidence of well-maintained and clean riverbanks in the River Ouzel running along Bletchley due to clearing works undertaken during the month of May, 2021.

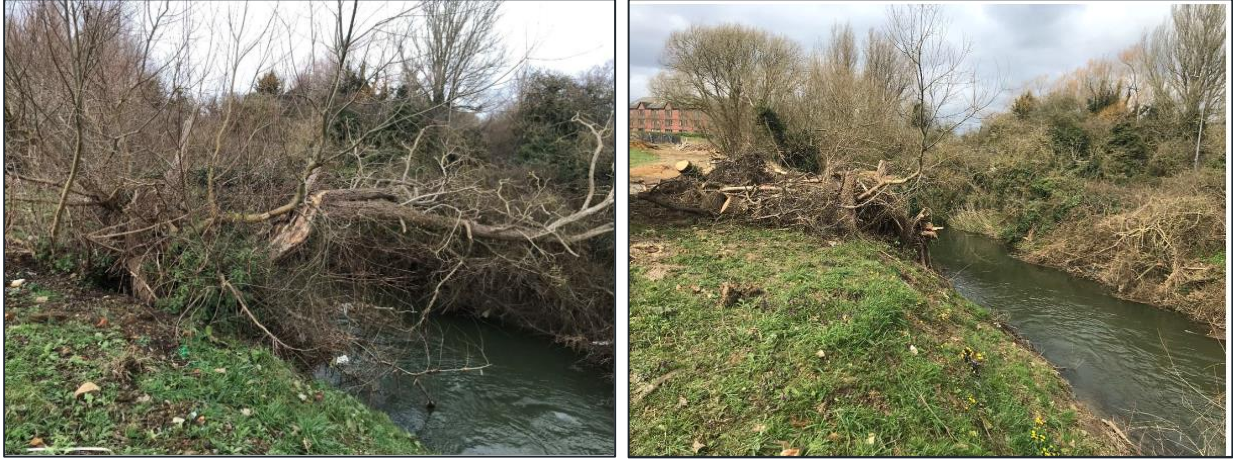
Figure 1-6 – Pre and post maintenance photos upstream of Watling Street Bridge

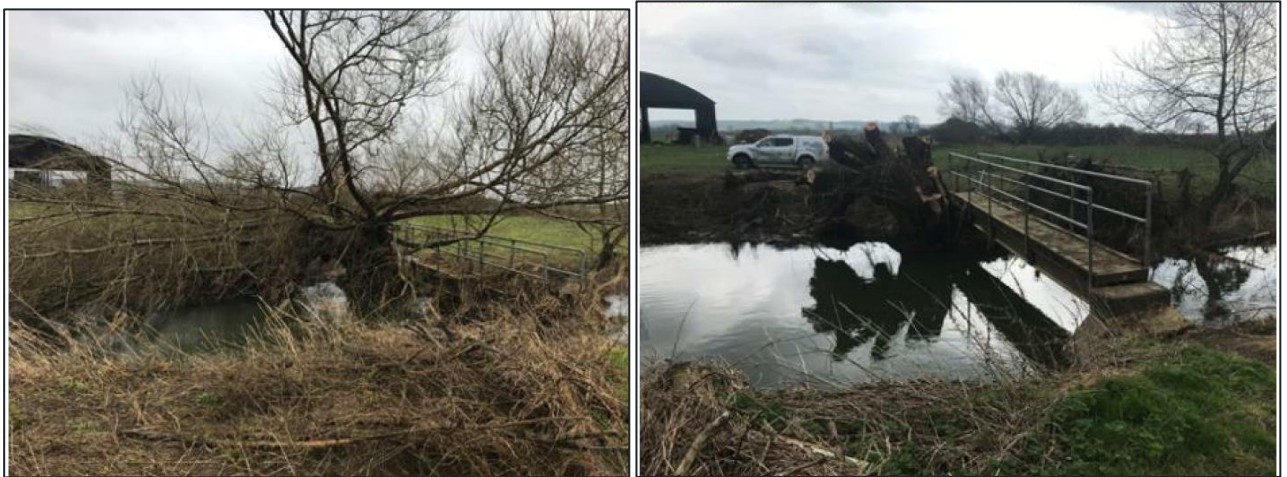
Figure 1-7 – Pre and post maintenance photos of Waterhall Park at the pedestrian bridge on Mill Road

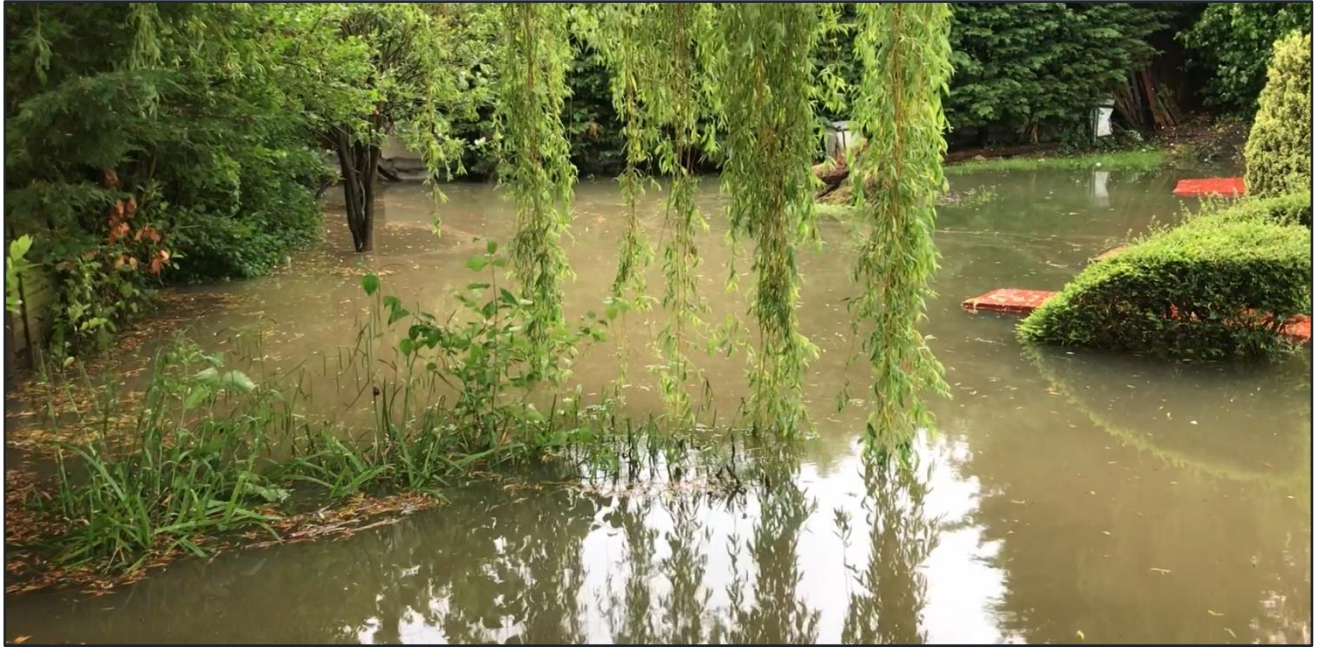
Figure 2-1 – Footage provided by resident showing flood extent in garden of the flooded property during the January 2021 flood event.

- 4.1.2. The flooding affected the garden of the property on Mill Road, owing to combined river and surface water flooding during the January flood event. Video evidence provided by a resident indicated that surface water runoff on Mill Road was unable to enter the sewer system due to flooding and therefore joined the River Ouzel near Mill Road bridge. The flow of the River Ouzel quickly increased, overtopping its banks and inundating the back garden of the property, merging with the ponds. Some flow was held back by a sluice gate and several pumping devices at the walled section at the eastern boundary of garden.

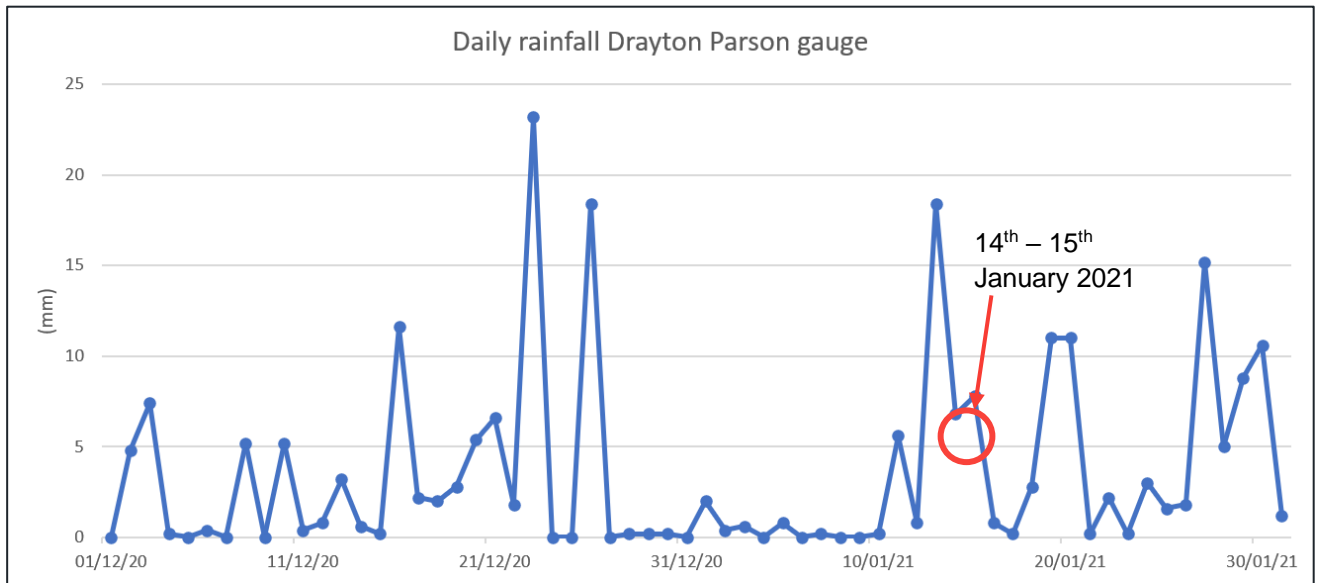
Figure 3-1 - 15 min rainfall (mm) recorded at Drayton Parslow

Figure 3-1 shows the results at Drayton Parslow from December 2020 to January 2021. Rainfall over the period of flooding from 14th to 15th January is shown to be less than 10mm, which is unlikely given the increase in surface water over the period. Additionally, reports by Flood Assist Insurance¹⁰ on 14th and 15th January, state that “river levels are rising at the Bletchley river gauge as a result of persistent rainfall. Consequently, flooding of property is expected over Thursday night and into Friday, 15/01/2021. We expect flooding to affect Mill Road, Watling Street and Belvedere Lane in Bletchley.”

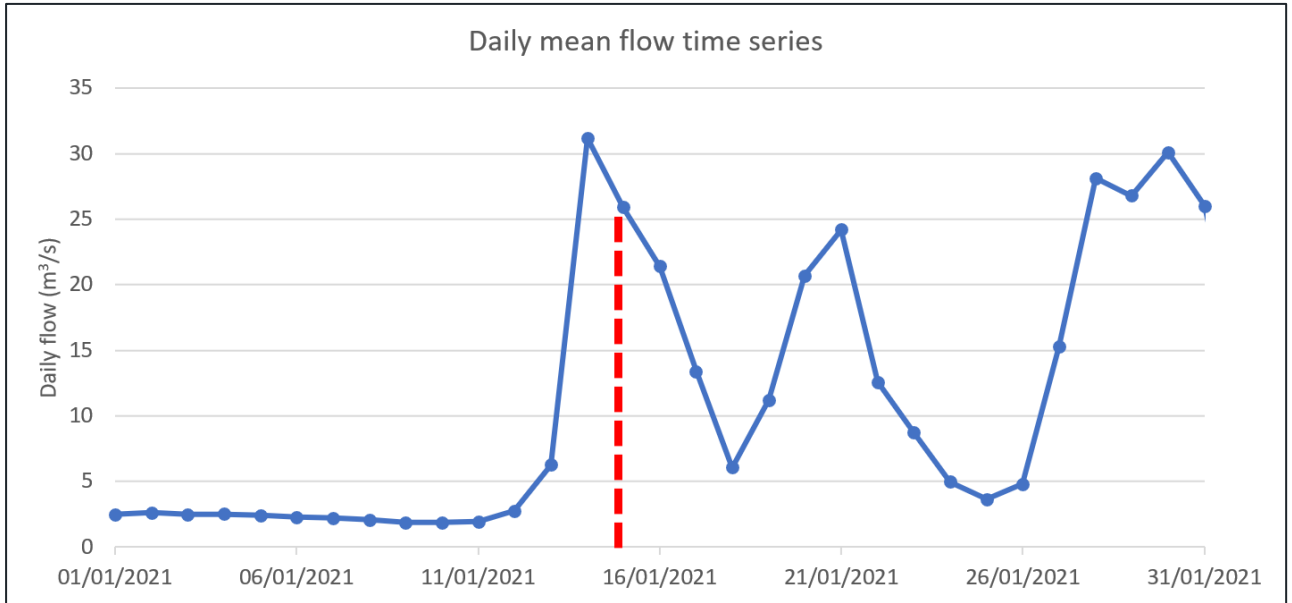
Figure 3-3 – Gauged daily flow at Bletchley gauge at River Ouzel. Source: National River Flow Archive (NRFA)

- 3.2.2. River gauge analysis has been based on gauging station data that has not been validated yet, which means that the outcomes from this analysis may change in future assessments.
- 3.2.3. Data obtained from the National River Flow Archive (NRFA)¹¹ and the Environment Agency for the 15th January 2020 at the Bletchley River gauge at River Ouzel is shown in Figure 3-3. This figure clearly displays a sharp rise in river flows, peaking at 31.2 m³/s on the 14th January, resulting from the heavy rainfall during the 14th and 15th January.

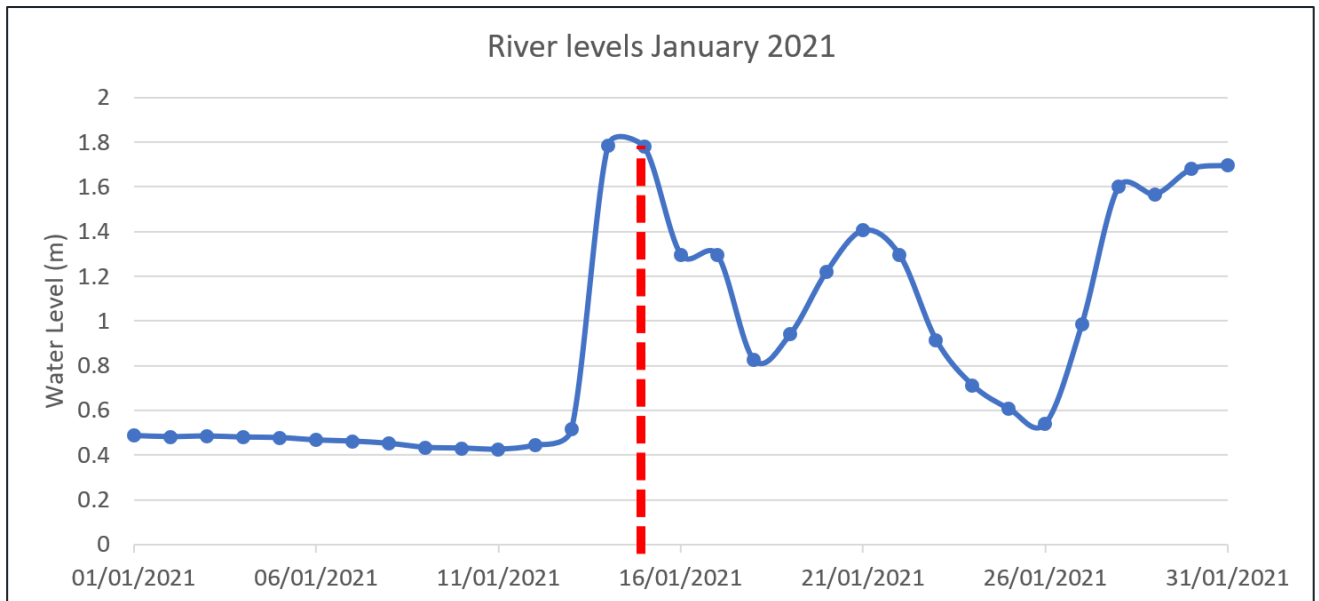
Figure 3-4 - River levels at Bletchley gauge

3.2.4. Figure 3-4 shows the river levels at the Bletchley gauge for January 2021. The water levels peaked at 1.79m at this gauge on 14th January and 15th January. This compares to an average daily water level of 0.46m between 1st to 12th January.
