MHA PSP4 MKCC Section 19 Flood Investigation Report

Section 19 Flood Investigation Report: 21st - 29th September
2024 Flood Event

Project number: 60740209

August 2025

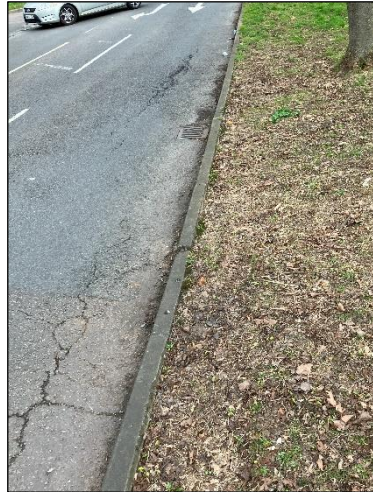
Photograph 1

As presented in **Photograph 1**, a depression in the road surface along Tattenhoe Lane at the junction of Sunningdale Way causes water to pond in this area next to the kerb, and as a result has led to cracks in the road surface. A gentle slope in topography of Tattenhoe Lane in both directions and Sunningdale Way conveys flows to the area of lowest elevation. During intense rainfall events, flows overtop the kerb and are channelled down the adjacent footpath towards the greenspace (**Photograph 2**). Site observations found a large area of raised ground in the greenspace which limits storage capacity in the area. As such, surface water is channelled down the side of the raised area towards impacted properties on Severn Way. Gullies were identified along Tattenhoe Lane, suggesting the capacity was exceeded or became blocked during the flood event.

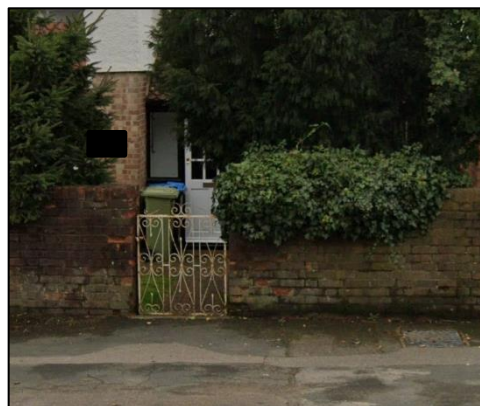
Photograph 3

Site observations found that the impacted properties along Buckingham Road (**Photograph 3**) have a ground floor and basement located below road level, which increases the risk of flooding in the event of overspill onto the footpath. A sewer manhole located on the footpath outside the impacted properties was also identified during the site visit.

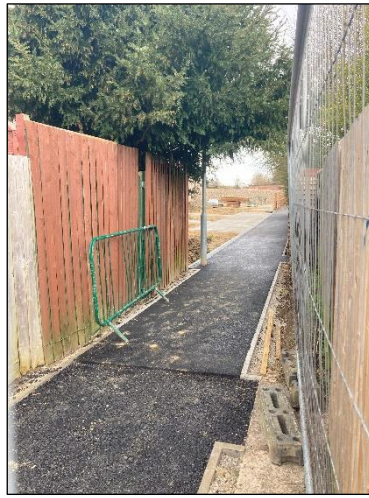
Photograph 4

Comparison of site visit observations and aerial imagery reveals a change in land use behind properties along Sheelin Grove. Previously greenfield land, the area was under construction for new properties at the time of the site visit, as shown in **Photograph 4**. This change likely increased impermeable surfaces, leading to surface water run off towards the back of impacted properties.

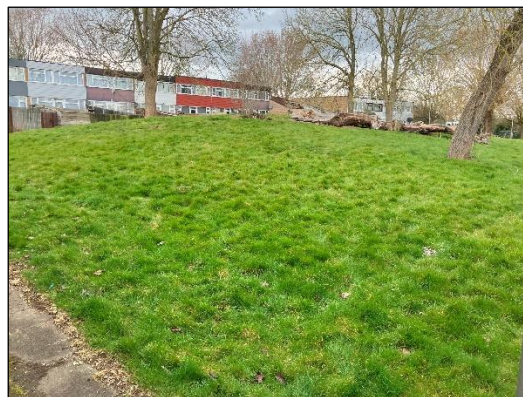
Photograph 5

Site observations noted that behind the affected properties along Nevis Road lies a greenspace characterised by a steep slope (**Photograph 5**). A small footpath, lacking drainage, separates the greenspace from the properties. It is likely that surface water flows are conveyed down the slope towards the properties, causing surface water ingress during intense rainfall events.

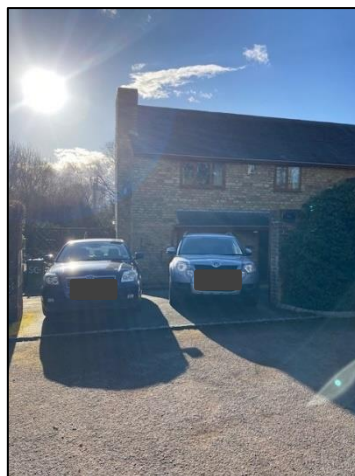
Photograph 6

Properties along Abbey Road are located at an area of low elevation with steep sloped driveway towards the front of the properties (**Photograph 6**). Site observations found that there were no gullies in Abbey Road outside of the impacted properties. Therefore, surface water likely runs off the road and down the sloped driveways leading to external flooding.

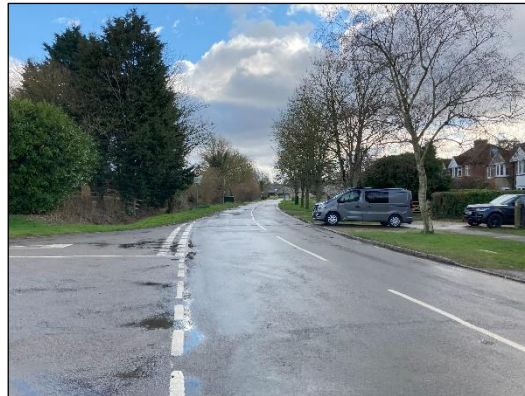
Photograph 7 shows that Olney Road is characterised by a gentle slope, which declines to the north towards Harvey Drive. At the northern end of Olney Road, a ditch is located opposite the impacted properties. However, it was noted that the ditch looked as if it had recently been de-vegetated and cleared. This suggests that this ditch may have been overgrown and highly vegetated leading to excess floodwater on the road causing external flooding at properties along Olney Road. During the site visit it was highlighted that Olney Road is busy with traffic. As such, bow waves are likely to have contributed to the external flooding at the impacted properties.

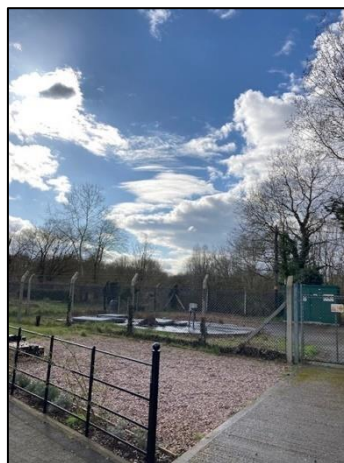
Photograph 8

As shown in **Photograph 8**, an AW Pumping Station is located in close proximity to properties along Harvey Drive. A large manhole is also located outside the impacted property. It is likely that stormwater from Emberton overwhelms the pumping station causing the manhole to discharge outside the properties.

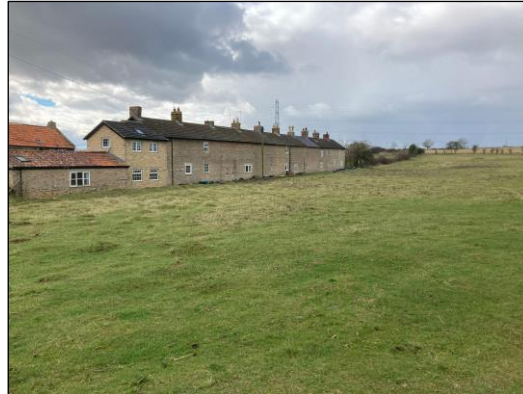
Photograph 13

Greenspace borders impacted properties at New Row and Rectory Farm. **Photograph 13** shows a decline in topography towards New Row with a natural depression behind the properties. It is likely that water seeped through the walls, at the back of the properties, due to the notable age of the buildings and relative structural stability. It was evident that residents had excavated a ditch behind the properties in an attempt to divert the water. At the time of the site visit, sandbags at the back of the properties were still in place. Similarly, the topography of the adjacent greenspace declines towards Rectory Farm, likely channelling surface water flows towards the property.

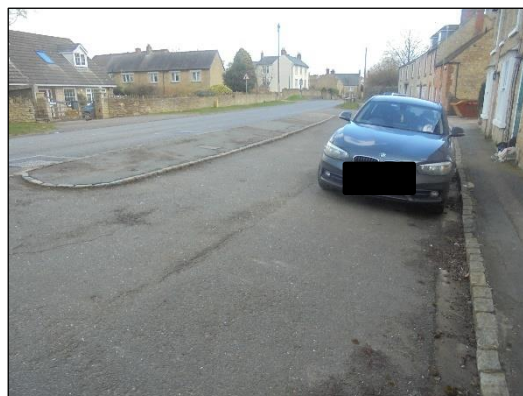
Photograph 14

Northampton Road is characterised by a slope which declines southeast. The road is relatively wide due to on street parking. The high levels of impermeable surfaces increase the rate and volume of surface water conveyed downslope towards the centre of Lavendon. Northampton Road slopes towards the impacted properties (**Photograph 14**) and flows are likely to be conveyed to the area of lowest elevation. Although there is a small kerb outside the properties, the property thresholds are at kerb height which increases the risk of water ingress in the event of surface water on the footpath. Site visit observations noted that there are numerous drains along Northampton Road which suggests that these may have been blocked or exceeded capacity during the flood event.

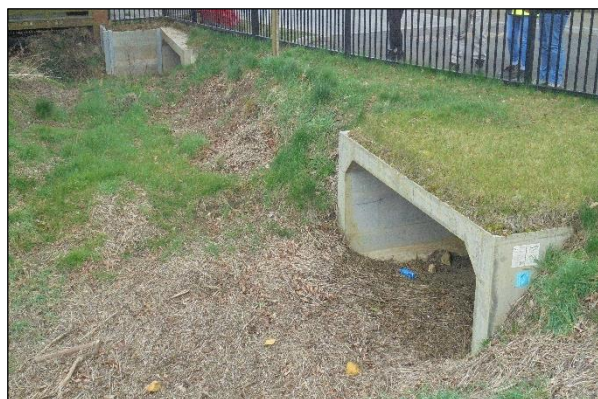
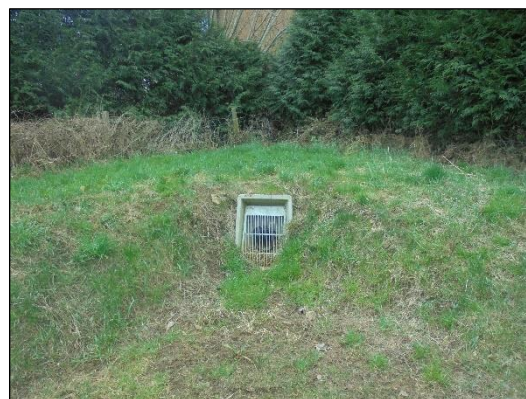
Site observations confirmed that two flood storage basins are located either side of The Glebe connected to a small unnamed Ordinary Watercourse. Two large square culverts (**Photograph 15**) allow water to follow under The Glebe into the second basin where the water is then culverted through a small pipe (**Photograph 16**) back into the unnamed Ordinary Watercourse. The water likely overspilled the two basins onto the road and into the gardens of adjacent properties due to a constriction in flow through the small pipe into the Unnamed Ordinary Watercourse. The gardens of the impacted properties also have a low threshold.

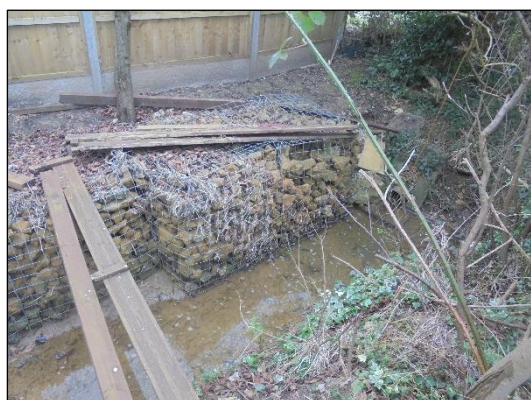
Photograph 17

An unnamed Ordinary Watercourse flows behind properties located in the south section of Castle Road (**Photograph 17**). The size of the channel alongside the intensity of the rainfall event likely led to flooding of the Ordinary Watercourse. The channel had been eroded (**Photograph 18**) and fencing and decking had been damaged during the flood event. As such, it is likely that the channel capacity was exceeded, and water flowed through the back gardens into adjacent properties.

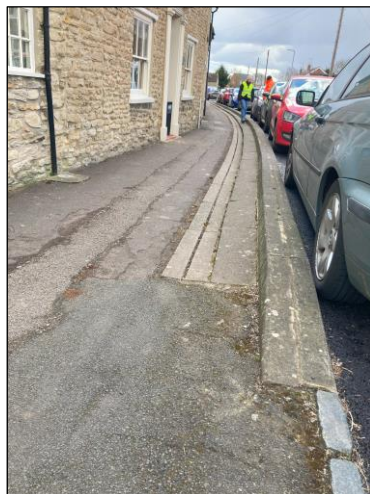
Photograph 19

been dropped at the top of Olney Road to allow for pedestrian access. The kerb then raises significantly in front of low threshold properties to prevent overtopping of flow from the road. However, it is likely that water is conveyed behind the raised kerb, due to the dropped kerb at the top of Olney Road, which then becomes trapped and flows into adjacent properties with low thresholds. Site observations found that there is a drain behind the raised kerb however this is small and was partially blocked. As such, the water likely ponds at the front of the properties during a flood event causing seepage and surface water ingress. The road slopes towards impacted properties at the south of Olney Road, down a small side street.

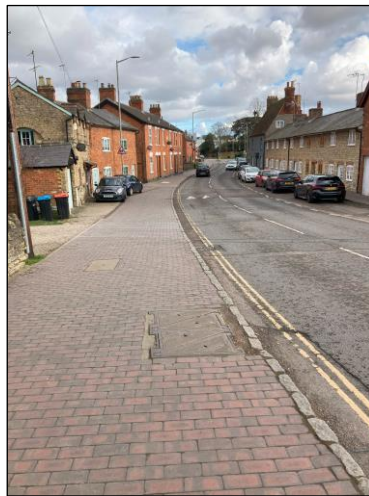
Photograph 24

Tickford Street is relatively wide due to on street parking, providing a large area of impermeable surface (**Photograph 24**). The road gradually slopes away from Tickford Bridge, likely channelling water down Tickford Street. Site observations found that Tickford Street is a busy road, with bow waves from passing vehicles potentially contributing to external flooding at properties along the road, as evidenced in **Photograph 21**. During the site visit, it was also noted that various gullies were located along Tickford Street which were clear.

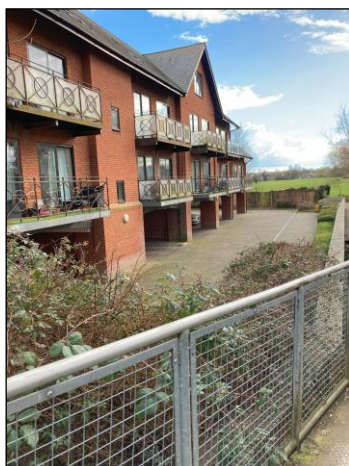
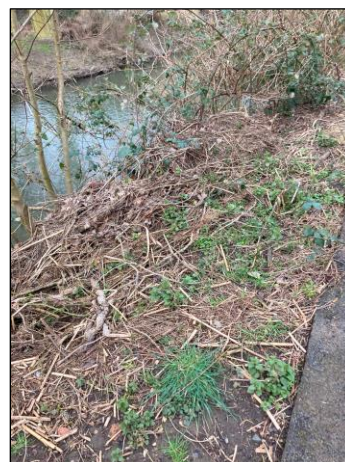
Reports also noted external flooding at impacted properties near Tickford Street. Site observations found that the building is situated at a lower elevation, at river level, compared to Tickford Street, and is adjacent to the Main River Ouzel. Despite the presence of a boundary wall (**Photograph 25**), it is likely that the river was overtopped during the flood event and floodwater seeped through and/or overtopped the wall. This was evidenced by damaged vegetation and the eroded embankment along the riverside, which was littered with washed up debris (**Photograph 26**). All residential properties in this location are elevated above river level, as the building is constructed on stilts and the area underneath is used as a car park (**Photograph 25**). The large impermeable area reduces capacity for infiltration and likely led to ponding of flood water behind the boundary wall.

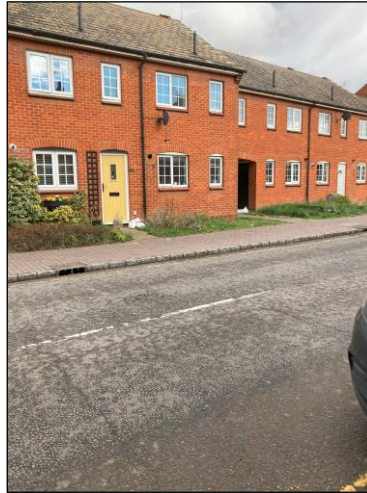
Photograph 27

Flooding on Priory Street occurred due to elevated water levels in the River Great Ouse, which prevented the discharge of surface water into the river. As a result, the capacity of the surrounding land to drain effectively was reduced, leading to the surface water system becoming overwhelmed and surcharging. Additionally, surface water accumulated behind fluvial defences, further contributing to the flooding. As shown in **Photograph 27**, the kerb heights along Priory Street are high, suggesting that floodwater exceeded this height, leading to surface water ingress. At the time of the site visit, sandbags were still in place at the front of properties. Numerous gullies were identified during the visit suggesting the capacity was exceeded or became blocked during the flood event.

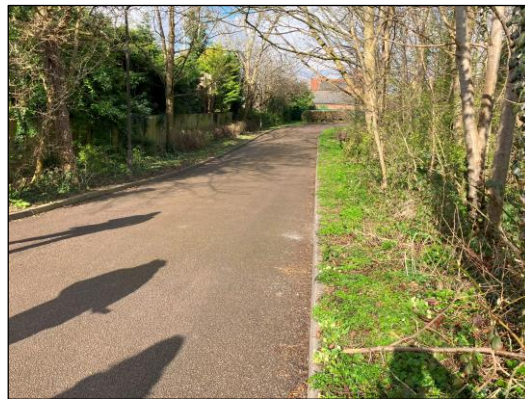
Photograph 29

A small, unnamed road is located behind the impacted properties along Milford Avenue, which connects London Road to Buttons Pre-School. The unnamed road is characterised by a slope from both ends which results in a low point behind the impacted properties, as shown in **Photograph 29**. Surface water is likely to flow from London Road and the pre-school car park to area of lowest elevation. During the site visit, no gullies were identified along the unnamed road which likely led to ponding, and subsequent overtopping of the kerb during periods of high rainfall. A manhole was identified on the unnamed road.

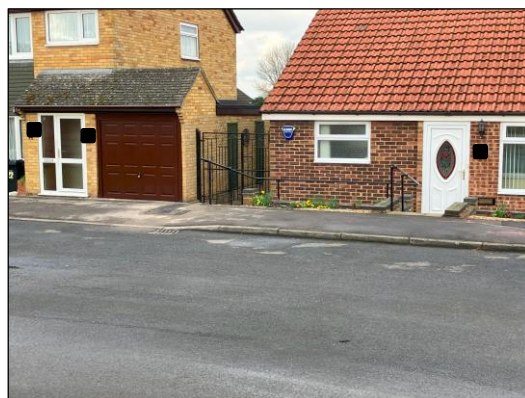
Photograph 30

Impacted properties on Goran Avenue have driveways that slope towards the buildings, while properties on the opposite side of the street have driveways that slope away from the buildings. It is likely that surface water flows towards the properties at a lower elevation leading to internal flooding. **Photograph 30** shows properties situated at a lower elevation than the road surface. Site observations noted that numerous properties had paved driveways, likely exacerbating surface water run off due to the increase in impermeable surfaces. The kerb height along Goran Avenue varies, allowing surface water to be transferred onto the pavement and towards impacted properties where the kerb is low. Furthermore, impacted properties also had low thresholds with entryways at the same height as the road. Numerous gullies were identified along Goran Avenue suggesting that these may have been blocked or exceeded capacity during the flood event.

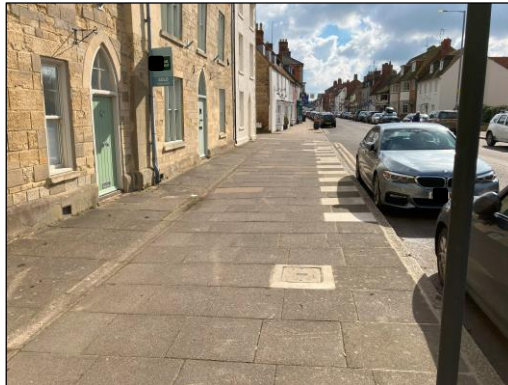
Photograph 31

Stony Stratford High Street is one of the longest and widest roads in the hotspot, due to on street parking on both sides and wide footpaths (**Photograph 31**). The topography of High Street is relatively flat, and the total impermeable area likely reduces capacity of infiltration, increasing the volume and rate of ponding. Due to being a commercial high street, property thresholds are the same level as the footpath for access. Numerous gullies were identified, however high water levels in the River Great Ouse prevented surface water discharge into the river. Furthermore, due to the age and design of buildings along High Street, surface water run-off from the properties flow directly onto the High Street and exacerbates flooding in the area.

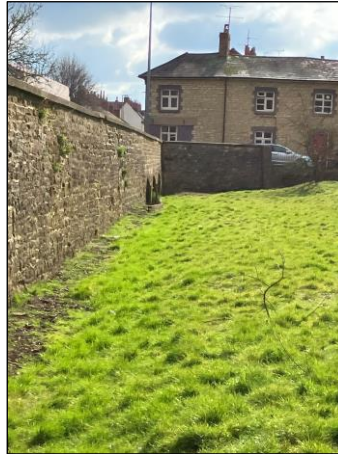
Photograph 32

The River Great Ouse borders an area of greenspace known as Tombs Meadow, which is adjacent to Temperance Terrace. Onsite MKCC representatives noted that during flood events, Tombs Meadow serves as a floodplain, with water flowing through the bridge arches into the greenspace on the opposite side (**Photograph 32**). The EA FMfP shows that Temperance Terrace is located within Flood Zone 2 and 3, therefore it is likely that internal flooding was caused by fluvial sources.

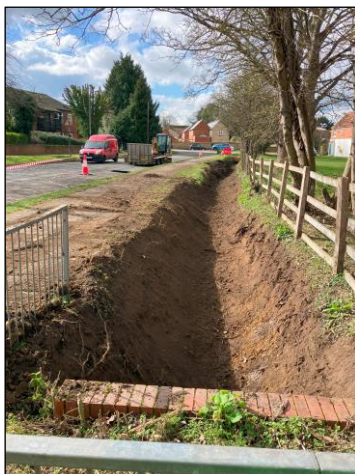
Photograph 33

At the time of the site visit, a large ditch was being maintained outside the Cricket and Football Club (**Photograph 33**). It was noted that during the flood event, the ditch was too shallow to store or divert surface water from Ostlers Lane and away from the clubhouses. Site observations found that Magdalen Close gently slopes towards Ostlers Lane, which borders the Cricket and Football Club. It is likely that surface water flows are channelled down Magdalen Close and along Ostlers Lane towards the impacted property via the sloped entries to the car park (**Photograph 34**).
