# FLOOD RISK INVESTIGATION

Stony Stratford Section 19 Report

**PROJECT NO. 70082487**

**DATE: NOVEMBER 2021**

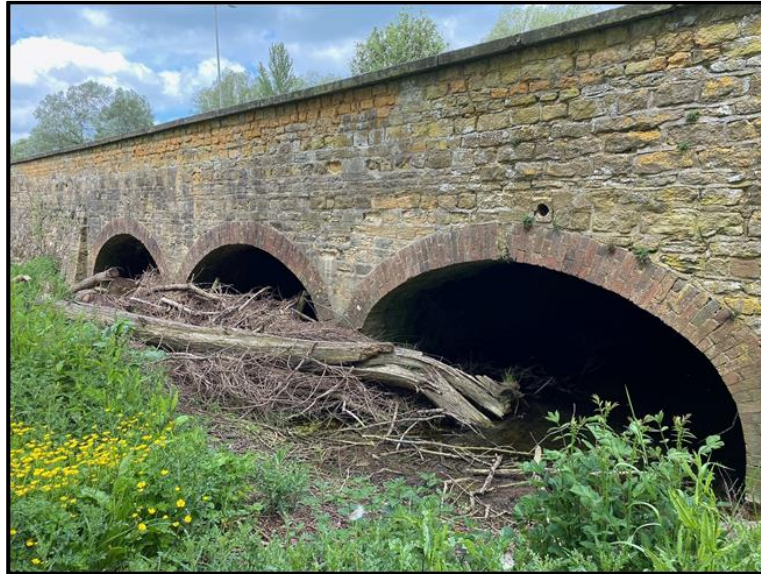
**Figure 1-1** - Tombs Meadow Arches located on London Road (north of the High Street) partially blocked by debris.

It is understood that high water levels of the River Great Ouse caused flooding in the southern and northern area of the High Street and the High Street itself at Stony Stratford. The overgrowth vegetation and raised land adjacent to the culverts underneath Queen Eleanor Street impeded fluvial flows getting into the Stony Stratford Nature reserve, this may have adversely impacted the flooding in the High Street.

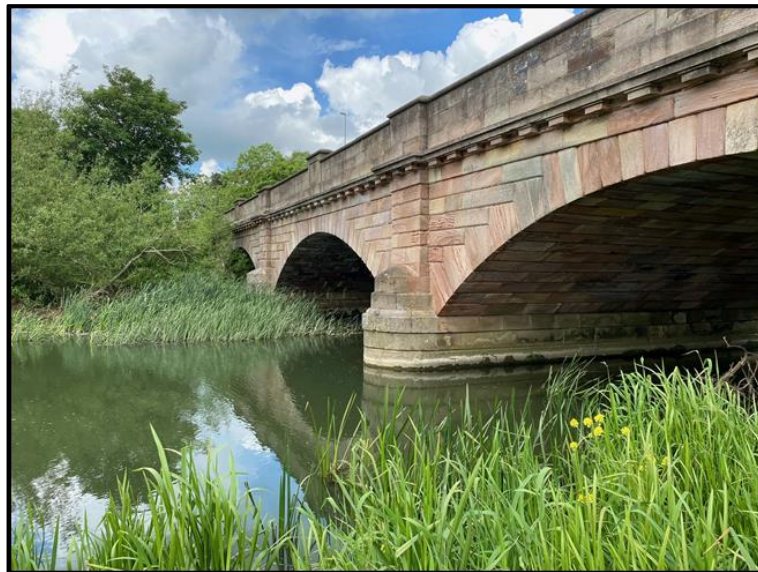
**Figure 1-2** – Three arch bridge located further north on London Road, with one arch partially blocked by overgrown vegetation. Evidence of reduction in river flow capacity of the River Great Ouse.

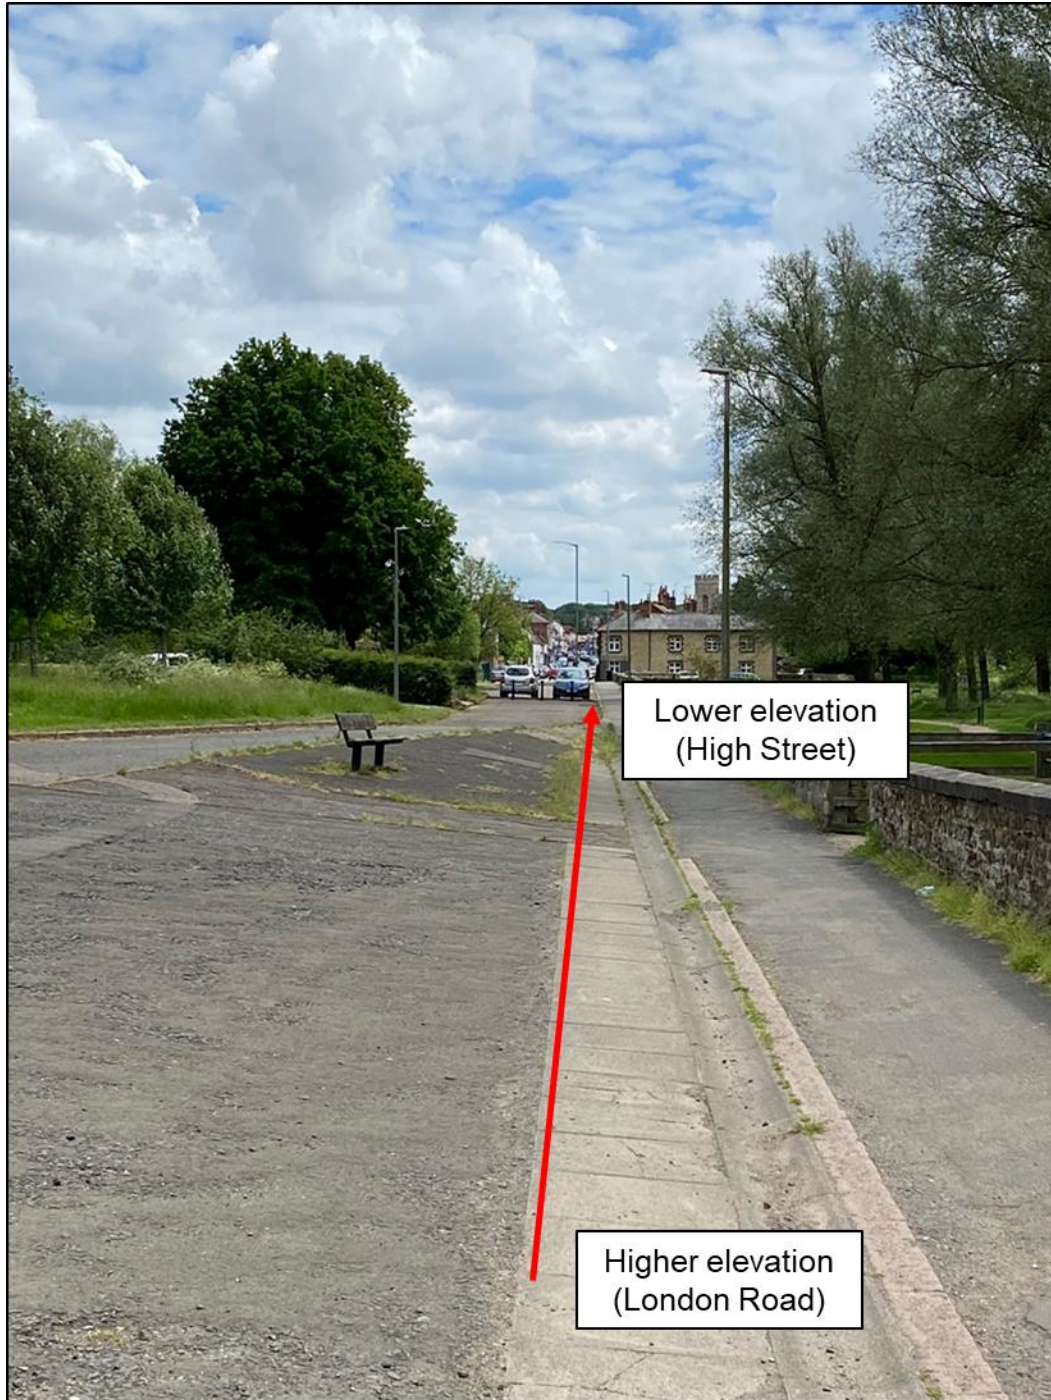
**Figure 1-3** - Evidence of drop in elevation from London Road (north) to the High Street (south) that might encourage conveyance of surface water runoff to the High Street located in local low point.

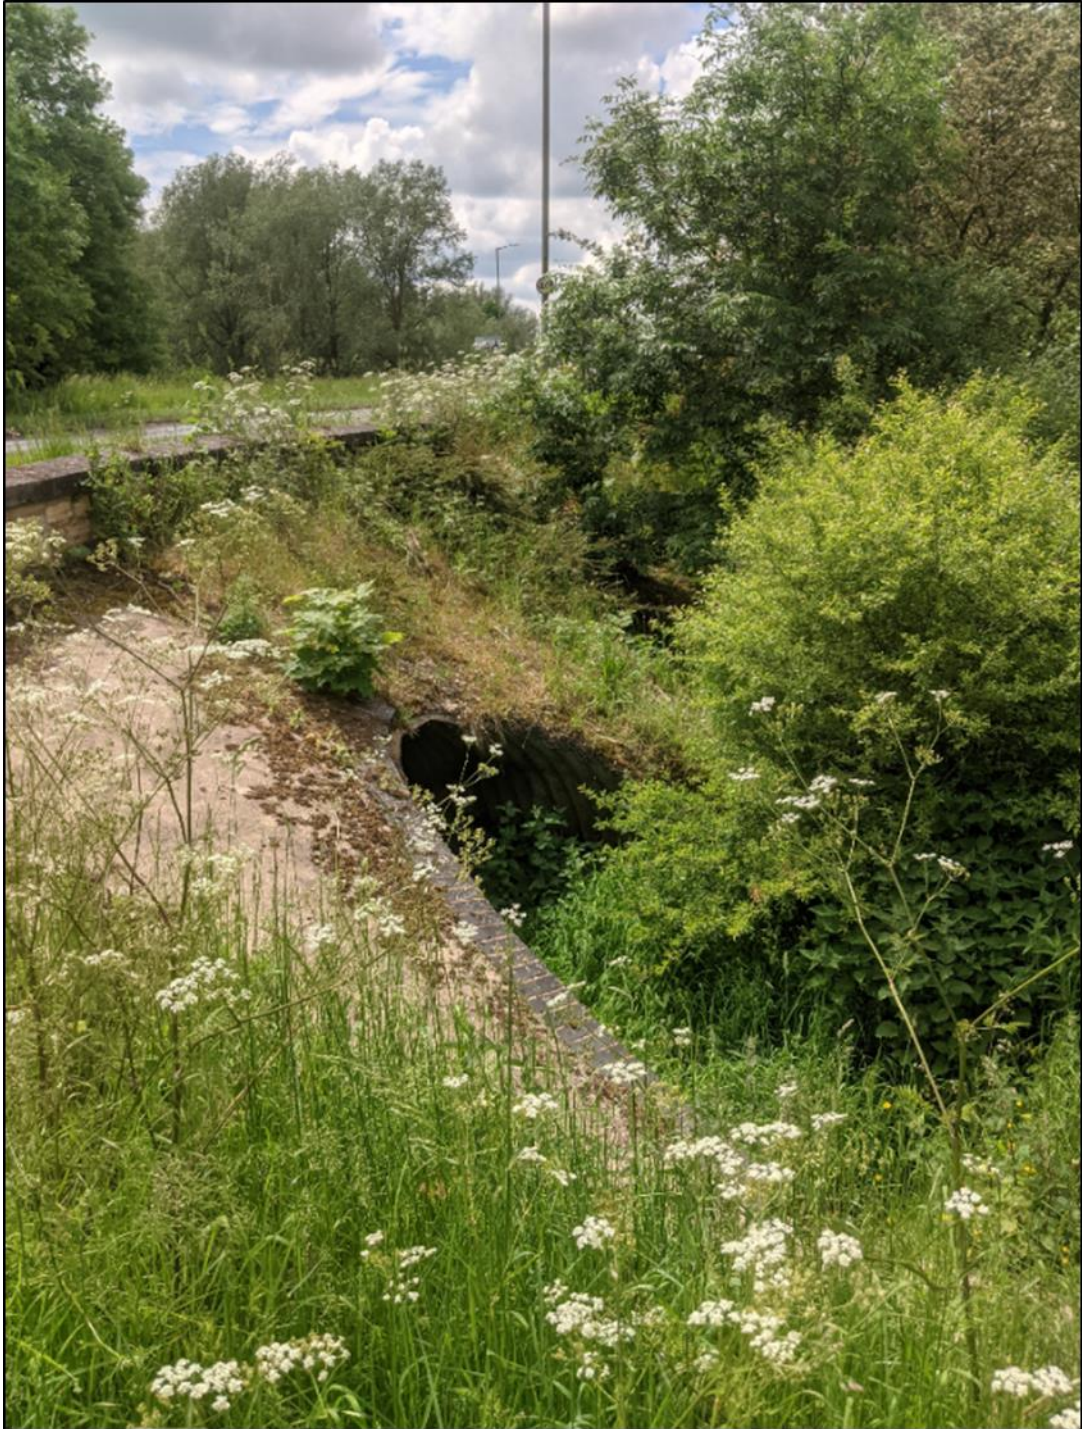
**Figure 1-4** - Three culverts under Queen Eleanor Street. Evidence of at least two of the three culverts partially or totally blocked with debris and overgrown vegetation. Culverts potentially connected to River Ouse Valley Park.

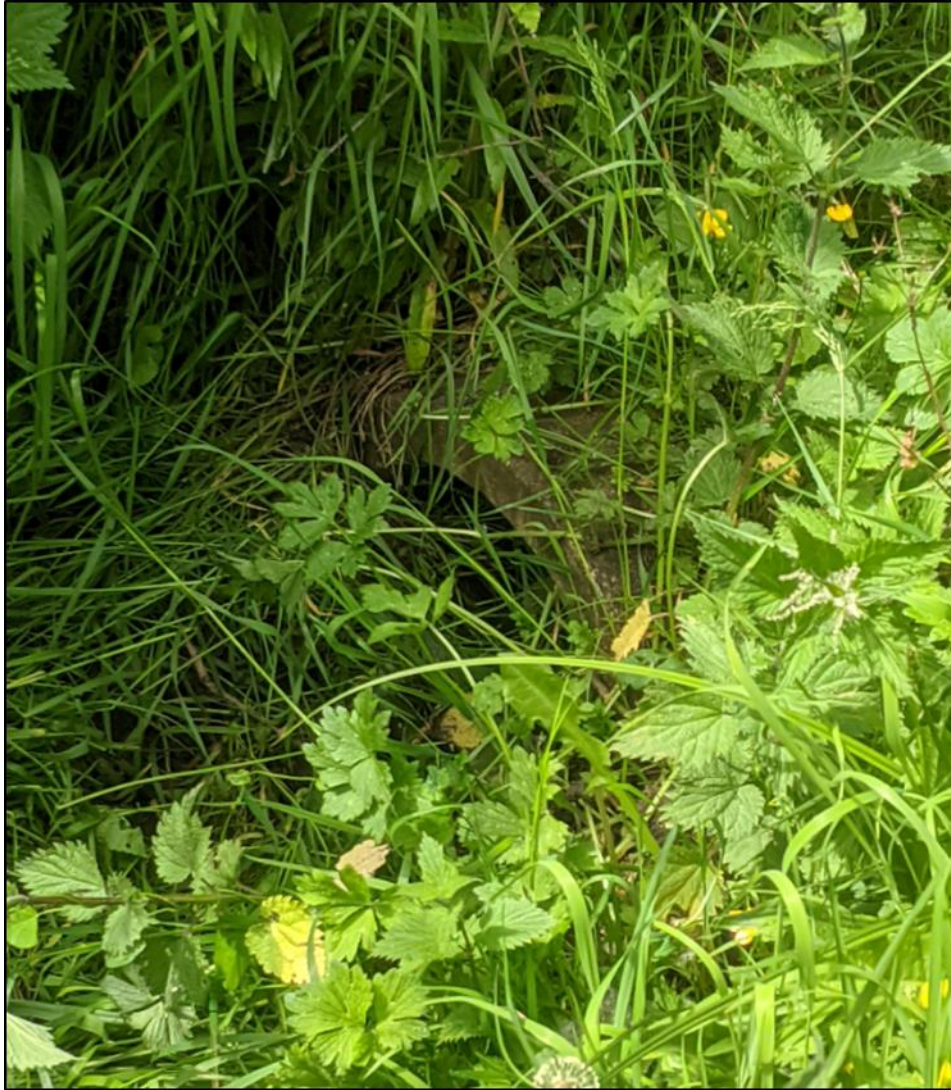
**Figure 1-5** - Evidence of approximately 300mm culvert partially blocked with debris and vegetation. This culvert is connecting culverts in Figure 1-4 (culverts of significantly bigger dimensions and capacity) with the River Ouse Valley Park.

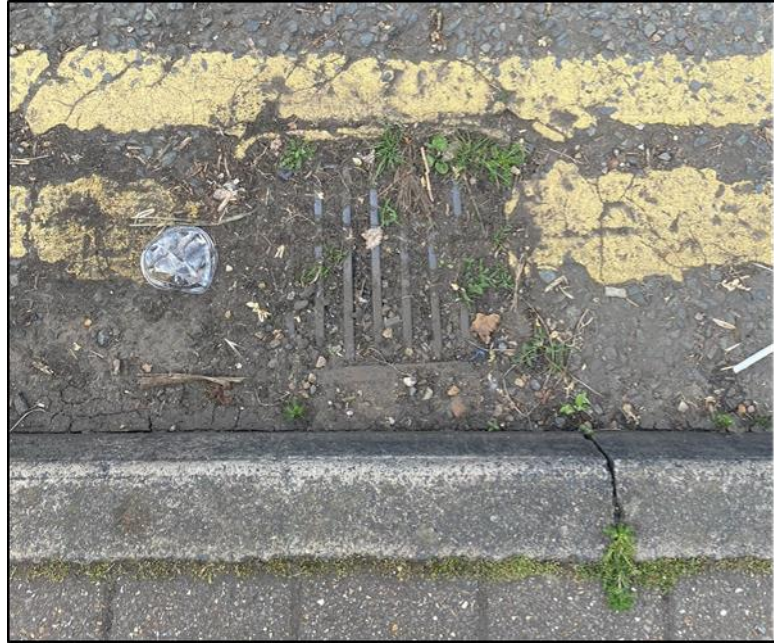
**Figure 1-6** - Evidence of blocked drain at Willow Lane and Prospect Road.

During the site visit, blocked gullies were observed at Willow Lane which could have been exacerbated surface water flooding in the area. However, it is unclear if the gullies became blocked after the event or the blockages were caused by the event itself. Therefore, a further study would be required if a greater understanding as to whether the condition and current capacity of the drainage network were a key factor in the flooding mechanisms at this location. Milton Keynes Highways reported that gullies were last cleaned in October 2017 and further maintenance is due in October 2021 based on the current cleansing cycle.

- Develop further hydraulic studies to determine any potential capacity issues within the surface sewer system.
- Undertake CCTV survey in critical areas to identify potential blockages or defects in the surface sewer network.

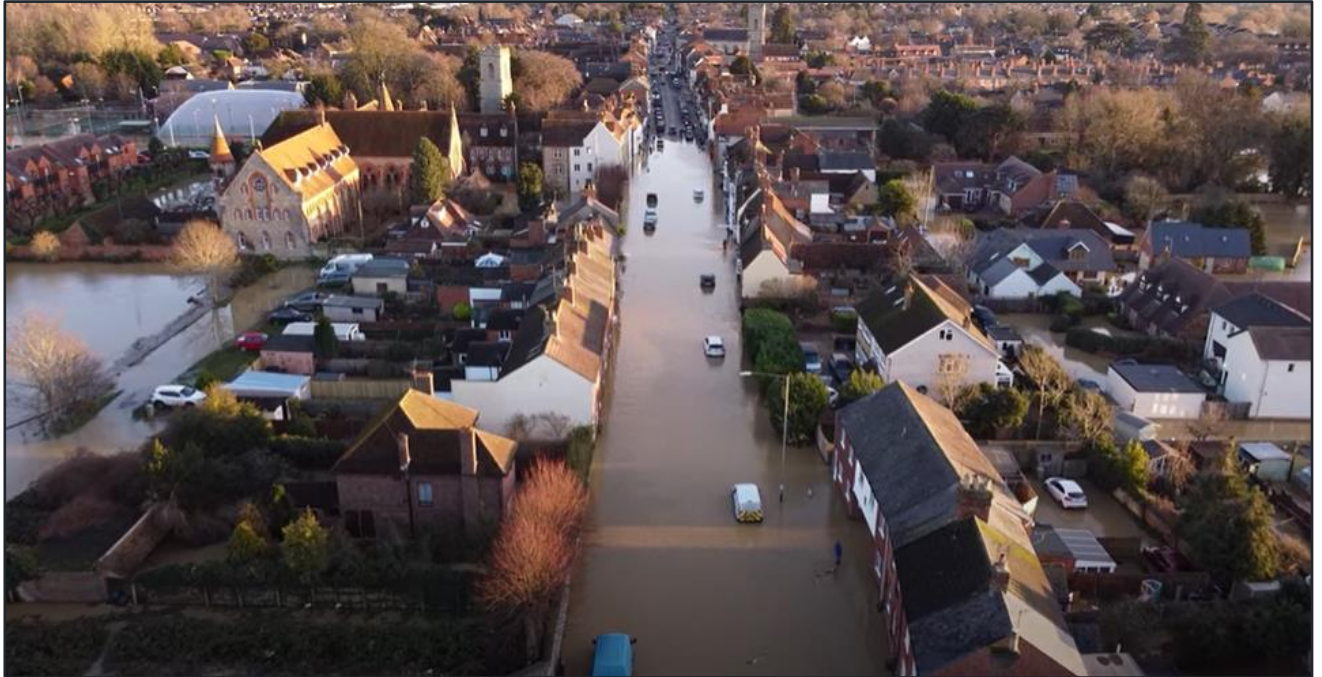
**Figure 2-1** – Drone footage showing flood extent at Stony Stratford High Street during the Christmas Eve flood event.

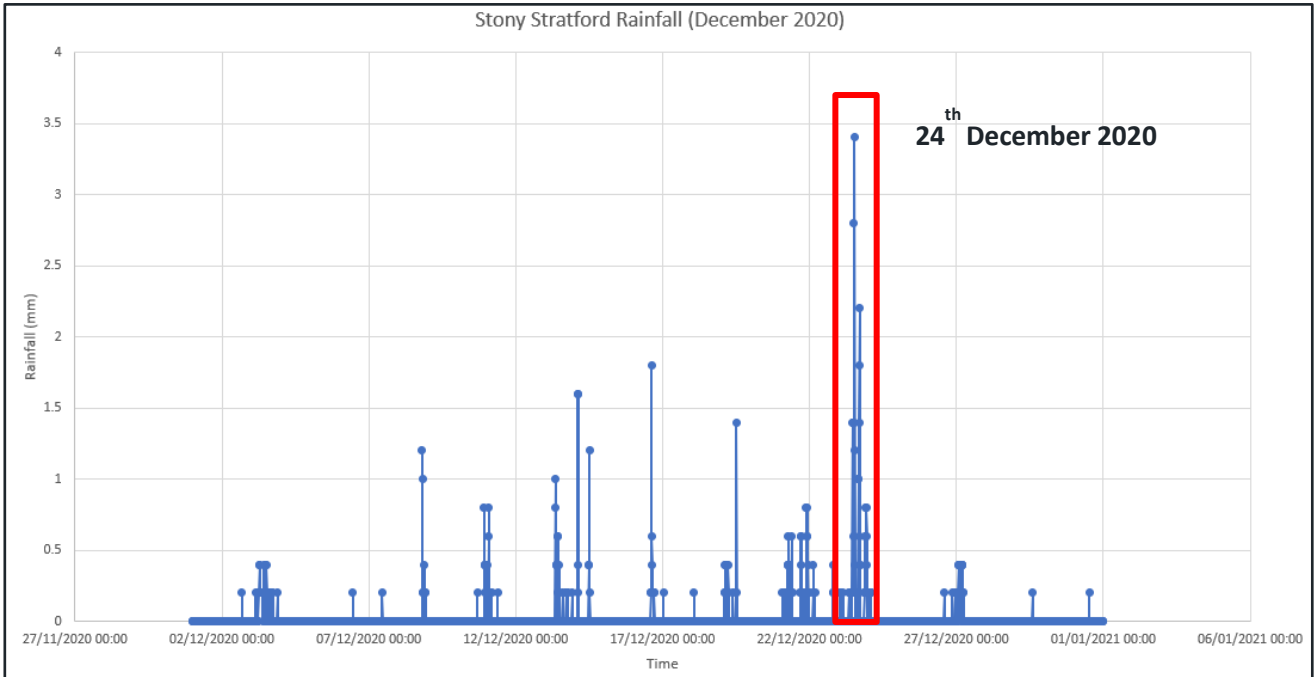
Figure 3-1 - 15min rainfall (mm) recorded at Foxcote E23657

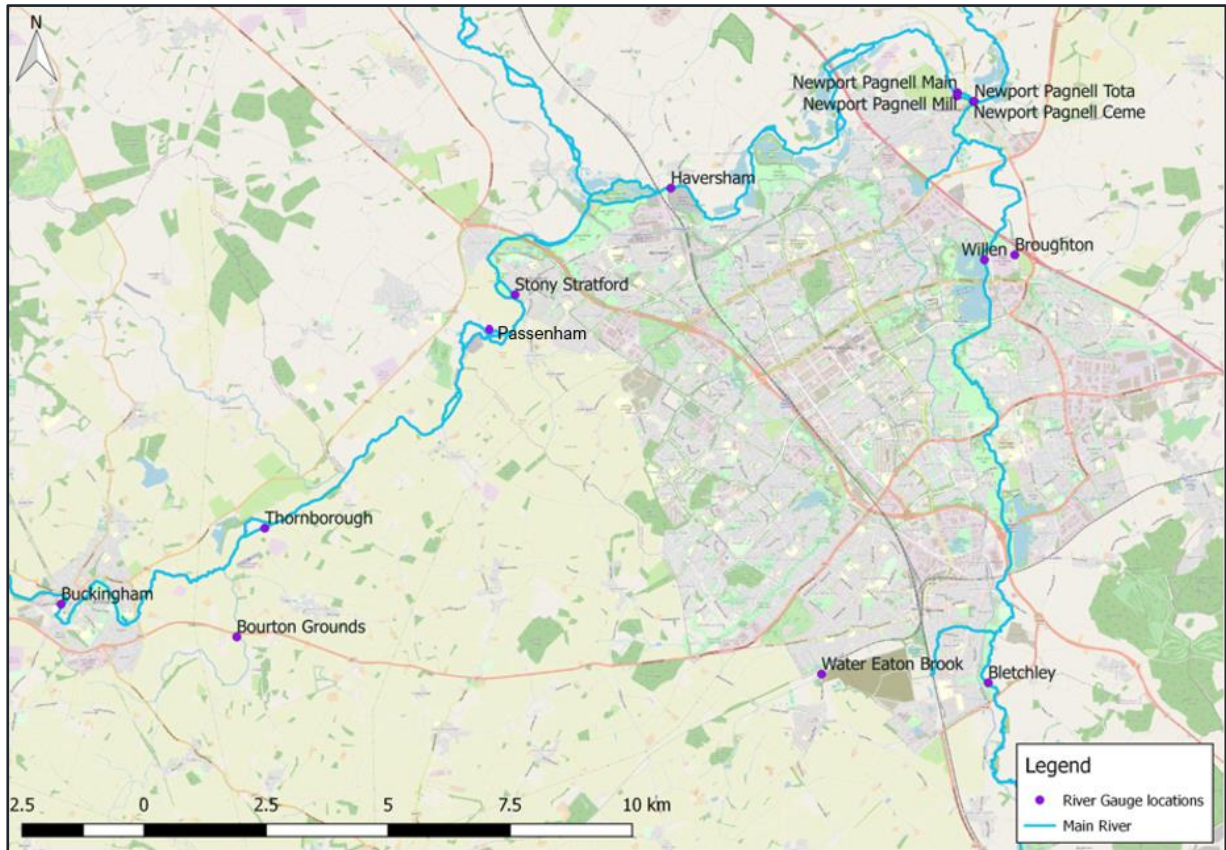
There are several river gauges along the River Great Ouse. Stony Stratford gauge is located within Stony Stratford next to the Mill Field (See Figure 3-3). The EA owns and maintains this gauge.

**Figure 3-3 - Location river gauges at Stony Stratford**

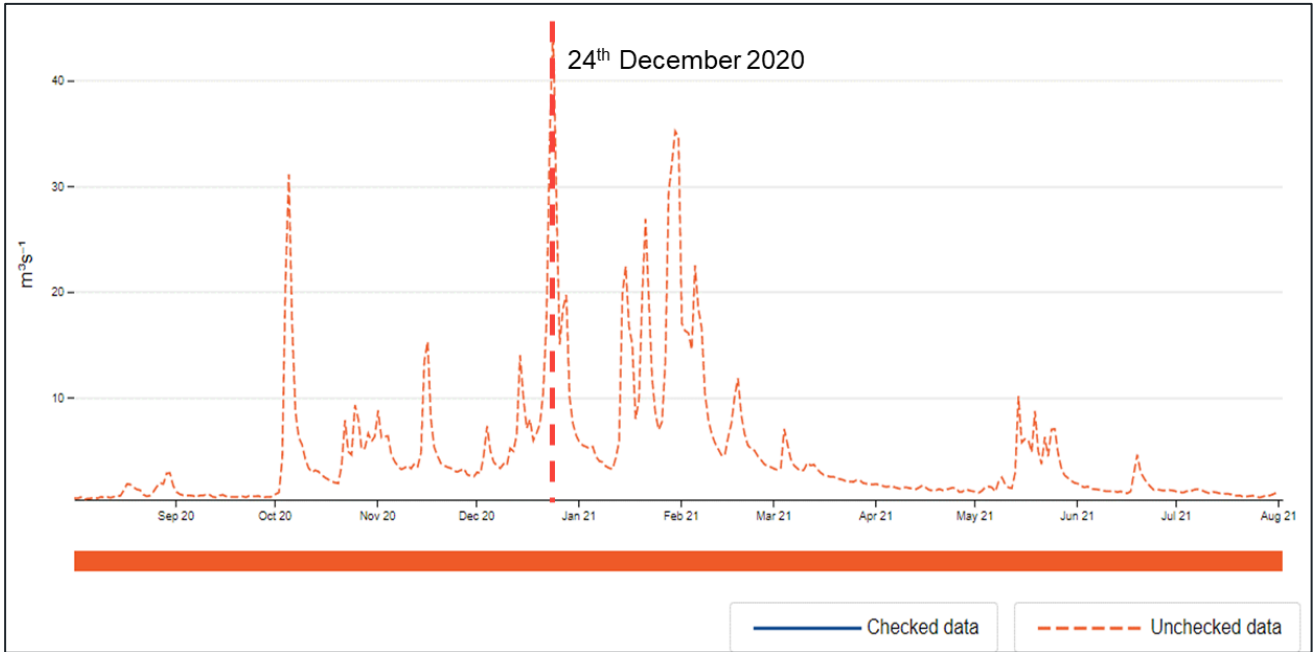
Data obtained from the National River Flow Archive (NRFA)<sup>15</sup> and the EA for the 23<sup>rd</sup> and 24<sup>th</sup> December 2020<sup>th</sup> at the Passenham Ultrasonic gauge at River Great Ouse is shown in Figure 3-4. This figure clearly indicating a steep rise in river flows, with a peak estimated above 45.3 m<sup>3</sup>/s on the 24<sup>th</sup> of December as a result of the heavy rainfall during the 23<sup>rd</sup> December on the River Great catchment Ouse upstream of Stoney Stratford.

**Figure 3-4** – Gauged daily flow at Passenham Ultrasonic gauge at River Great Ouse. **Source:** National River Flow Archive (NRFA)

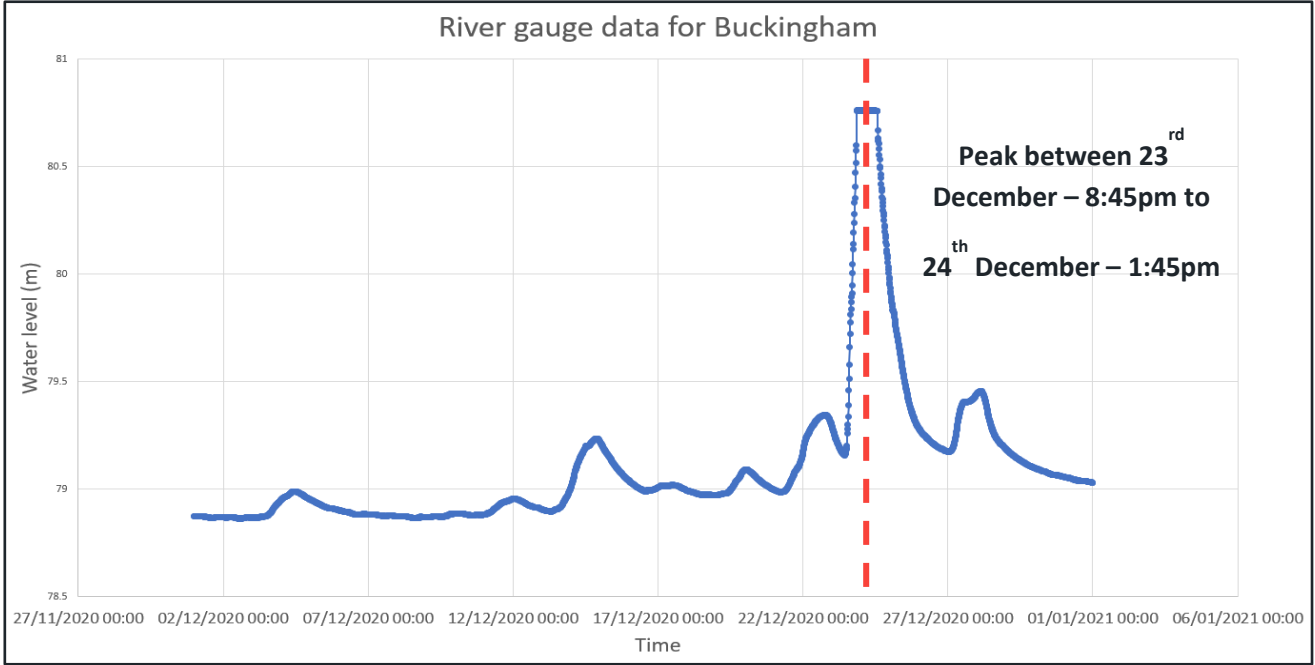
**Figure 3-5** - River levels at Buckingham gauge

Figure 3-5 shows the river levels at the Buckingham gauge which is located within the upstream reach of the catchment. The water levels peaked at this gauge from 23<sup>rd</sup> December – 8:45pm to 24<sup>th</sup> December – 1:45pm, indicating high water levels overnight of the 23<sup>rd</sup> December. Figure 3-6 shows river levels at the Thornborough gauge which is located further downstream of the River Great Ouse, between Buckingham and Stony Stratford. The water levels peaked here on the 24<sup>th</sup> December at 10.00am. This indicates the high-water levels in Buckingham overnight of the 23<sup>rd</sup> December propagated downstream to Thornborough where high water levels were present by the morning of the 24<sup>th</sup> December. Figure 3-7 shows river levels at the Stony Stratford gauge (location indicated in the Figure 3-3), for which there is a data gap between 14<sup>th</sup> December 2020 and 11<sup>th</sup> January 2021.

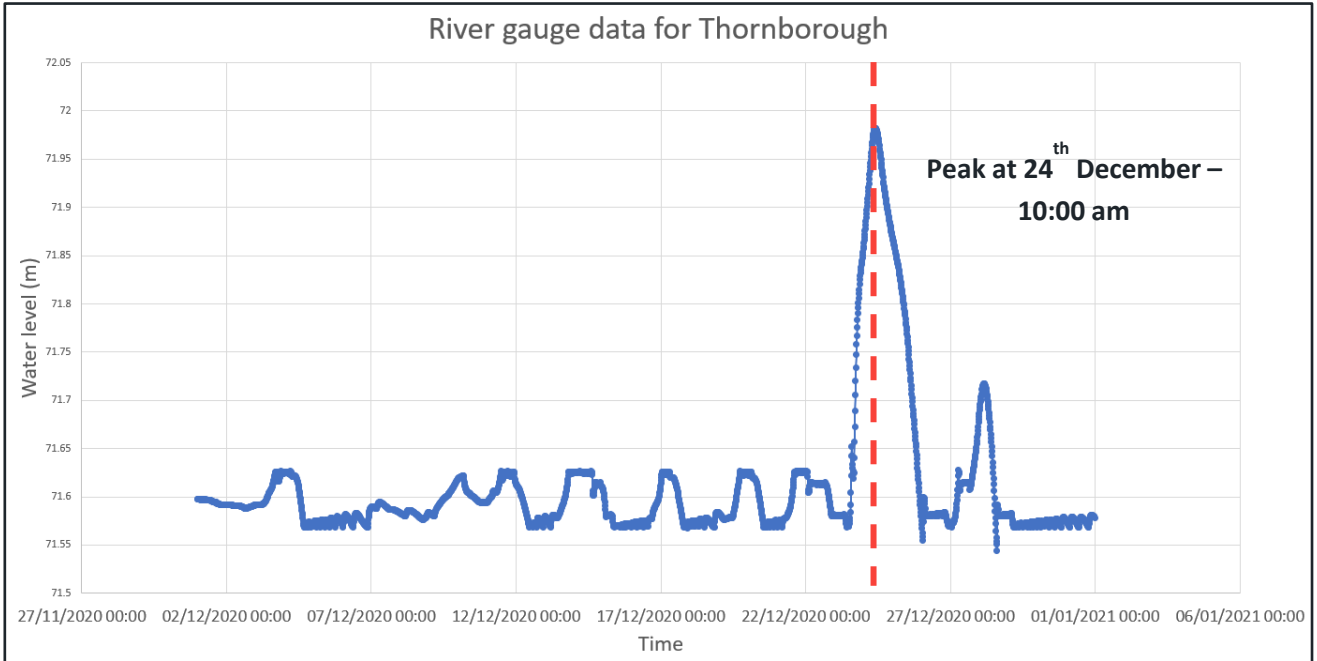
**Figure 3-6 - River levels at Thornborough gauge**

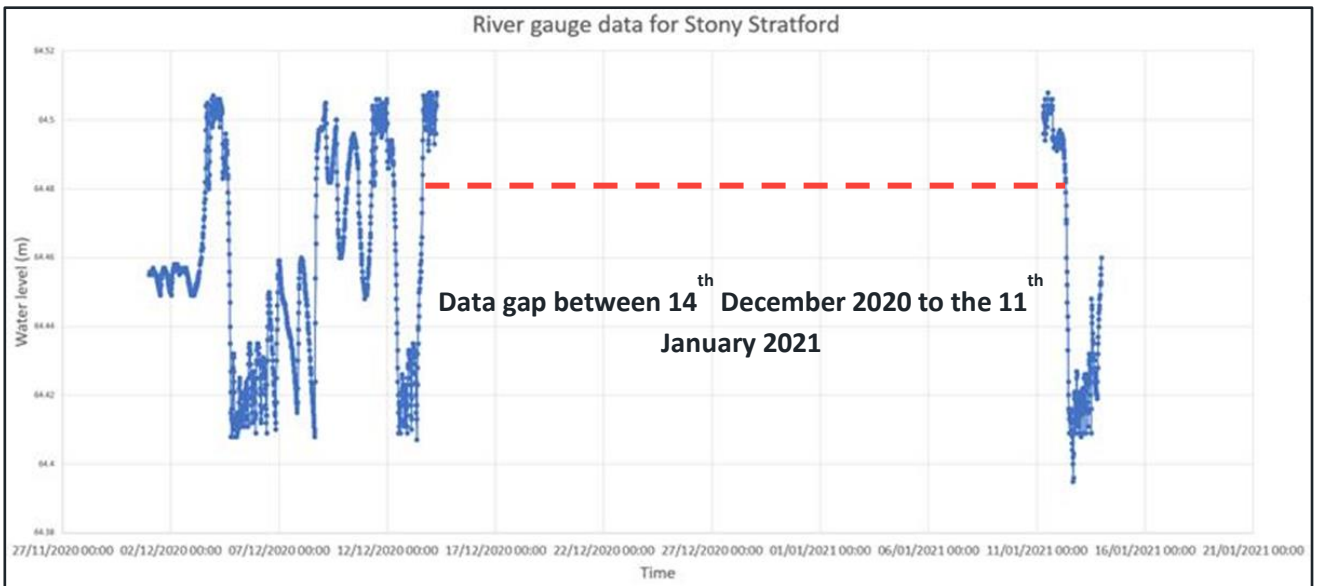
**Figure 3-7 - River levels at Stony Stratford gauge**

This discontinuity in the river level data was caused by a communication issue with the gauge, resolved and reconnected on 11<sup>th</sup> January 2021.

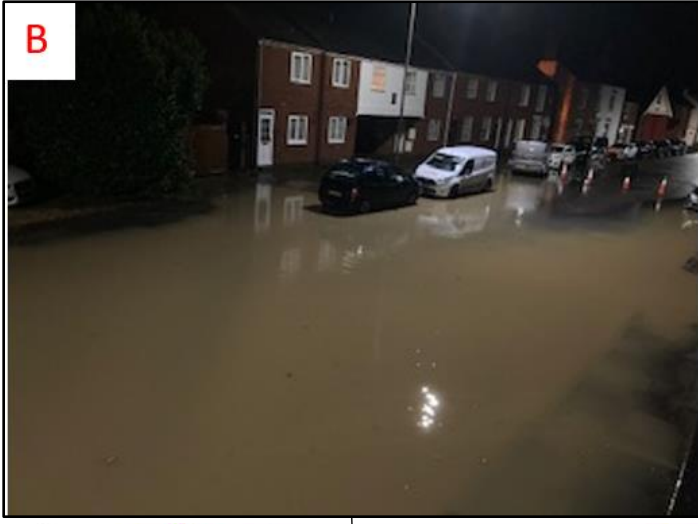
Flood extent at the High Street during the night of the 23<sup>rd</sup> December 2020

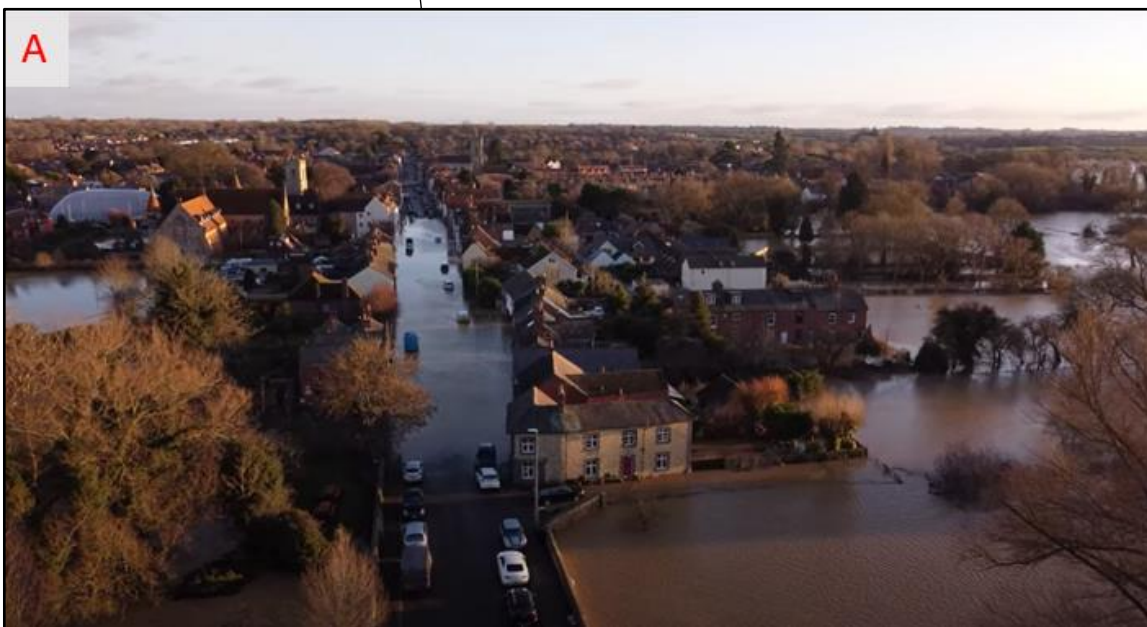
Drone footage showing flood extent at Stony Stratford High Street during the Christmas Eve flood event.

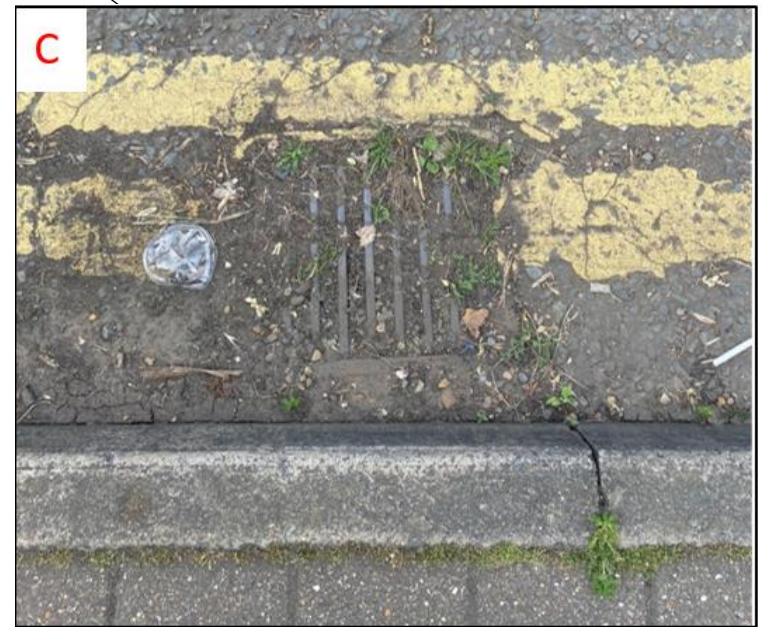
A number of road gullies in this area were observed to be silted up during the site visit on the 7<sup>th</sup> June 2021 (Refer to Figure C in Appendix D). Even in optimum condition during very heavy rainfall, these gullies would only collect a small proportion of the surface water runoff from the roads, resulting in surface water flowing to lower points along the road. It is possible that the siltation observed within the gullies could have resulted from or been exacerbated during the rainfall event on 23<sup>rd</sup> December 2020 when silt and debris were washed off from the road and surrounding areas.

Blocked drain at Prospect Road which had the potential to exacerbate flooding during a storm event.
