## FLOOD INVESTIGATION REPORT

### TATHALL END

23<sup>th</sup> DECEMBER 2020

Milton Keynes Council  
Flood Investigation Report  
Tathall End

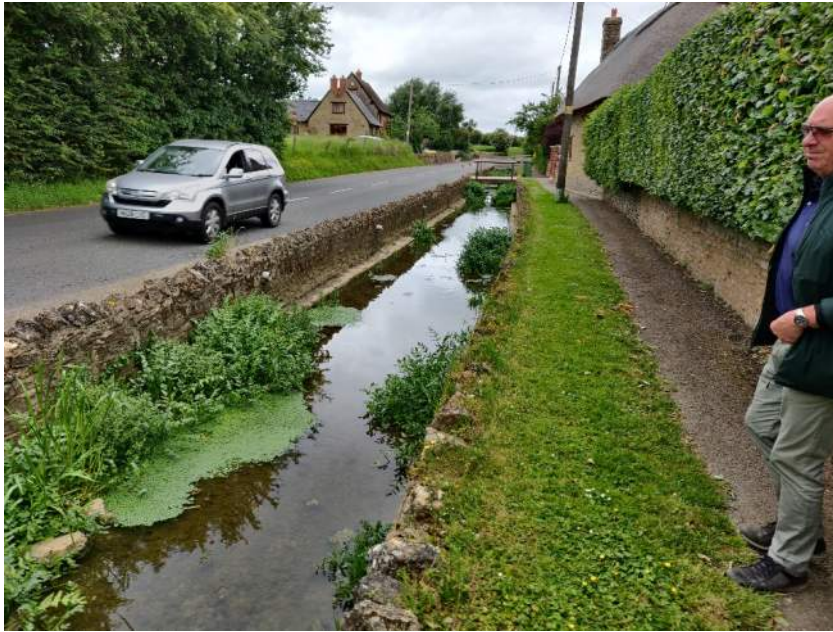
**Figure 1: Typical watercourse detail through Tathall End**

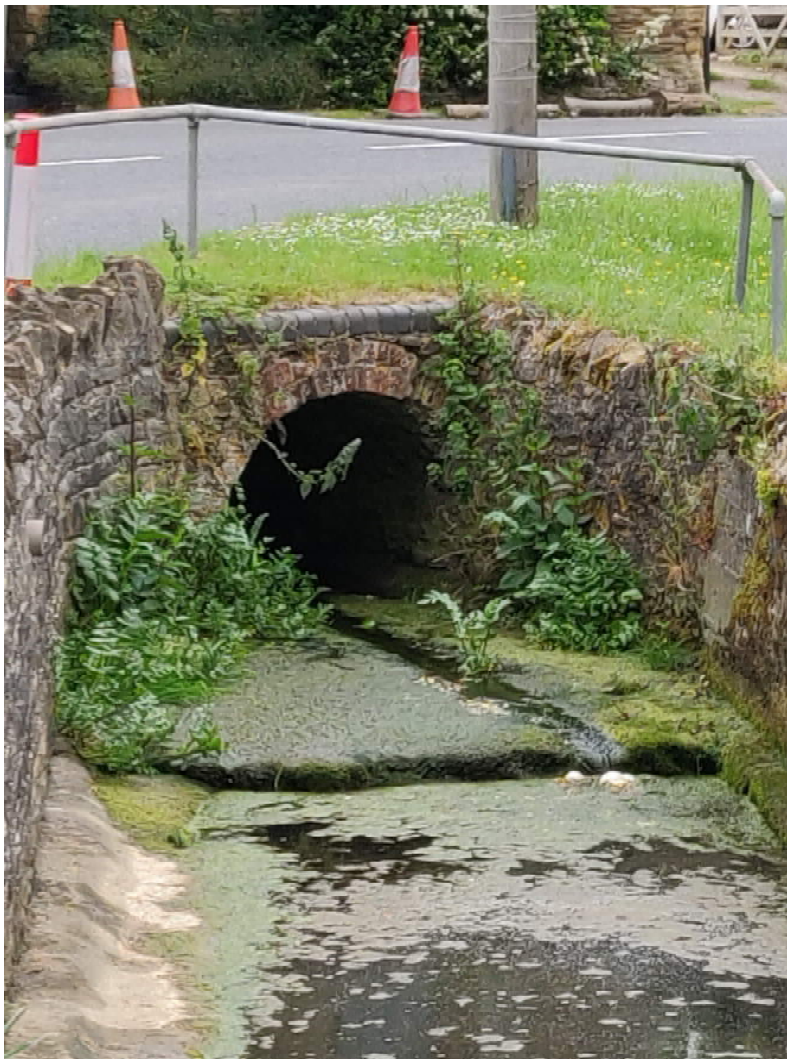
**Figure 2 Watercourse looking upstream away Tathall End**

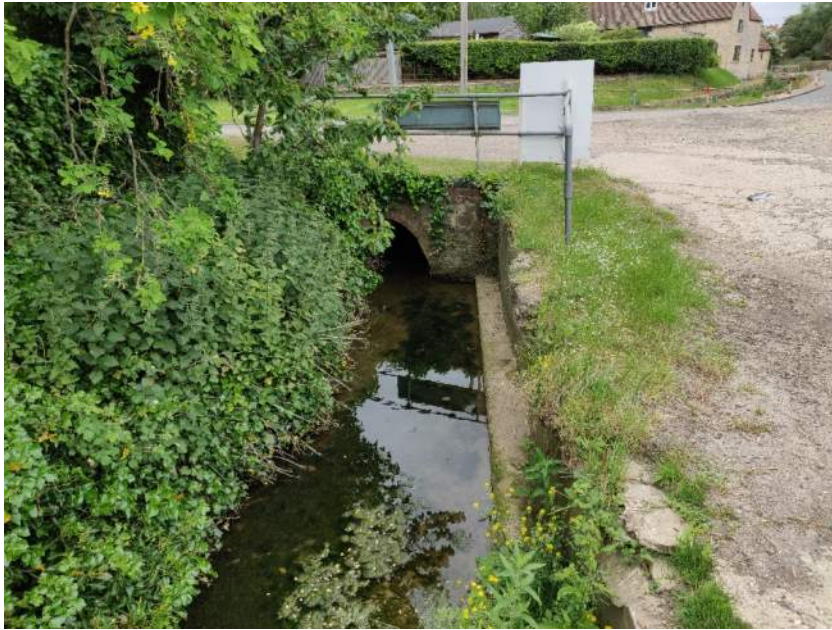
**Figure 3: Watercourse looking downstream towards Tathall End**

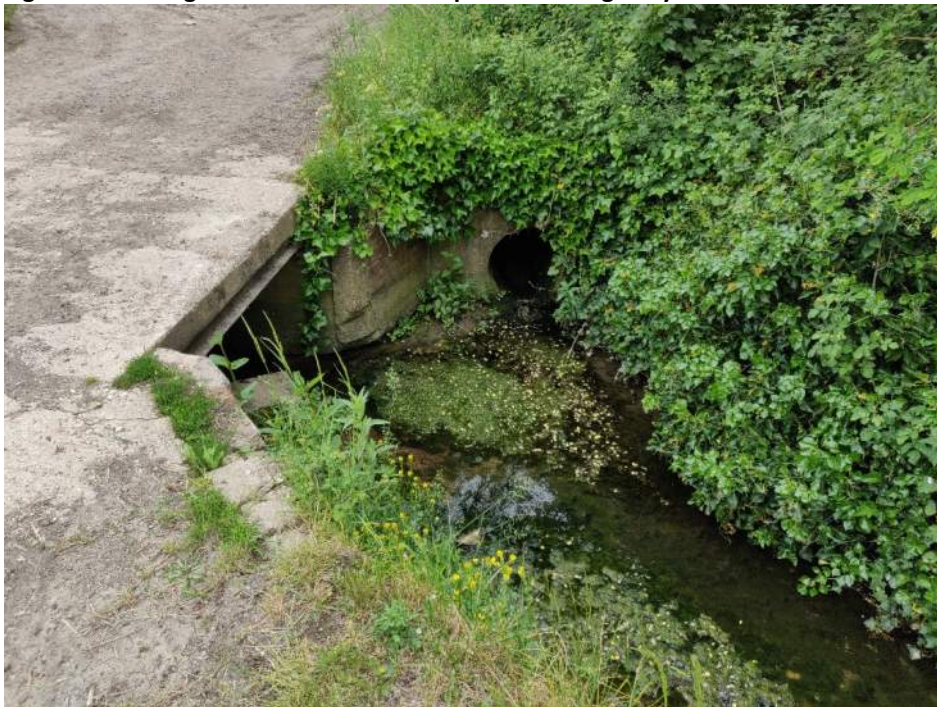
Where the watercourses converge downstream of the bunds, the watercourses are culverted under farm accesses and the highway. In this location the culverts were unable to accommodate the significant volumes of water and breached the banks of the watercourse. Water then flowed some 300m overland until it could re-enter the watercourse.

**Figure 4: Convergence of watercourses upstream of highway**

Additional options for getting the flood water back into the channel should the capacity of the culverts be exceeded in the future should also be considered.

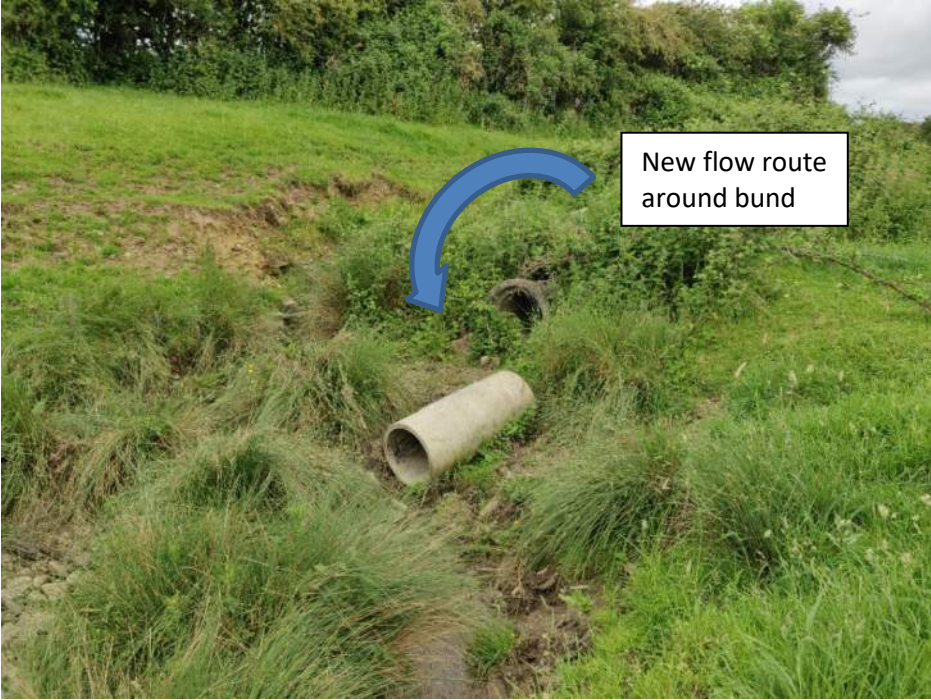
7.1.5.2 Bunds 1 and 2 of the upstream flood alleviation were identified as having failed during the site visit. The watercourse has created a bypass channel 'around and through' the bund to avoid the piped 'flow control' element of the bund. It is not known whether this occurred prior to or because of the flood event on the 23<sup>rd</sup> December. The resident described the flood water as arriving in a rush but this could have been due to the short duration but intense storm on a saturated catchment or because of the failure of the flood bunds. For images of the failed bunds refer to Appendix C.

- 8.1.1.2 Flood alleviation bunds on Woad Farm constructed after the 2007 floods were found during the site visit to have failed. The watercourse has found a route around / through the bunds. The condition of the bunds prior to the flood event is not known.

Figure 4: Bund 1 (Failed) - with new flow route

- 8.1.1.4 The condition of the bunds on Woad Farm should be reviewed and a remediation strategy for the bunds should be implemented.
- 8.1.1.5 Additional options for getting the flood water back into the channel should the capacity of the culverts be exceeded in the future should also be considered.

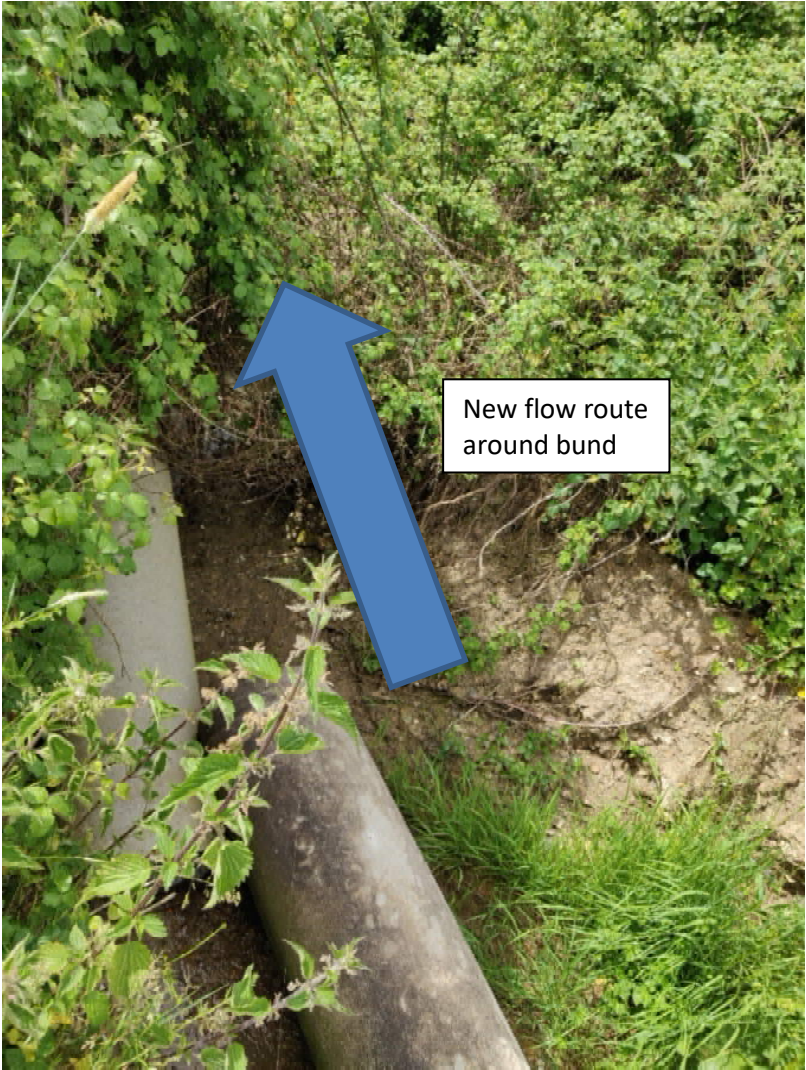
Figure 4: Bund 2 (Failed) - with new flow route

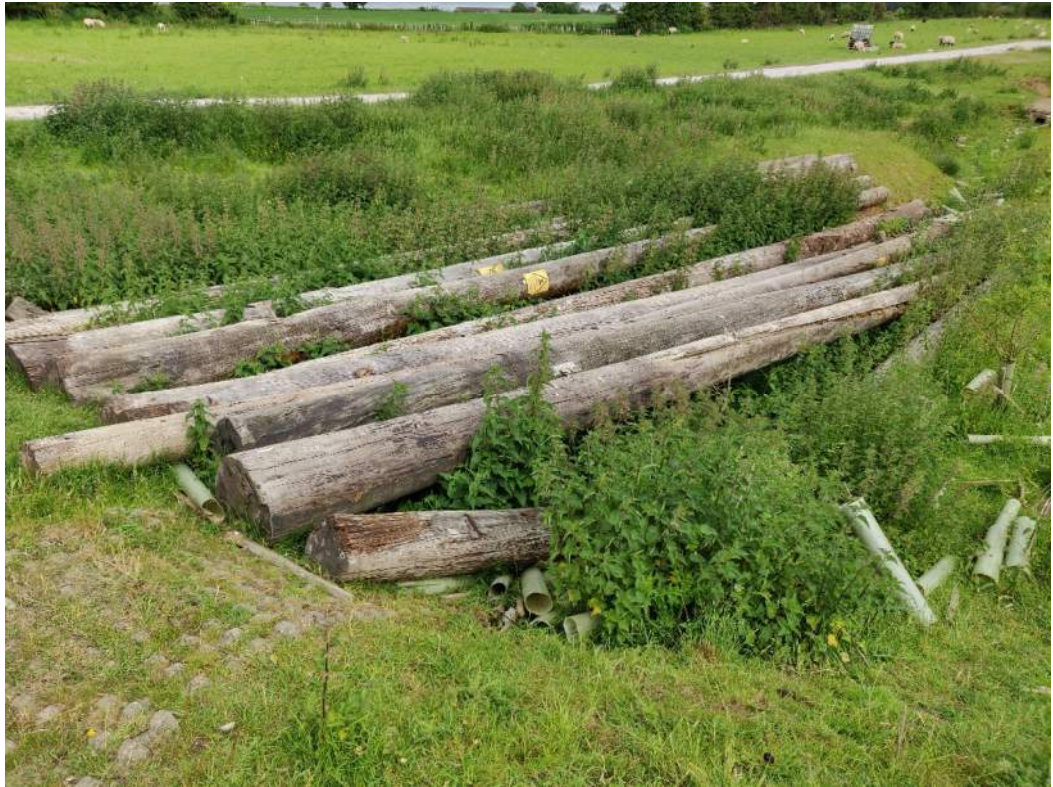
7.1.5.3 Bund 3 was found to be used for the storage of telegraph poles. Water could still pass through the flow control and the water had not managed to bypass the bund.

**Figure 4: Telegraph poles in Bund 3**
