Flood Investigation Report

Newport Pagnell – 27th May 2018 Flood Event

Milton Keynes Council

August 2019

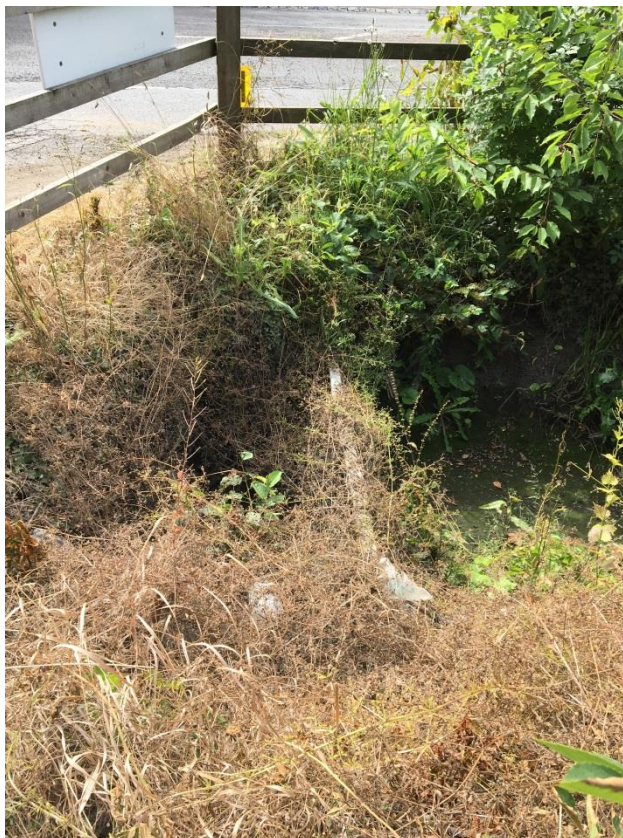
Figure 1-2: Private ditch alongside Wolverton Road, west of M1

Newport Pagnell acts as a confluence for multiple watercourses, including the River Great Ouse, Tongwell Brook, Chicheley Brook and the River Ouzel, as shown on Figure 1-1. These are a combination of open channels, such as one alongside Wolverton Road to the west of the M1 (see Figure 1-2), and also culverted watercourses.

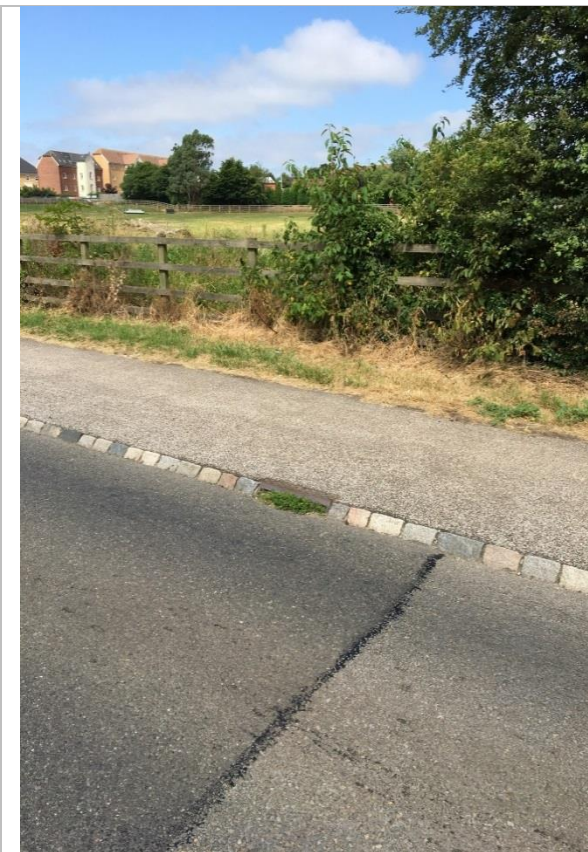
Figure 3-1: Heavily vegetated gully

The roads within this area were inspected during the site visit on 27th June 2018 and it was observed that the topography would enable overland flow to be channelled towards the flooded area. Given the poor condition of some of the gullies (see Figure 3-1 & Figure 3-5) within the nearby roads, it is possible that during heavy rainfall, road gullies would only collect a small proportion of the surface water runoff from the roads, resulting in surface water flowing overland to the lower points. However, it is possible that the siltation observed within the gullies could have resulted from or been exacerbated during the rainfall event on 27th May 2018 when silt and debris was washed off the road and surrounding areas. There is also evidence of additional drainage being retrofitted into some of the roads, such as on the south side of Little Linford Lane, where a concrete channel runs along the back of the footpath. This was observed to be in poor condition and overgrown in places (see Figure 3-2 & Figure 3-3), although properties in this location were not reported to have been flooded during the 27th May 2018 rainfall event.

- MKC identified that the road gullies were becoming blocked more often in a number of locations due both to a greater build-up of street debris and to silt building up more than normal in the surface water sewers. The latter was identified from CCTV and the information was passed to AWS.

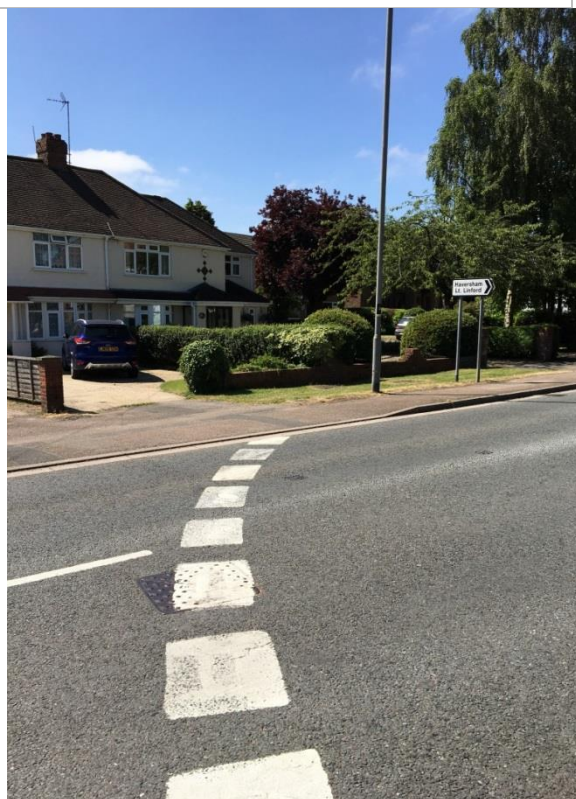
Figure 3-4: Dropped kerb adjacent to roundabout

Runoff from private areas, such as driveways, could contribute to the volume of surface water on the roads. The addition of dropped kerbs in this area will have modified the flow paths and enabled water to more easily move between the highway and private properties (see Figure 3-4).
