HB (South Caldecotte) Ltd  
South Caldecotte  
Milton Keynes  
Phase 1 Geo-Environmental Assessment

April 2018

Document Number:	SCD-BWB-XX-YE-RP-0001_Ph1
BWB Reference:	NTS2682

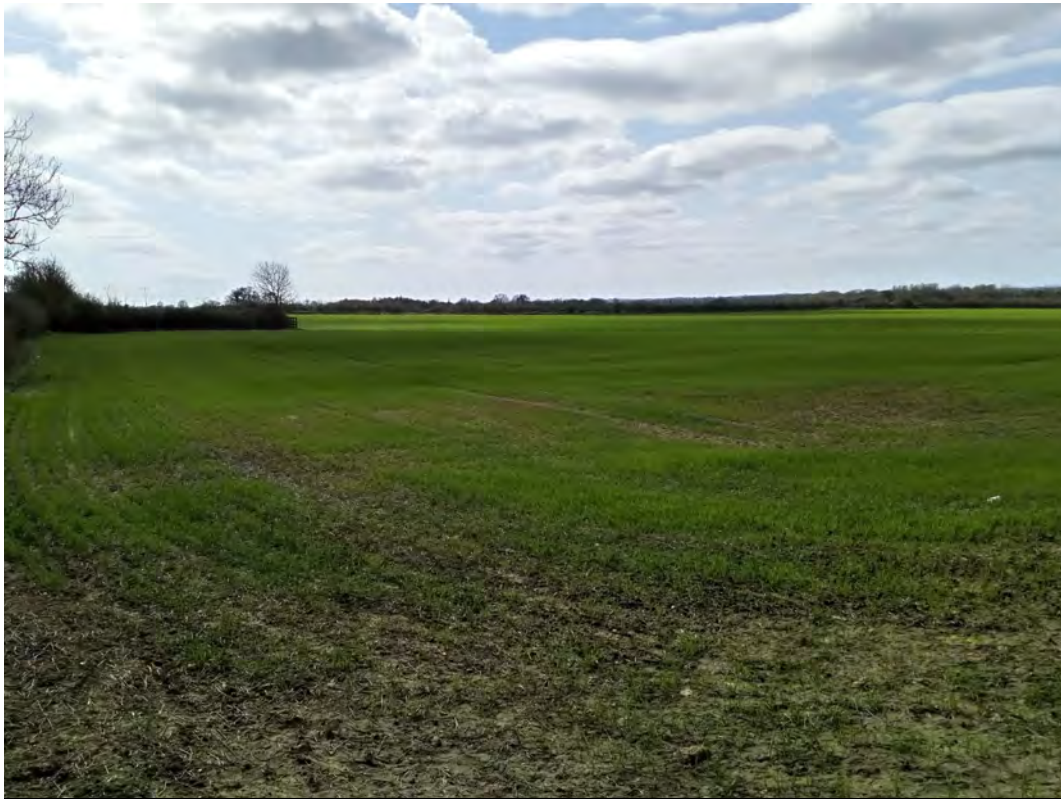
- 2.16 Moving north, a small area of land, slightly elevated and surrounded by a ditch and wooden fence in poor condition was understood to belong to Anglian Water. The majority was overgrown, with evidence of electrical cabinets in the north of the area.

Photo 1 — Looking south from the northern footpath entrance off V10 Brickhill Street, opposite Station Street, towards the Anglian Water land

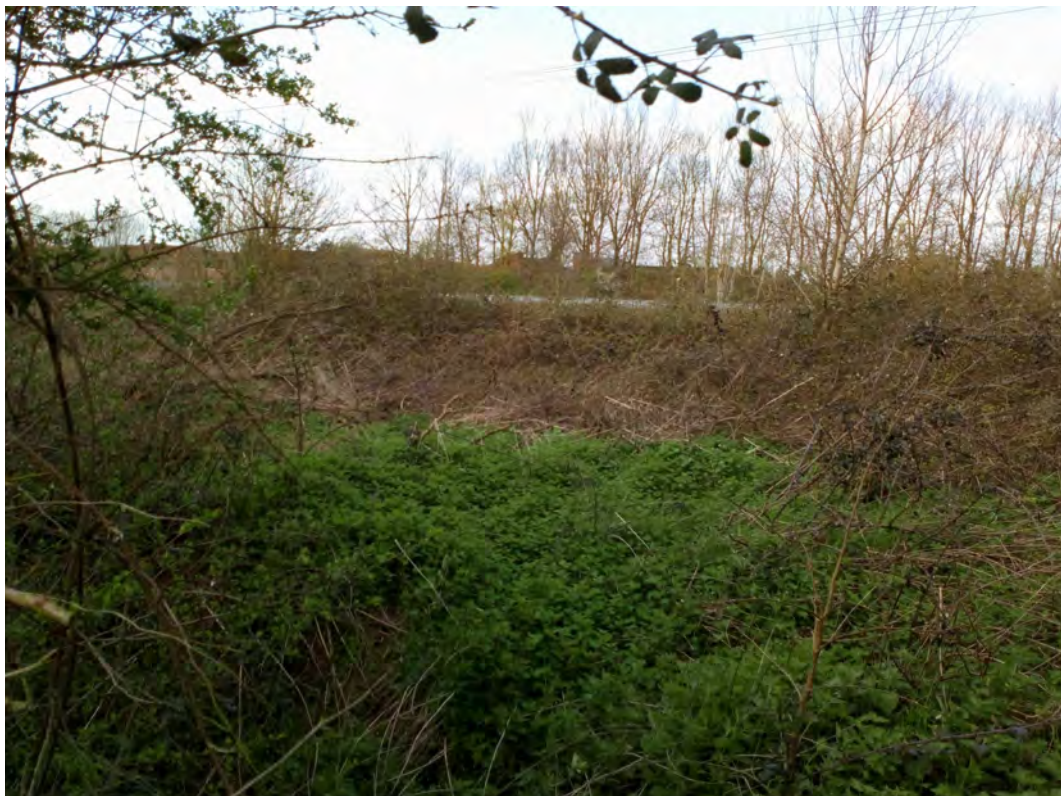
- 2.8 The land was observed to slope gently to the southwest. The drainage ditch ran broadly parallel with the palisade fencing separating the site from the railway land to the north and ran both inside and outside of the fencing. Moving west, the ditch ran predominantly outside of the boundary and was culverted to allow access over to the railway bridge and public land beyond.

Photo 2 — Looking northwest to the area of overgrown land north of the ditch draining from east to west along the northern site boundary

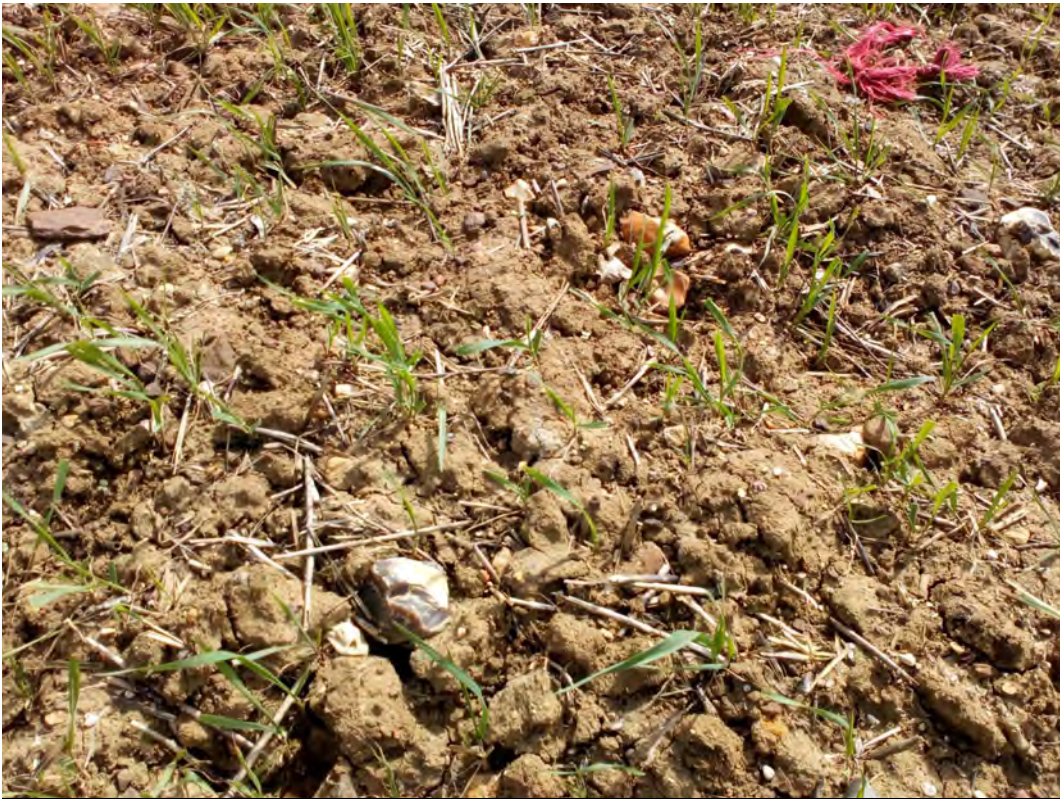
- 2.10 Exposed soil within the cropped fields indicated principally cohesive material, with abundant fine to coarse angular to subangular flint and chert gravel. Sporadic pottery and tile fragments could be observed throughout the site, particularly concentrated towards the centre.

Photo 3 — Soils at the surface predominantly cohesive with angular to subrounded flint and chert gravel

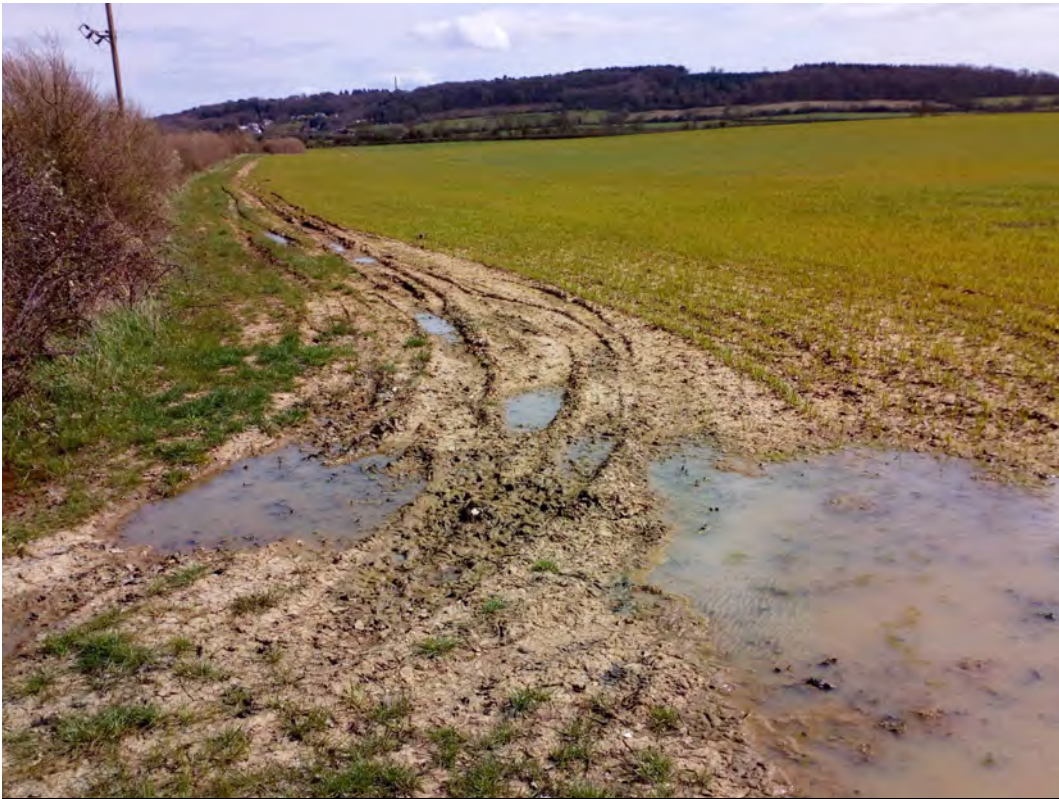
- 2.12 The majority of the site was dry and firm underfoot, although localised waterlogging was observed in places, particularly at access points in field boundaries.

Photo 5 — Patches of surface water-logging, usually at boundaries or entrances to fields, in this case broadly in the centre of the site

- 2.20 All landowners and access requirements will need to be confirmed prior to undertaking any intrusive works.
- 2.21 Ground conditions were generally good in terms of vehicle access, although localised soft or wet areas must be anticipated.

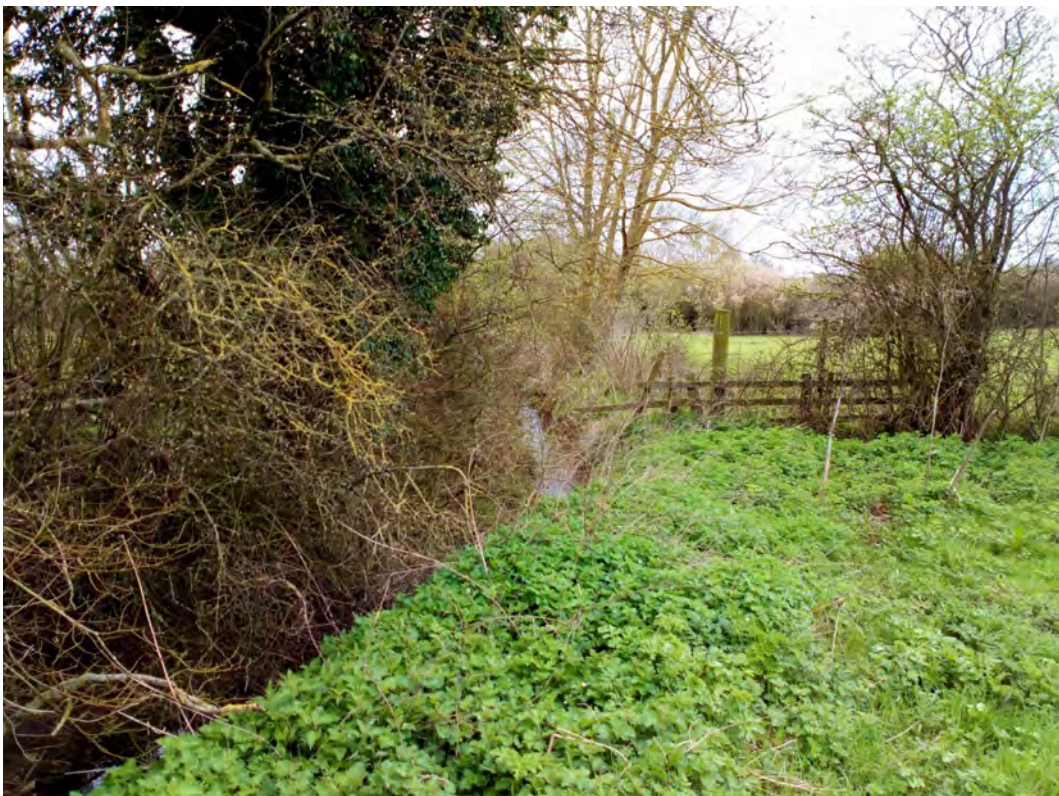
- 2.14 Cattle and sheep were observed within separate fields in the south of the site. Ridge and furrow were observed in a number of the fields, typical of Middle Age open field system. Pastureland ran the majority of the length of the A5 to the island in the southern corner. Drainage ditches could be observed along many of the field boundaries.

Photo 8 — Looking west along the ditch separating the cropped land from pasture to the south and east

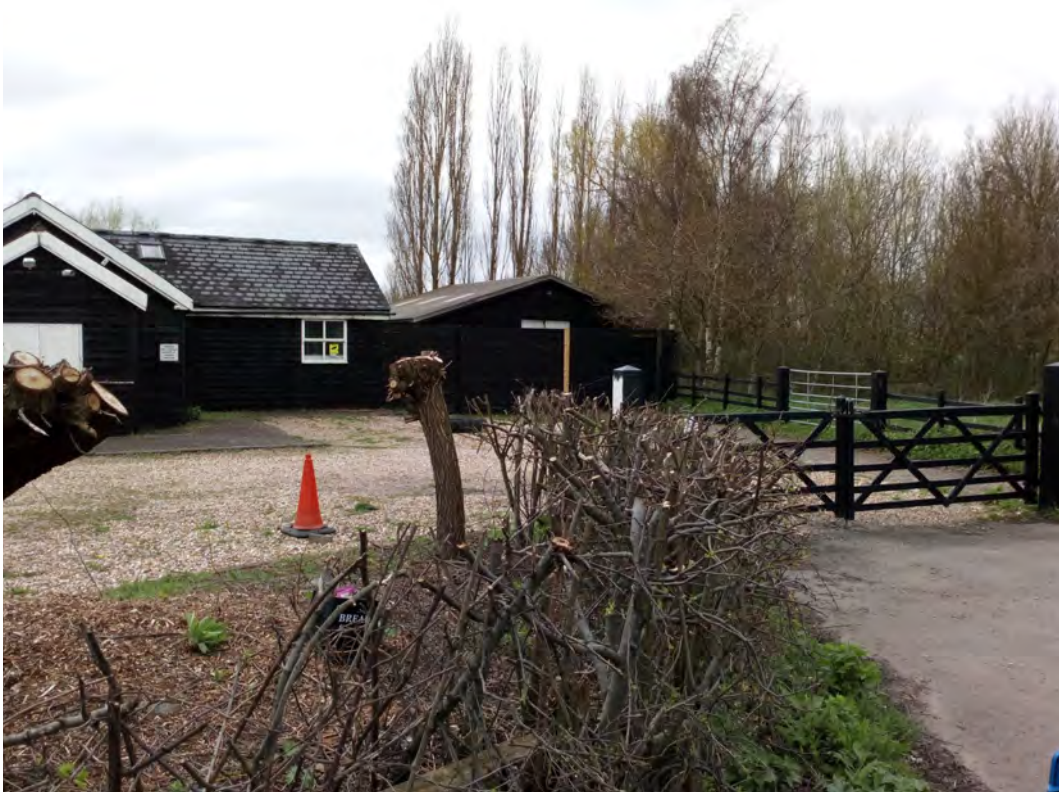
- 2.6 With the exception of one small area of buildings, set around a courtyard with one further external barn to the north, no other evidence of construction was observed on site. No access was available to the farm buildings. Other than that associated with the farm buildings, there was no other evidence of hardstanding.

- 2.18 There was no visual or olfactory evidence of sources of significant sources of on-site contamination in the form of spillages or surface staining. No tanks were observed, although there was no access to the farm buildings adjacent to V10 Brickhill Street.

Photo 10 — looking west at the farm buildings off V10 Brickhill Street

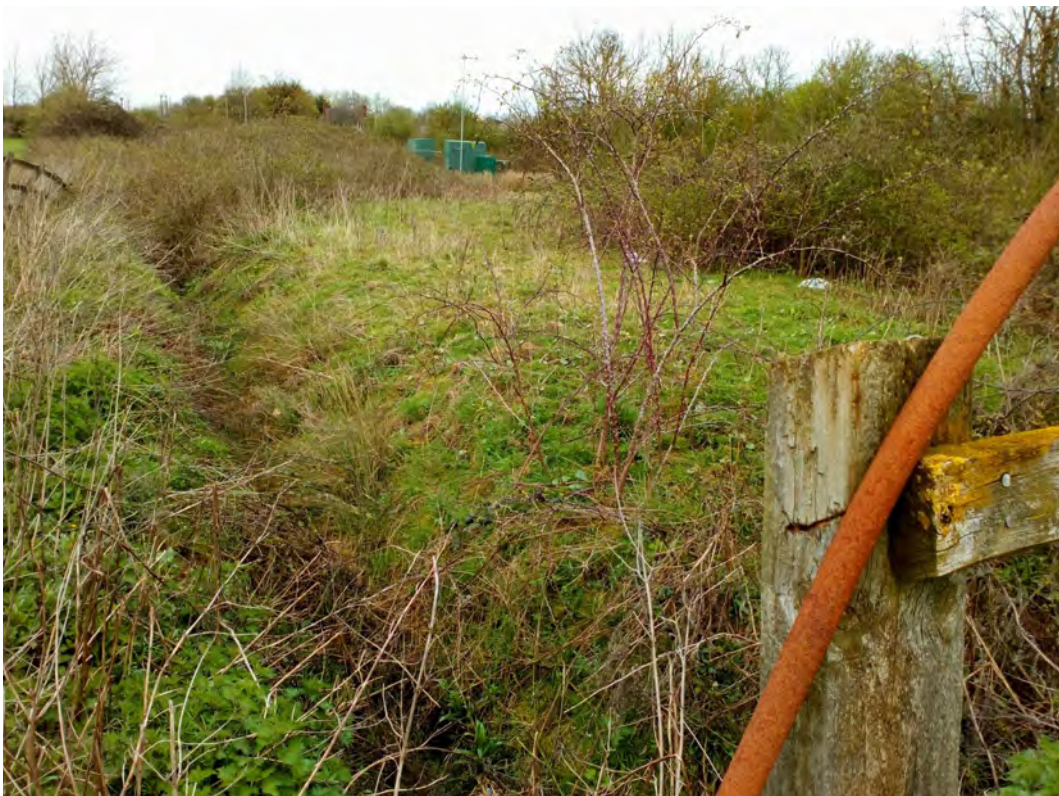
Photo 12 — Looking north into the Anglian Water land adjacent to V10 Brickhill Street
