TITLE:  
 Land South West of Milton Keynes;  
 70069442-11578

***PHASE I REVIEW & STRATEGIC PHASE II  
GEO-ENVIRONMENTAL ASSESSMENT***

***LAND SW MILTON KEYNES  
WHADDON ROAD  
MILTON KEYNES  
MK17 0EG***

***December 2017***

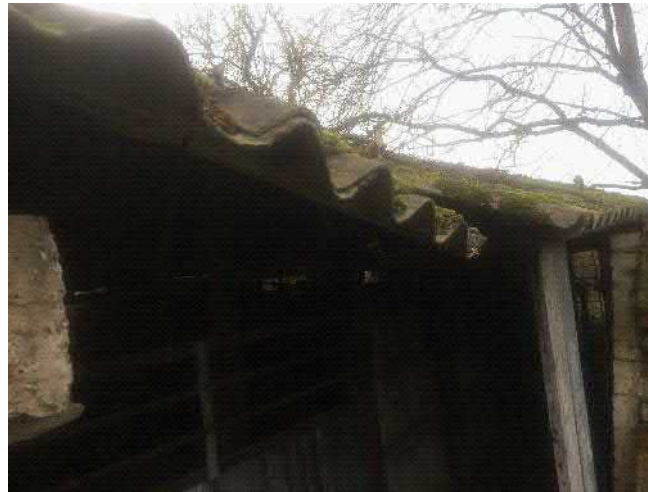
**Photo 3:** Derelict farm building in north west of site.

**Photo 4:** Derelict farm building in north west of site.

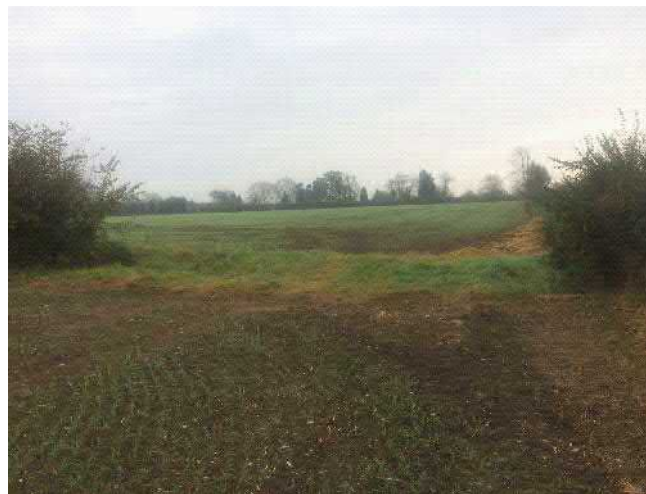
**Photo 7:** Depression in wooded area considered to be location of historical pond in the north of the site.

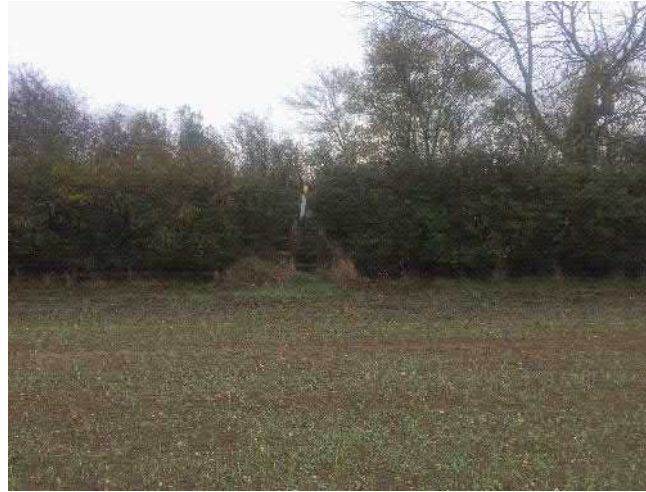
**Photo 10:** Fuel pipeline marker in centre of site.

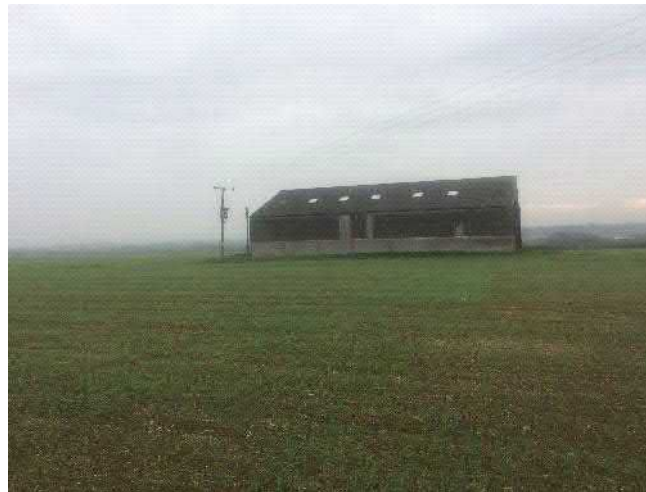
**Photo 16:** View south of barn on western edge of site.

A metal structure barn was located in the south west of the site which was well maintained and observed to be in use. This had an electrical climate control system attached to its eastern elevation.

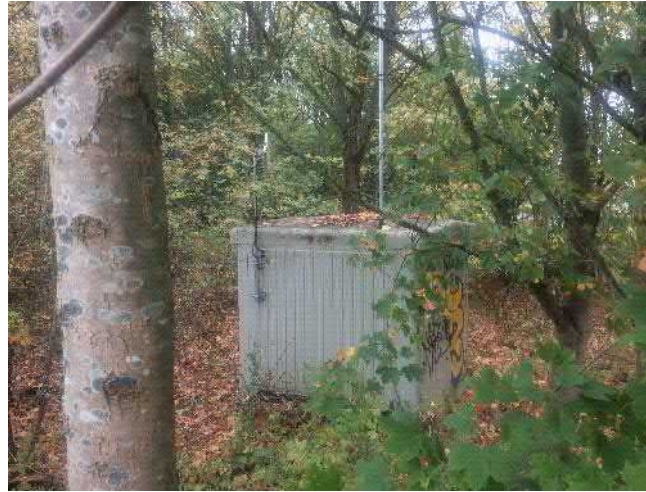
**Photo 22:** Electricity substation off site to the north.

A strip of woodland and an access track with the A421 located beyond. An electricity substation was noted within the wooded area approximately 50m from the site boundary.

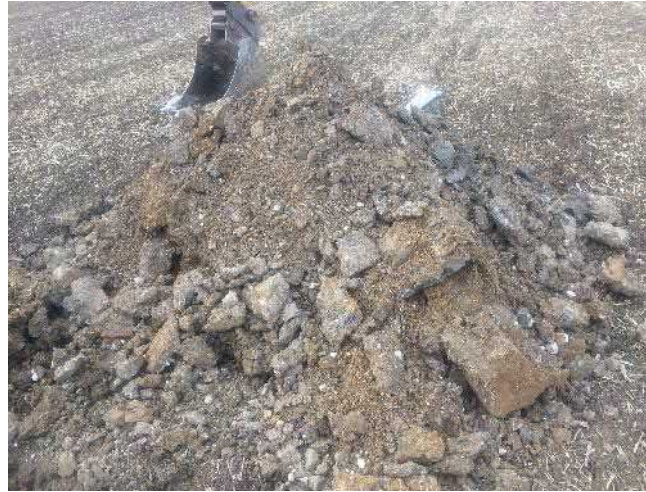
**Photo 25:** Excavation of trial pit IT03.

**Photo 26:** Arisings from trial pit IT03.
