FLOOD RISK INVESTIGATION

Newport Pagnell Section 19 Report

DATE: OCTOBER 2021

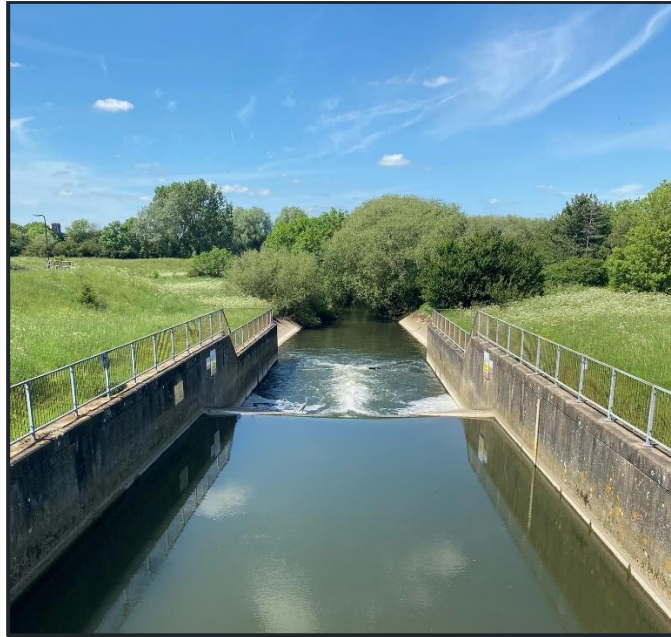
Figure 1-1 - Sluice/control feature for Willen Balancing Lake (owned and managed by AW).

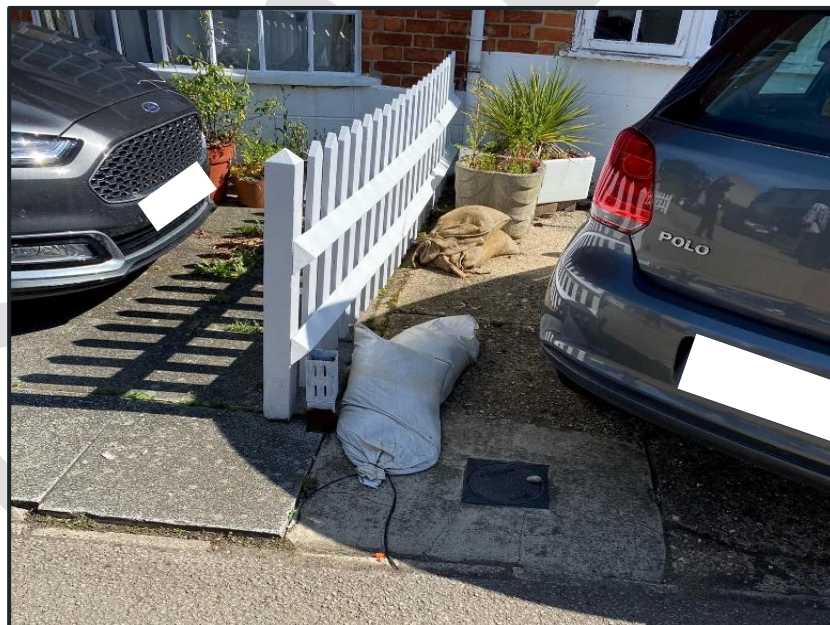
Figure 1-2 – Sandbags present outside property on Mill Street which experienced flooding during the flood event.

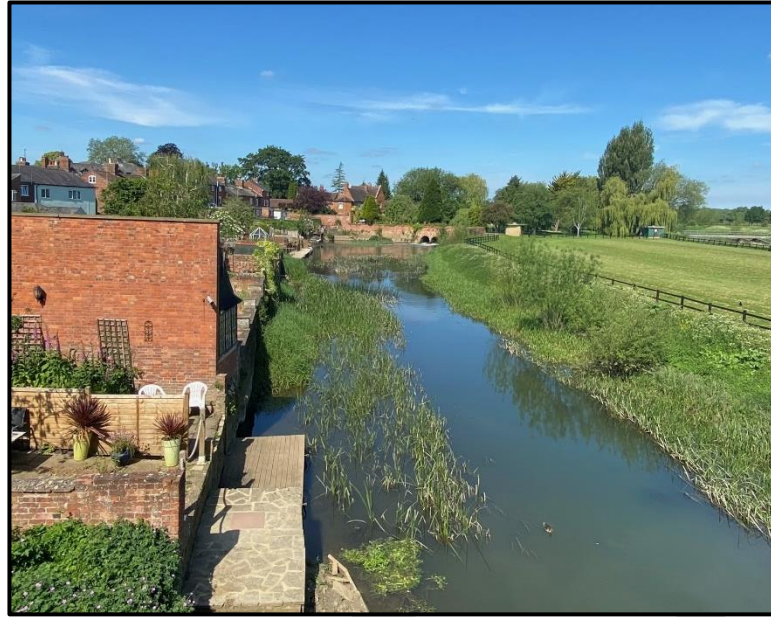
Figure 1-3 - Section of the River Great Ouse near The Mill House, Mill Street.

- 1.5.4. The river was reported to have had high water levels during the flood events of interest, with these reaching the back gardens of several properties. Newport Pagnell Main Gauging Station and Newport Pagnell Mill Gauging Station are located on this reach, both owned and maintained by the EA.

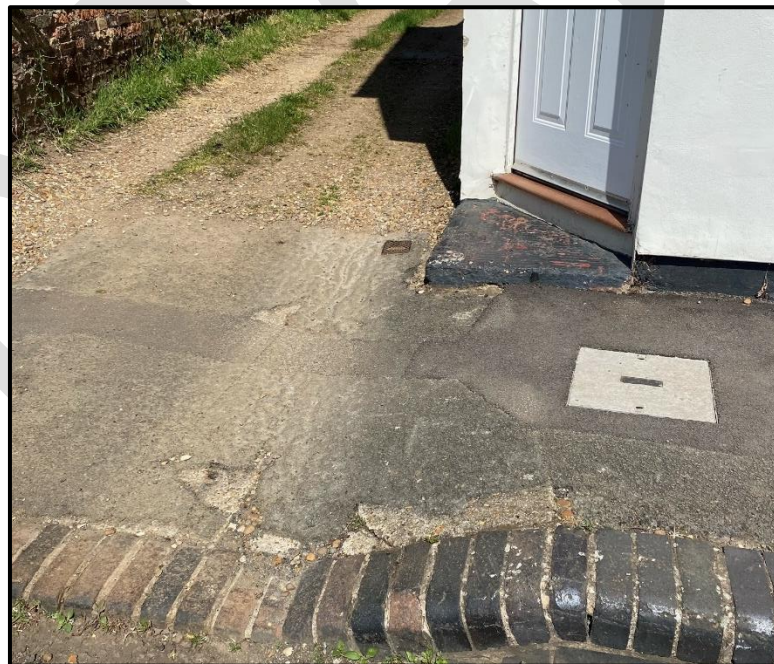
Figure 1-4 – Kerb on Priory Street

- 1.5.5. Flooding impacted a number of properties on Priory Street during the flood events of interest. Evidence of low kerbs and potential flow path next to a property that was flooded on December 24th 2020.

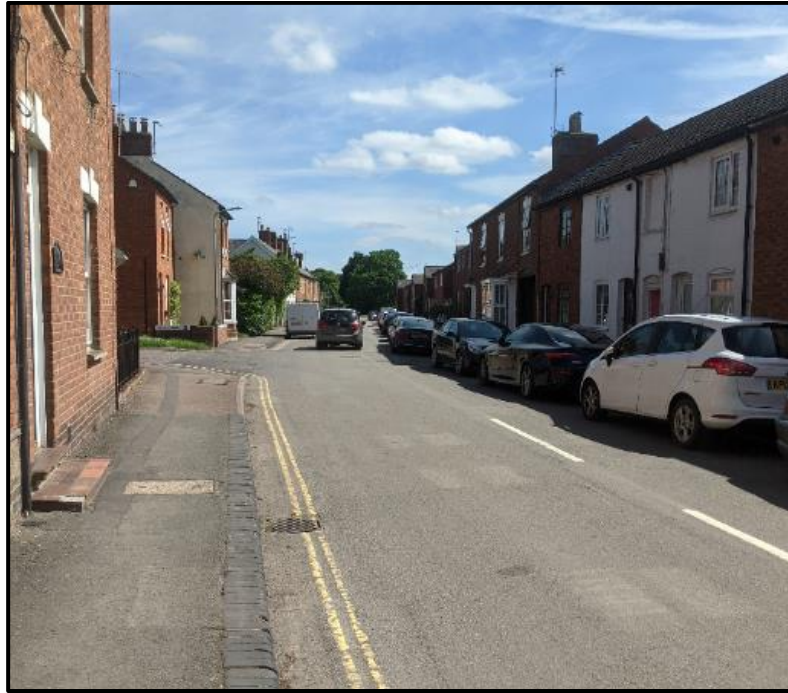
Figure 1-5 – Priory Street

- 1.5.6. During the flood event of interest witnesses reported surface water sewer surcharging from the drains at Priory Street.

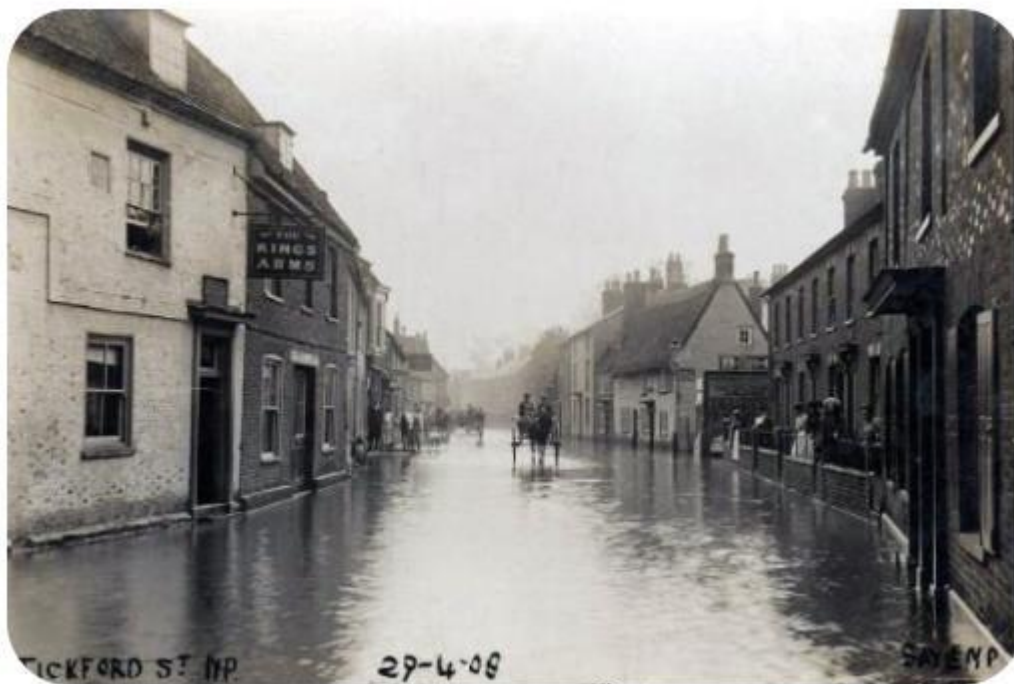
Figure 2-5 – Tickford street flooding, 1908. Source: © Pinterest 2021

- 2.7.1. There are a number of historic flood events that have been occurred in Newport Pagnell prior to the event on the 24th December 2020. Figure 2-5 shows flooding at Tickford Street on 1908. Newport Pagnell was affected by the 1947 flood event with flooding recorded in Tickford Street, Silver Street, Caldecotte Street and Priory Street to a maximum depth of approximately 1.0m, as well as Lakes Lane and Willen Road with the latter recording a maximum depth of approximately 0.75m. The peak water level reported at the Newport Pagnell cemetery gauge was 55.12m AOD. In 1992 a flood event resulted in 9 residential and 6 industrial premises recording flooding, with a further 101 residential and 3 industrial properties suffering access disruption. After the 1998 flood 78 residential properties and one non-residential property were reported as flooded. Of the 78 residential properties, 72 were located in Lakes Lane. The peak water level reported at the Newport Pagnell cemetery gauge was 55.12m AOD, reportedly the same as the peak level recorded for the 1947 flood event.

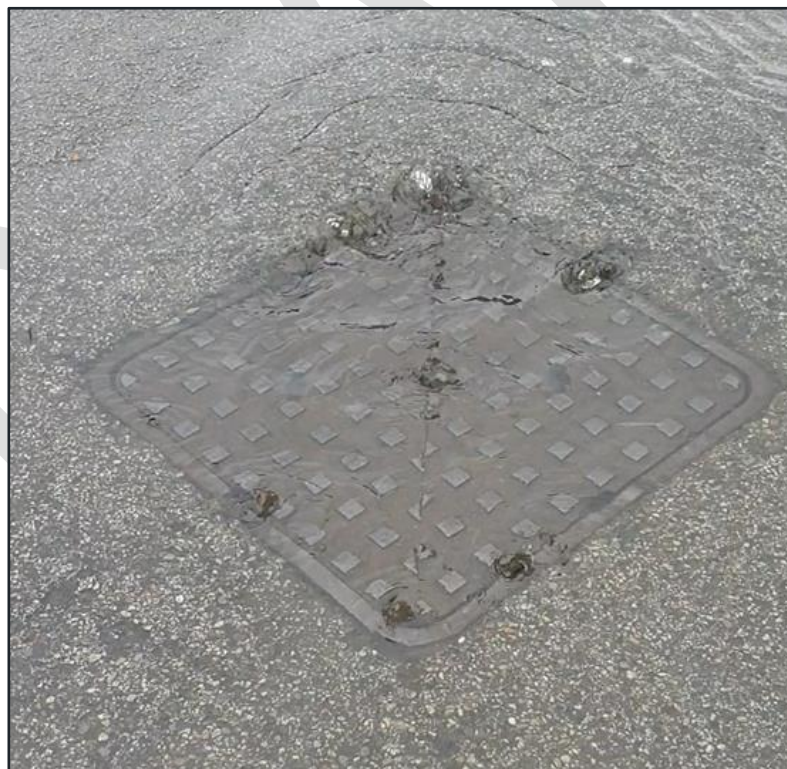
Figure 2-6 – Surcharging manhole on Priory Street, June 2021.

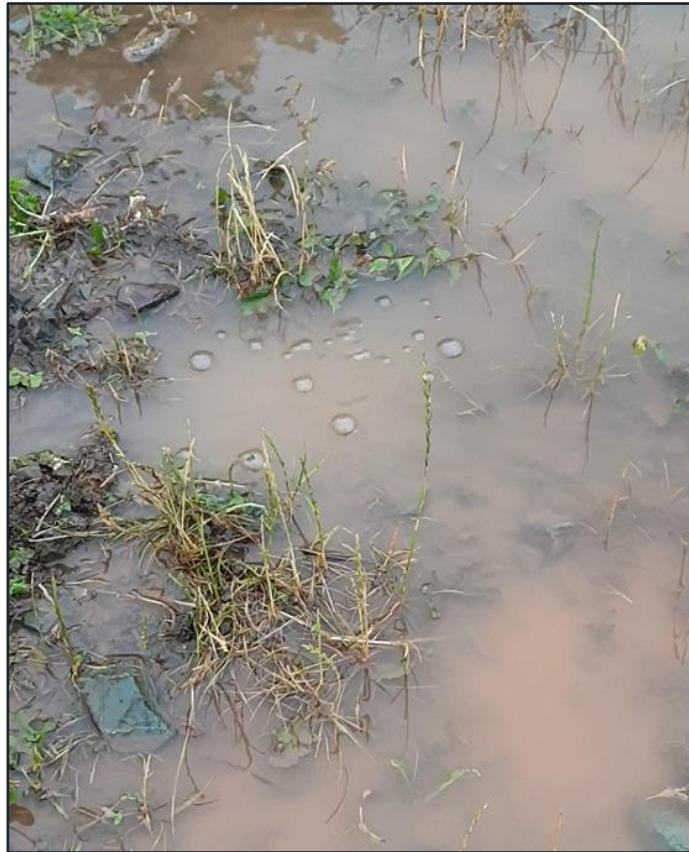
- 2.7.2. More recently, in July 2007 Buckinghamshire experienced flooding originating from the River Great Ouse. A Section 19 report was previously undertaken by MKC in response to a flood event in May 2018 resulting in the internal flooding of 15 properties. It should also be noted that in the process of writing this report flooding was reported in Newport Pagnell on 18th June 2021. Figure 2-6 below shows a manhole on Priory Street surcharging and Figure 2-7 shows potential groundwater emerging from the ground at Castle Meadow.

Figure 2-7 - Potential groundwater emerging from the ground at Castle Meadow, June 2021.

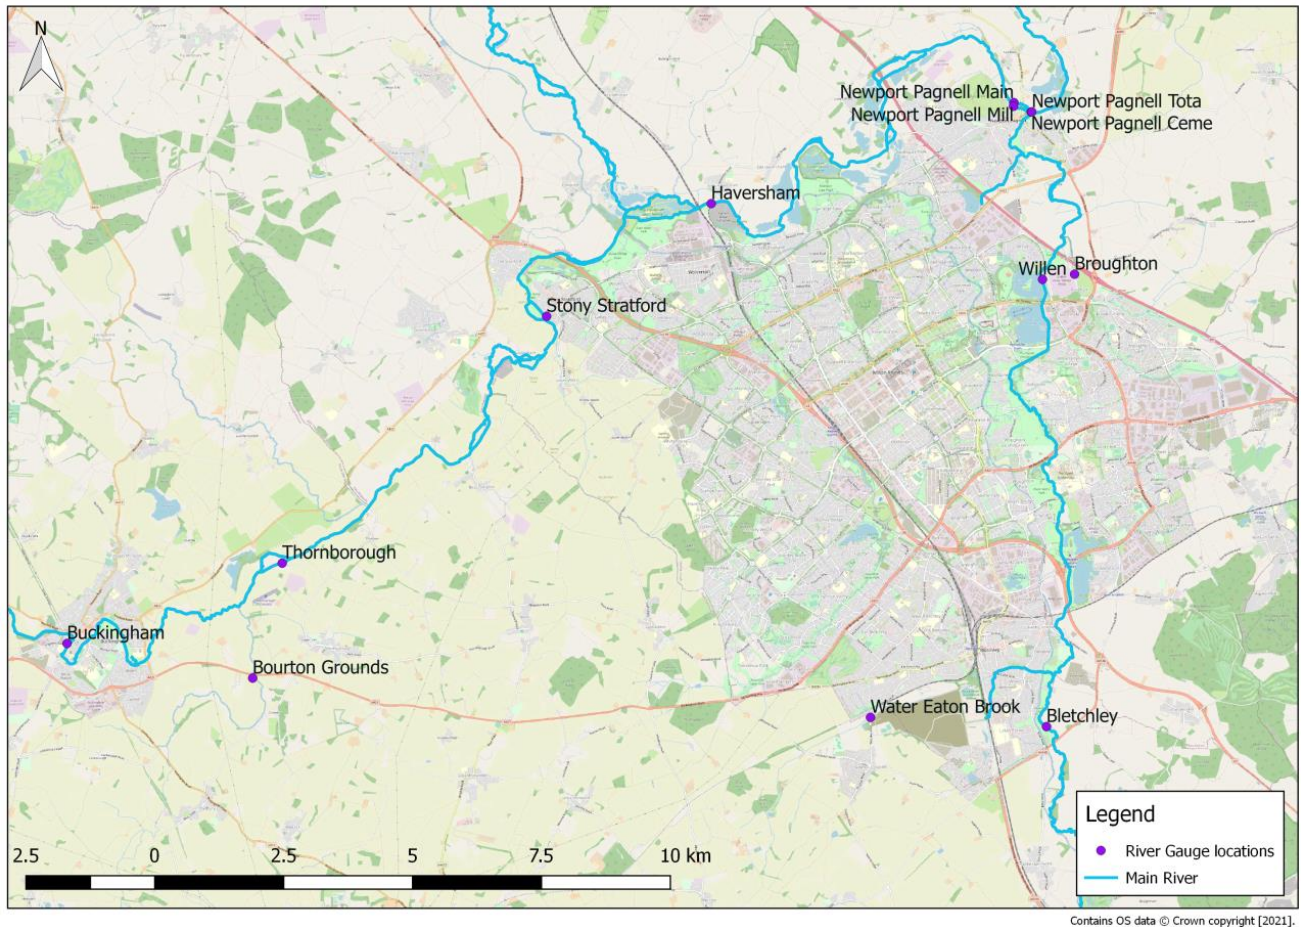
- 3.2.1. There are several river gauges along the River Great Ouse and the River Ouzel. There are four river gauges located within Newport Pagnell on the River Great Ouse; Newport Pagnell Main, Newport Pagnell Mill, Newport Pagnell Cemetery and Newport Pagnell Total (see Figure 3-2).

Figure 3-2 - Location of river gauges at Newport Pagnell

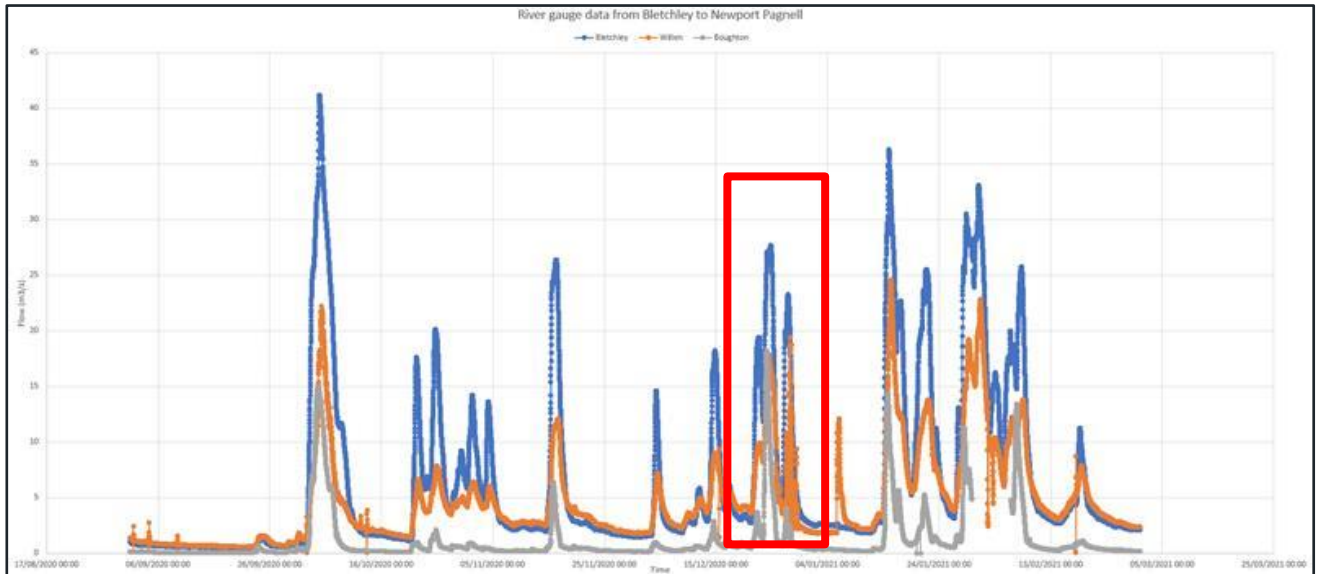
Figure 3-5 - River flows from river gauges between Bletchley and Newport Pagnell (Bletchley Willen and Boughton)

- 3.2.6. Figure 3-5 indicates that the flow of the River Ouzel from Bletchley to Newport Pagnell although peaked on the 23rd of December recording a maximum flow of 27.7m³/s at the Bletchley gauge, this was not an unusually high peak. A drop in river flow is evident at the downstream Willen river gauge

around this time. Further investigation is required to understand the trend in flows and the role of the balancing lakes in this location.
