FLOOD INVESTIGATION REPORT

RAVENSTONE

23rd DECEMBER 2020

Reference: 21/42983/04

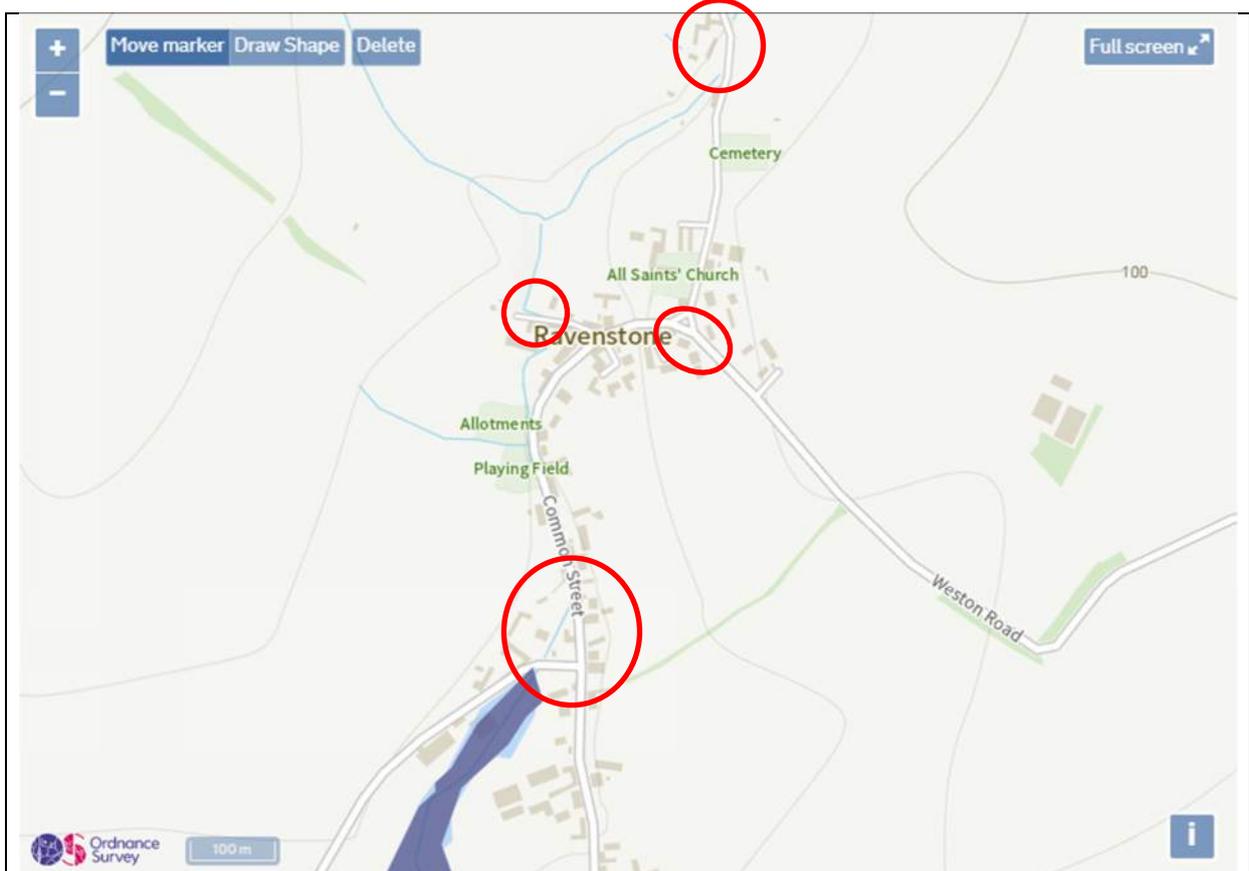
4.1.2.5 Flood Risk from Surface Water

This is in an area that has a HIGH chance of flooding from surface water. This means that each year, this area has a chance of flooding of greater than 1 in 30 (3.3%).

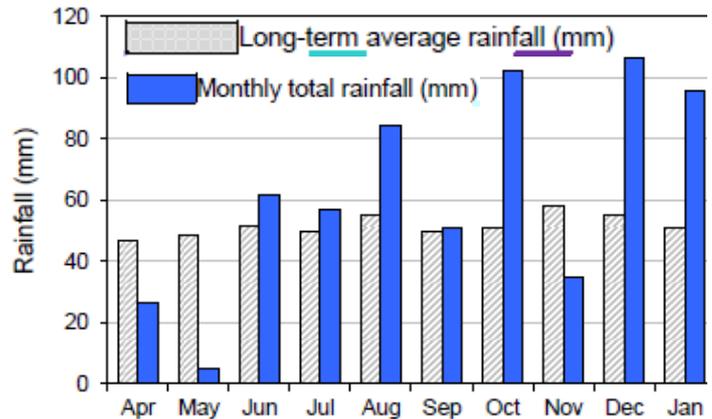
Figure 1: LTA vs 2020 observed rainfall

Even with a relatively dry November, the 3 months from October - December rainfall was 154% of the LTA. Figure 1 shows the surplus of rainfall seen in October, December and then January.

Over 2020, rainfall across the area was 115% of the LTA (Figure 1). The consistently above average rainfall in the months ahead of the main flood contributed to the catchment response on the 23rd December.

"Over 2020, rainfall across the area was 115% of the LTA (Figure 1). The consistently above average rainfall in the months ahead of the main flood contributed to the catchment response on the 23rd December."

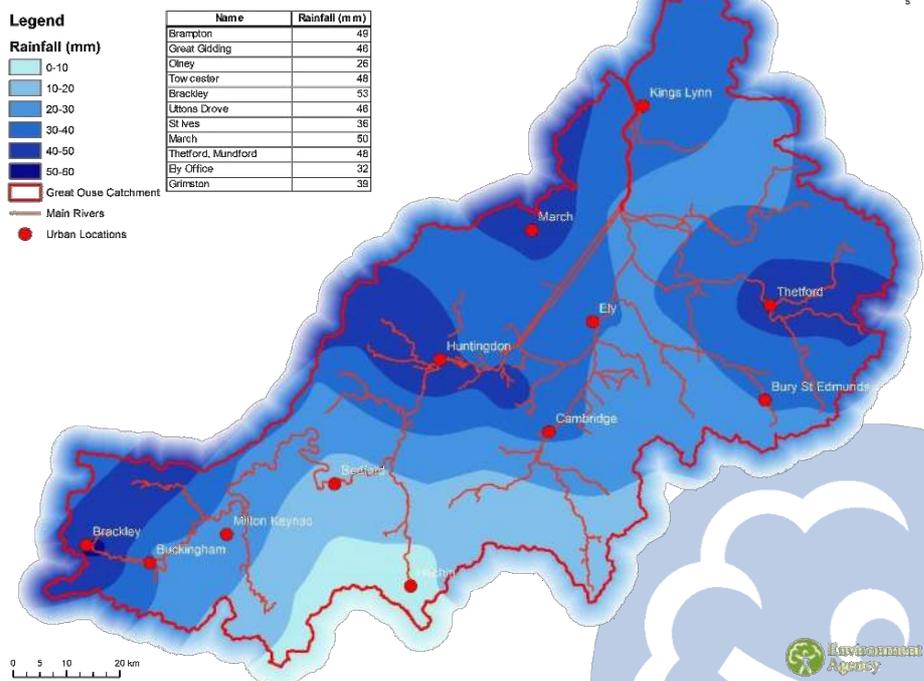
Figure 2: Rainfall distribution on 23rd December 2020

Figure 2 indicates the distribution of rainfall which fell across the Great Ouse catchment on December 23rd 2020, along with spot totals. Much of the rainfall was in the afternoon of the 23rd, rather

than over the course of the day. This intensity of rainfall contributed to the fast reaction of watercourses. The December LTA of 55mm shows that almost a month's rainfall was seen in certain locations on the 23rd.

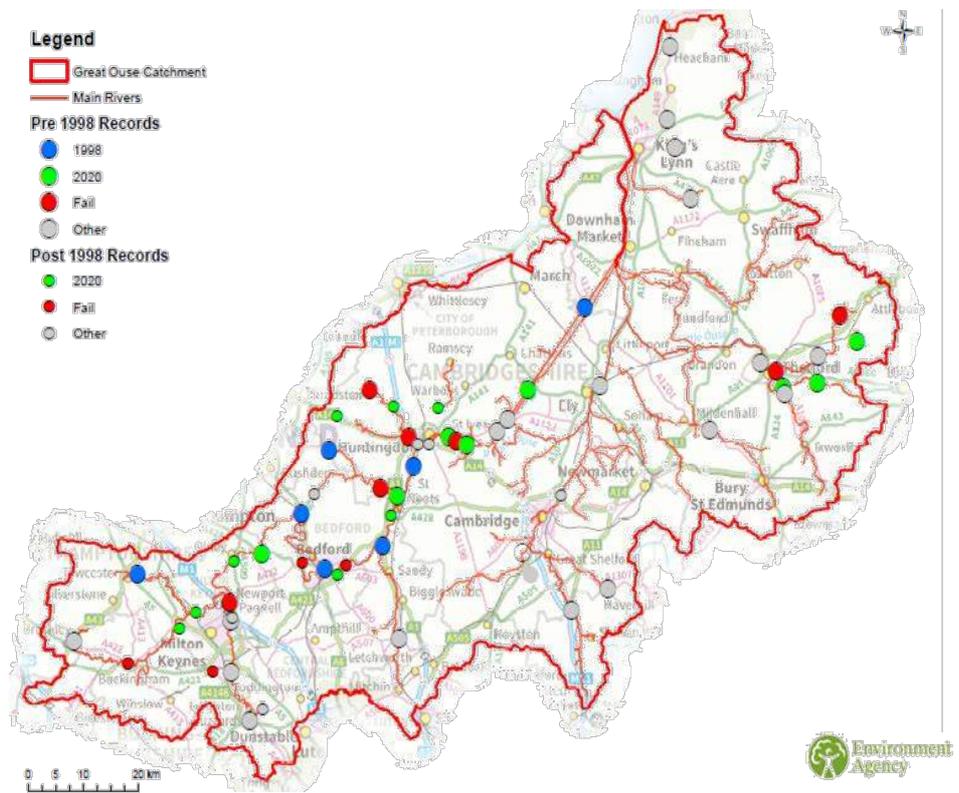
Figure 3: Year of highest recorded gauge level. 'Fail' indicates the gauge did not record an accurate level during the December 2020

Figure 3 shows a number of river level gauges in the Great Ouse catchment. The map shows that following the 23rd December rainfall, several gauges recorded river levels exceeding those of 1998 and are the highest level on record. The river response reflects the severity of rainfall.

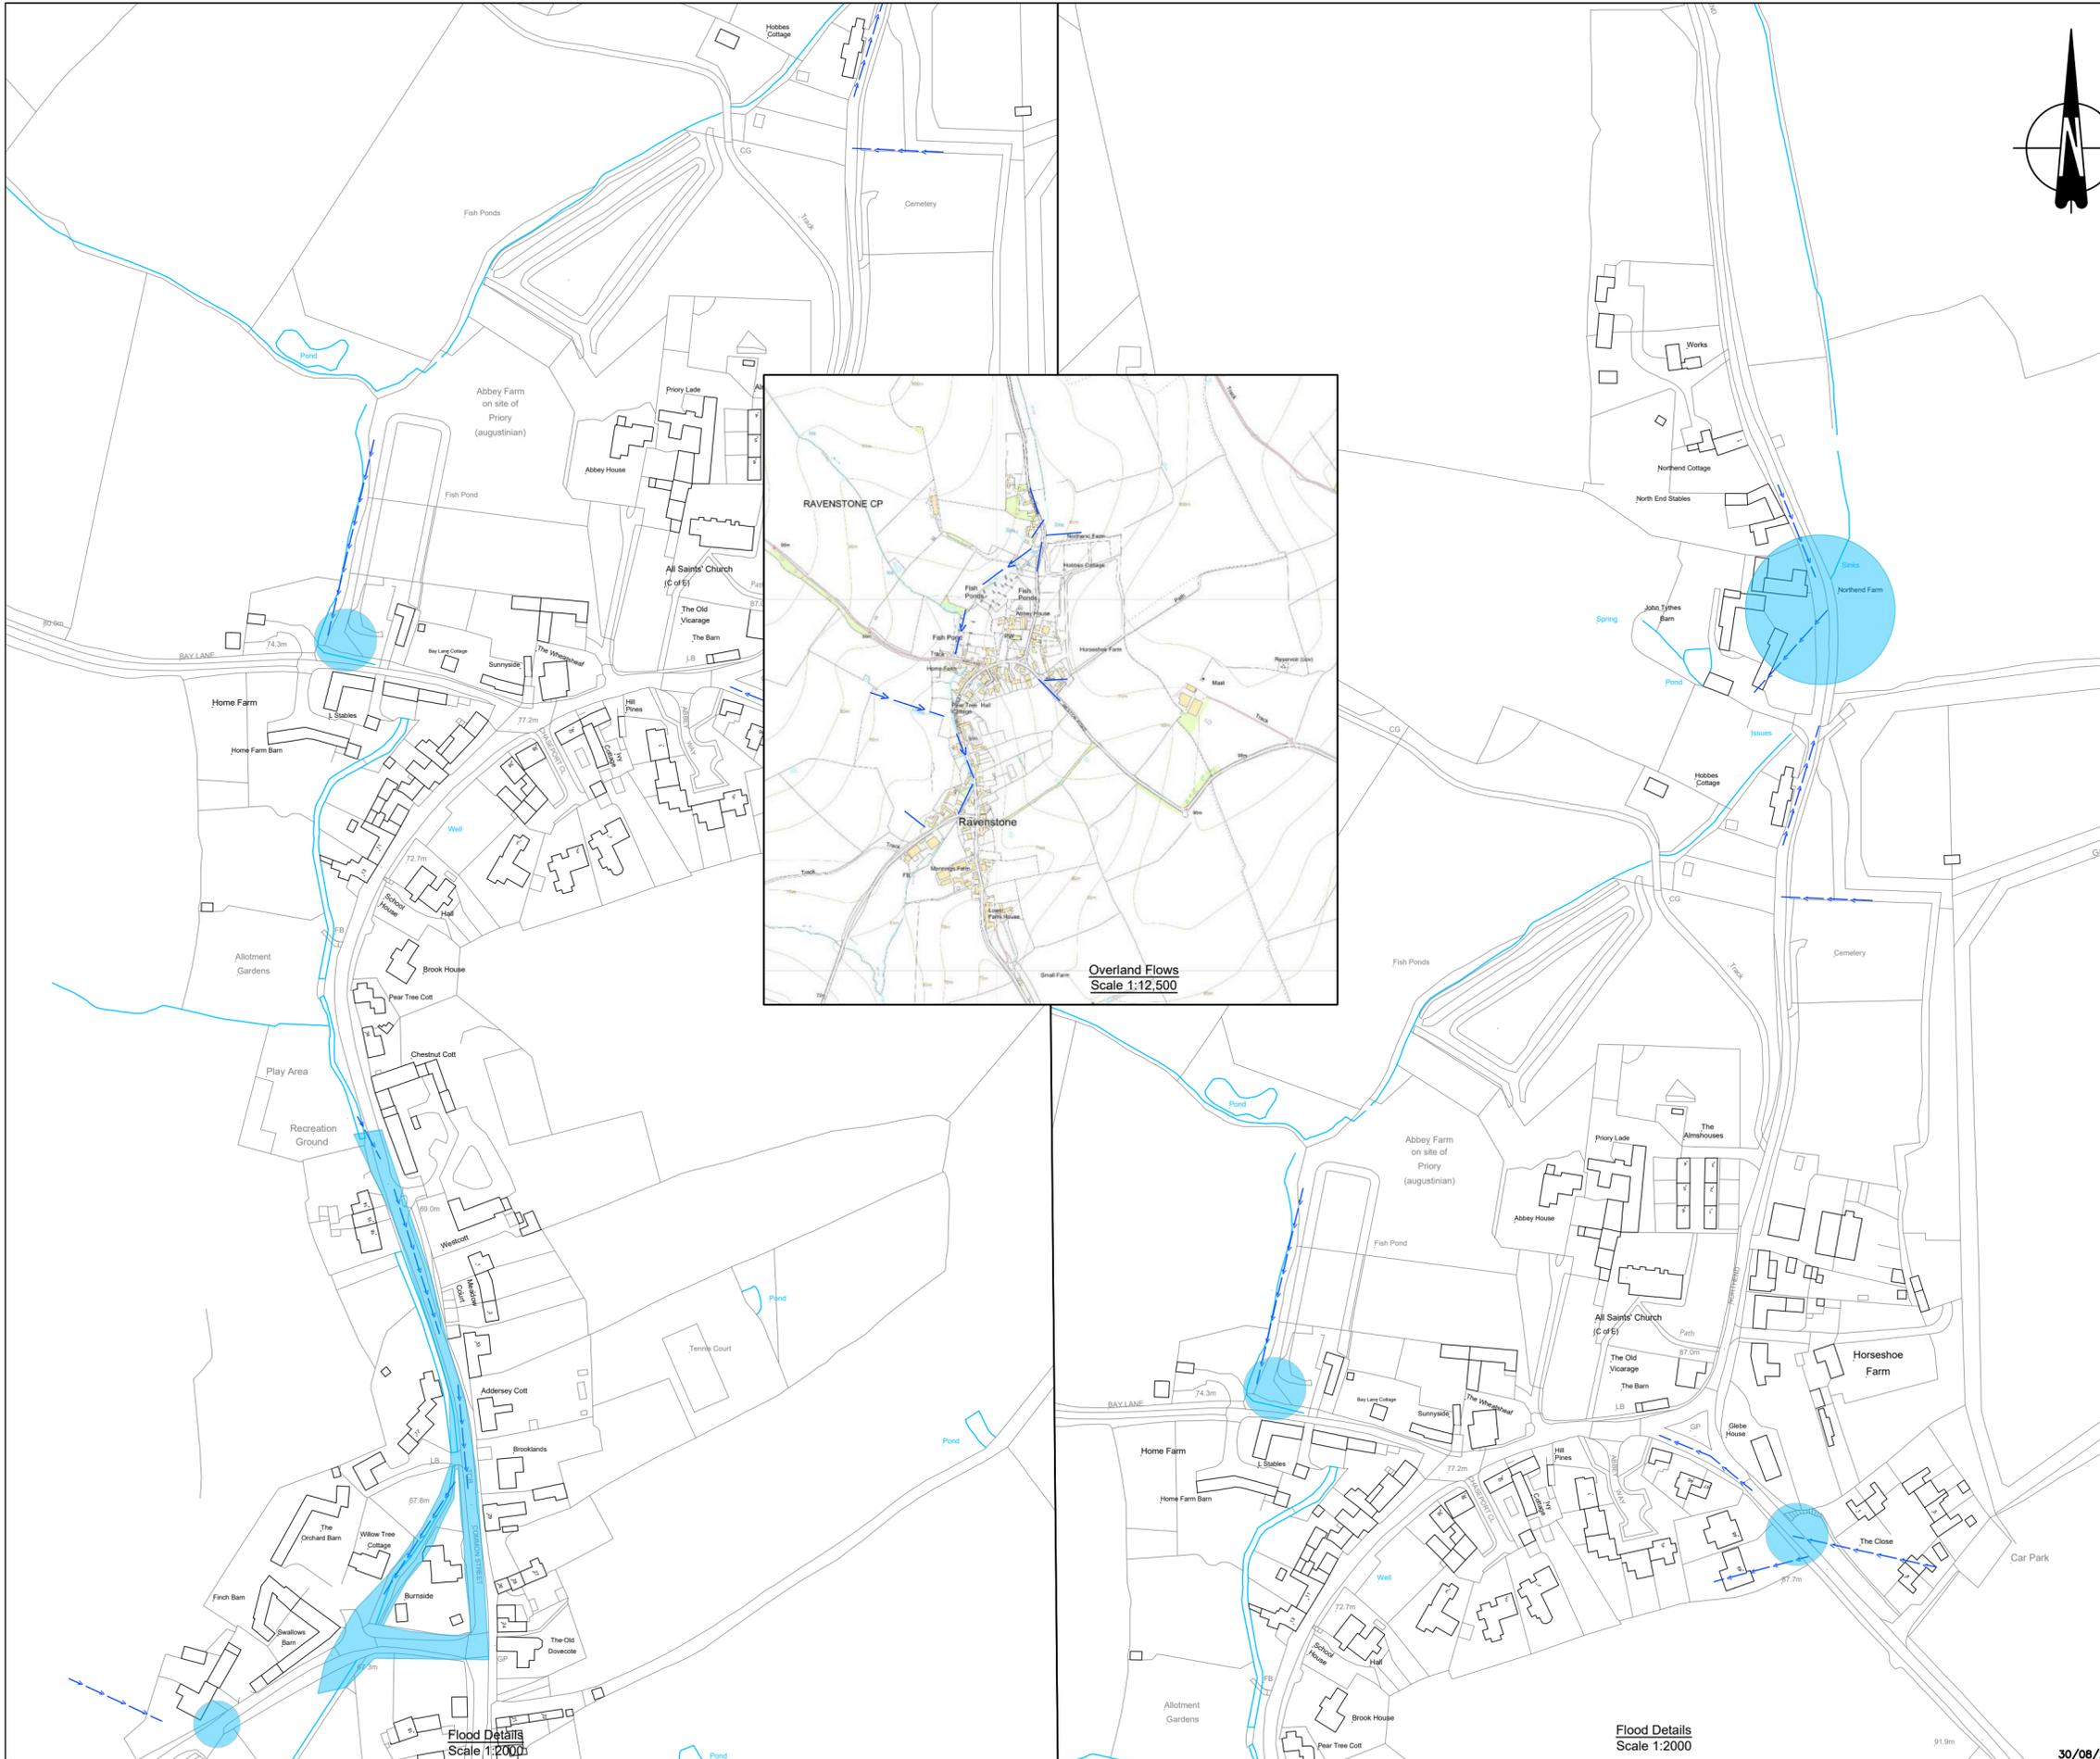
Flood Incident Plan

Properties were flooded on North End and Common Street. These were mostly caused by watercourse flooding. Whilst the depth of flooding was generally limited to between 50 and 100mm.

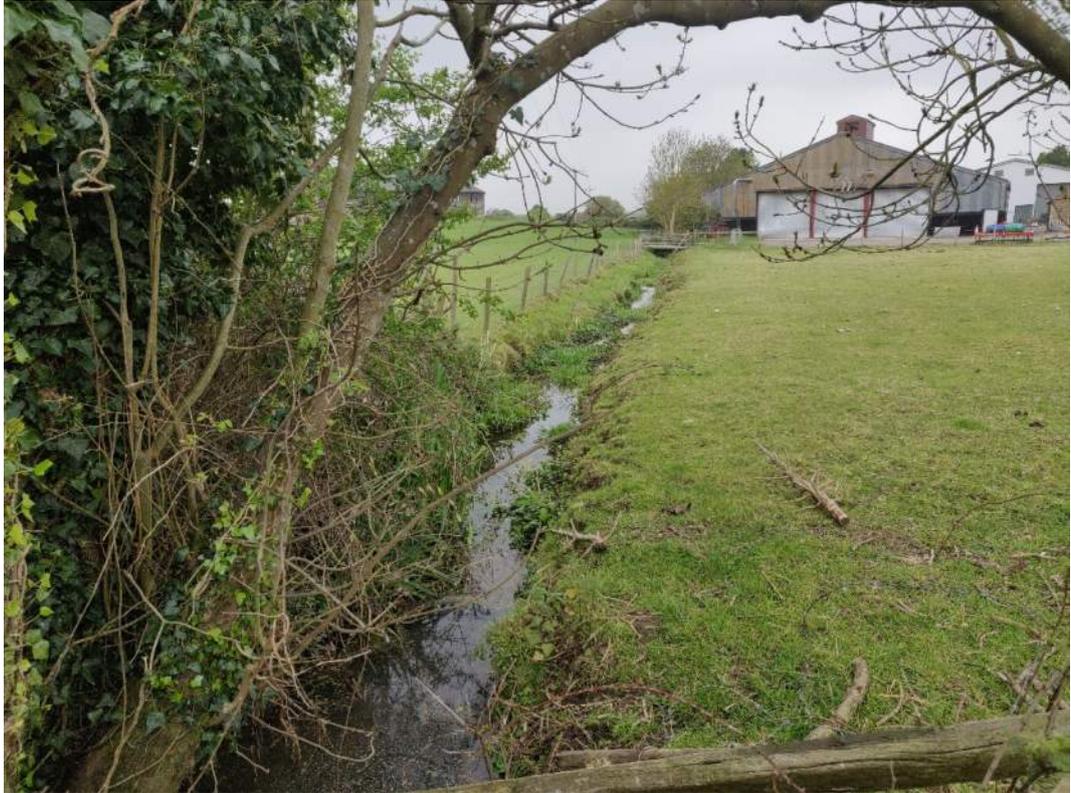
Figure 1: Watercourse downstream of Stoke Goldington Road

5.2.1.1 Generally, the watercourse, where observable adjacent to Common Street, appeared to be in a good condition. Downstream, where the watercourse is much flatter, near Stoke Goldington Road there was some sign of silting. We understand the parish council is proposing to organise some maintenance of this riparian watercourse in this location.

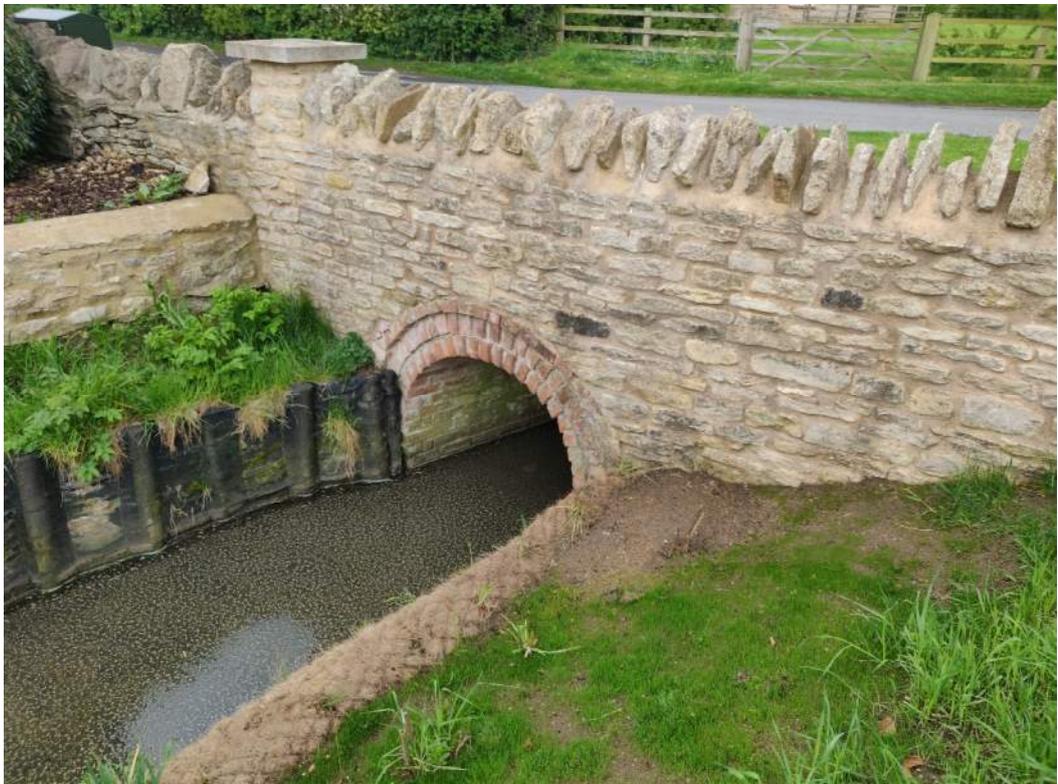
Figure 2 Culvert under Stoke Goldington Road

5.2.3.1 There are various culverts for road or access crossings. The majority of those observed appeared to be in good condition although a couple of culverts were showing signs of significant silting. Some examples of this are shown on the photographs included in Appendix C.

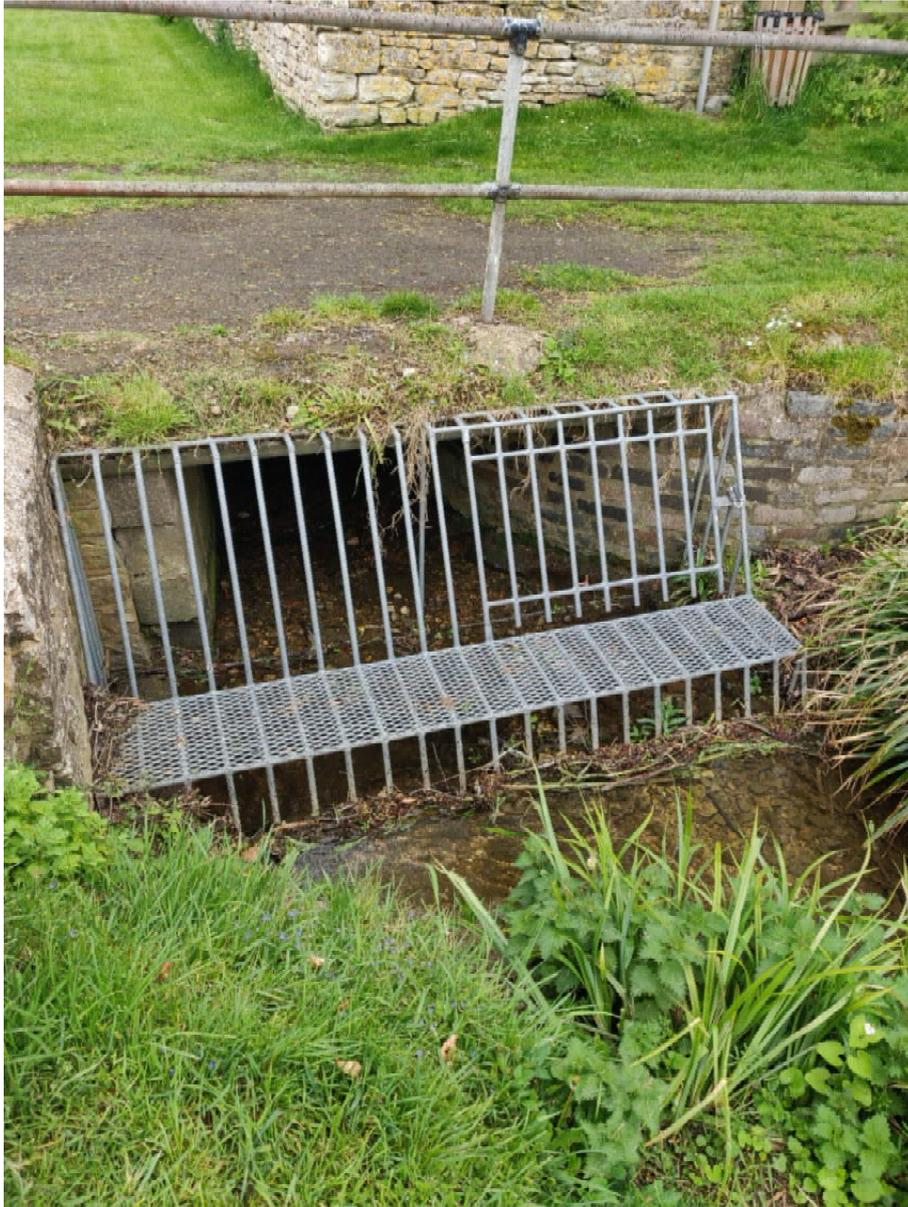
Figure 7: Culvert at recreation ground – start of buried watercourse

7.1.2.3 This culvert has a trash screen and appeared to be reasonably well maintained, it can be seen if Figure 7 in Appendix C. It was reported that residents removed debris from the trash screen on a number of occasions during the flood event. The debris was caused by the flood event.

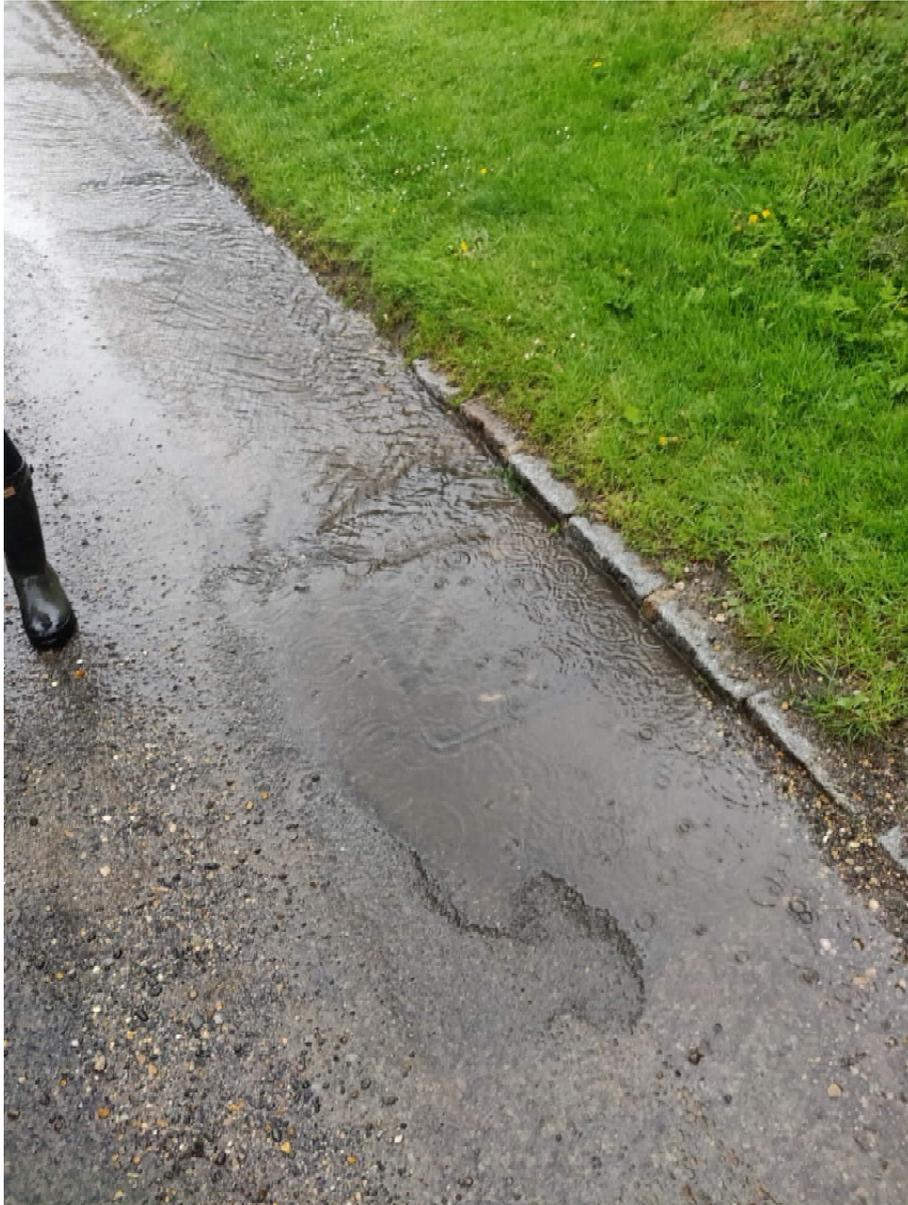
Figure 10: Road gully on North End during site visit

5.3.2.1 Highway drainage within Ravenstone generally comprises road gullies although there are some grips. Some highway gullies were observed to be unable to cope with the relatively light rainfall during the site visit.
