Milton Keynes Borough Council

# **FWMA SECTION 19 REPORT**

Flood Event: May 2018

**DATE: OCTOBER 2018**

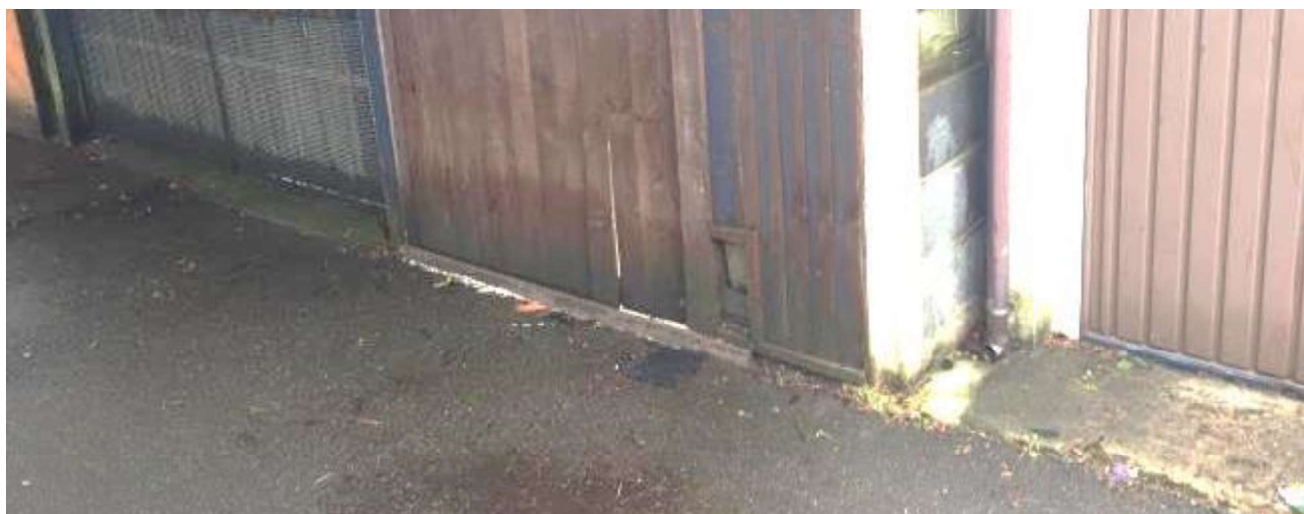
**Figure 2 – Indicator of Water Damage Daniels Welch**

- 7.2.4. The Site Investigation focused on Daniels Welch, of which there was significant evidence of flooding affecting a number of properties on the left hand side (evidence of carpets having been removed, and placed to dry / be disposed of in the front gardens.

- 7.2.5. The rack marks indicated that water is likely to have exceeded the door thresholds by around 100 mm to 200 mm, significant variation was observed, with some properties with evidence of water up to the letter box, mid door level. The flood water is likely to have exceeded the level of the damp-proof course, and many of the properties have front facing air bricks. Therefore water ingress into the properties is likely to have occurred. Figure 2 and 3 provide a sample of the types of indicators observed during the site walkover. Figure 4, presents the locations where photographs were taken, and clusters of photographs indicate areas where the greatest number of flooding indicators were observed.

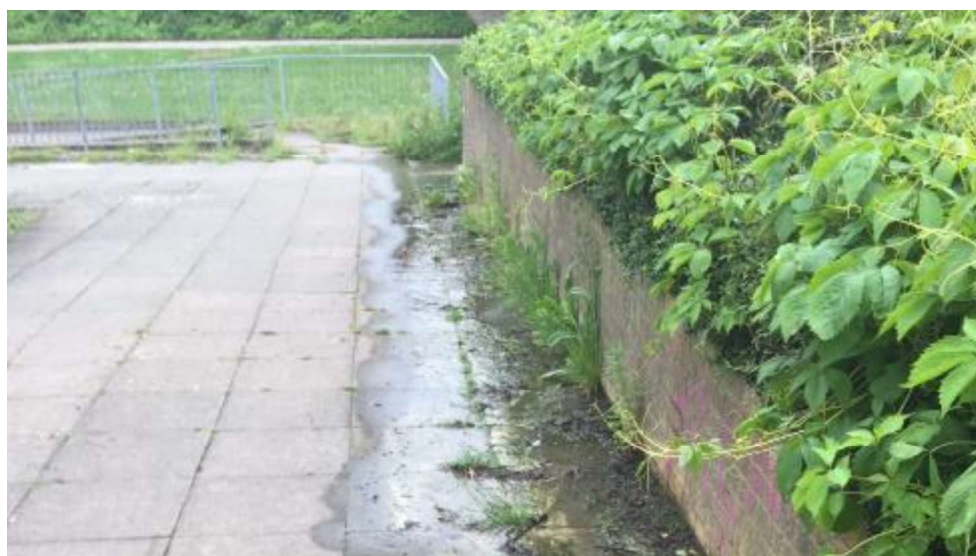
**Figure 6 – Evidence of Siltation near to Highway Embankment**

- 7.3.5. Milton Keynes Council shared video of surface water discharging over the steps adjacent to the V7 Saxon Street, and during the Site Inspection there was evidence of siltation on the footway adjacent to the embankment of the bridge, as shown in Figure 8.
- 7.3.6. Figures 9 to 11 provide photographs of the indicators of flooding in the area.

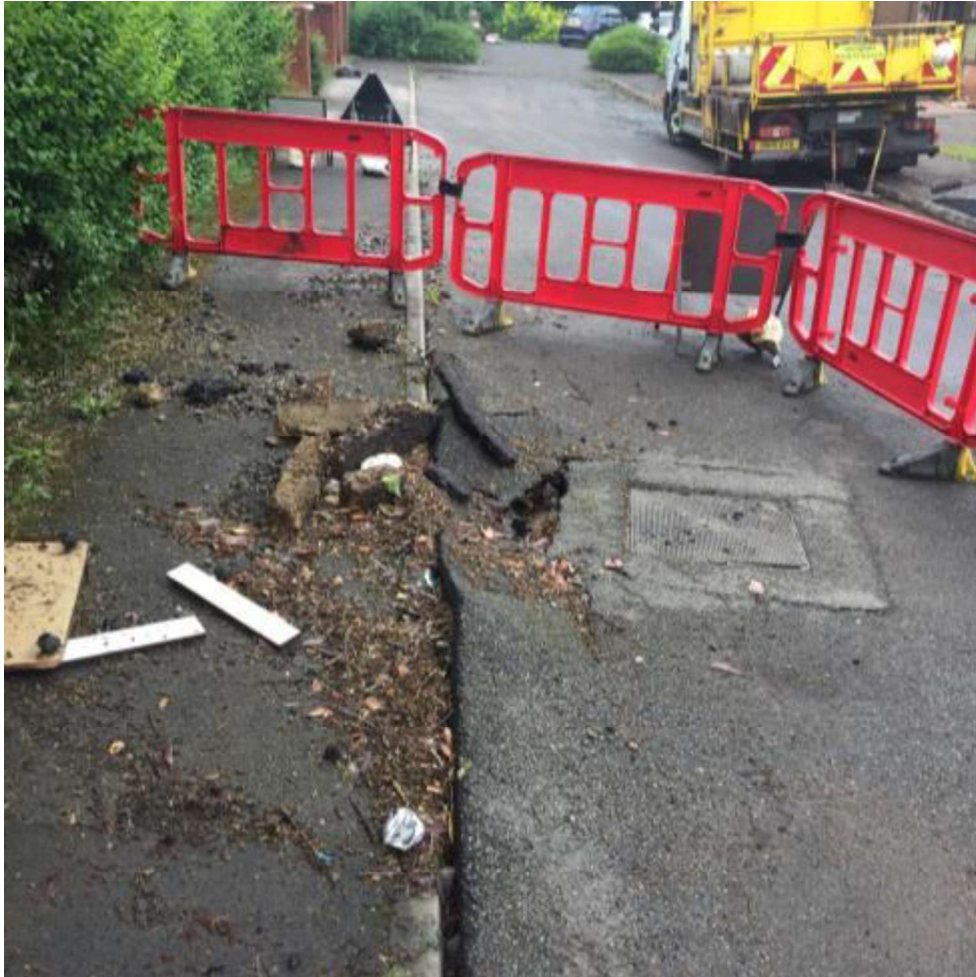
**Figure 10 – Damage caused by surface water burst pipe**

- 7.3.7. Figure 5 below shows the damage caused by a surface water sewer burst pipe. From inspection, of the local topography the chamber that failed is likely to be at the confluence of a number of drainage pipes from higher ground. Figure 6 shows the local ground terrain from LiDAR data.

- Evidence of sewer surcharging, causing damage to the overlying pavement has been observed, indicating that significant volumes of water were present within the sewer system.

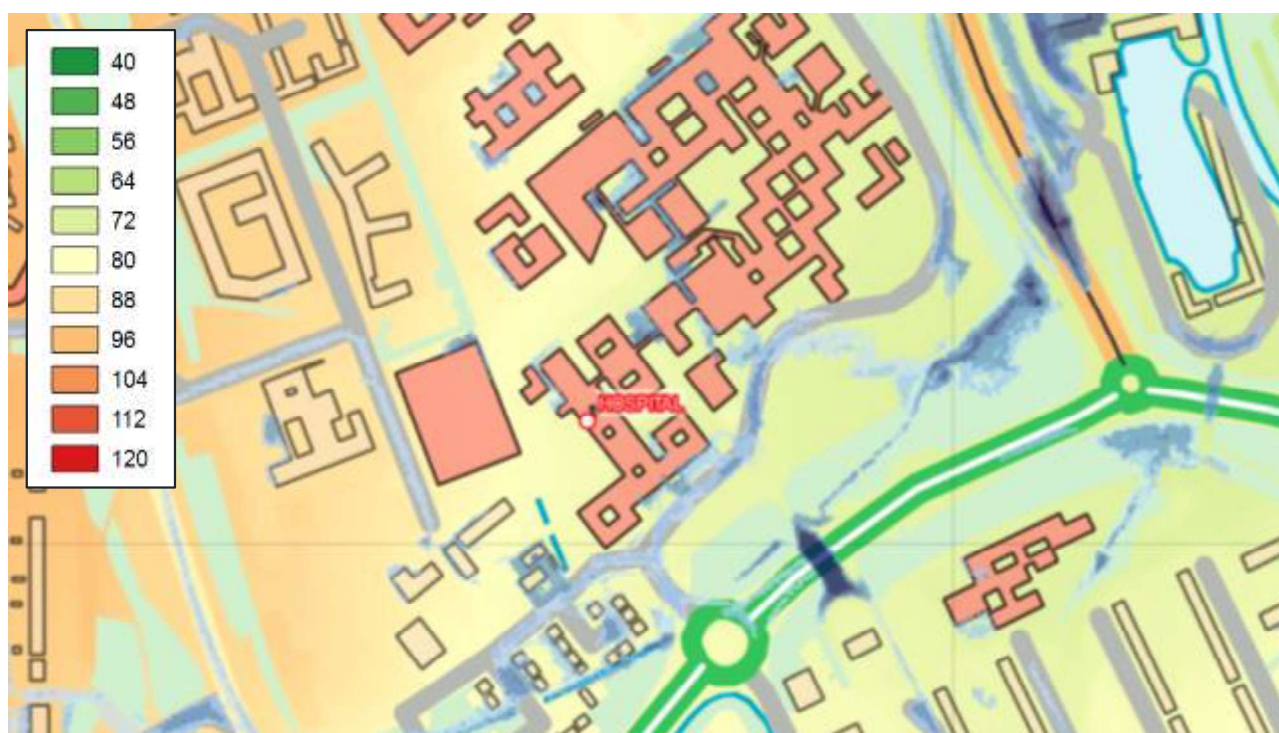
**Figure 12 – Hospital flood flow route, flood map for surface water and LiDAR**

- 7.4.1. Milton Keynes Hospital was flooded during the event, and from discussions with the Estates Team, flooding of the Hospital has occurred a number of times previously.
- 7.4.2. Indicators of flooding were noted along the access road from Flemming Drive, around the Hospital. Figure 12 presents the LiDAR data, and Flood Map for Surface Water outline.

- 7.4.3. The indicators of flooding generally follow the predicted extents from the Flood Map for Surface Water.

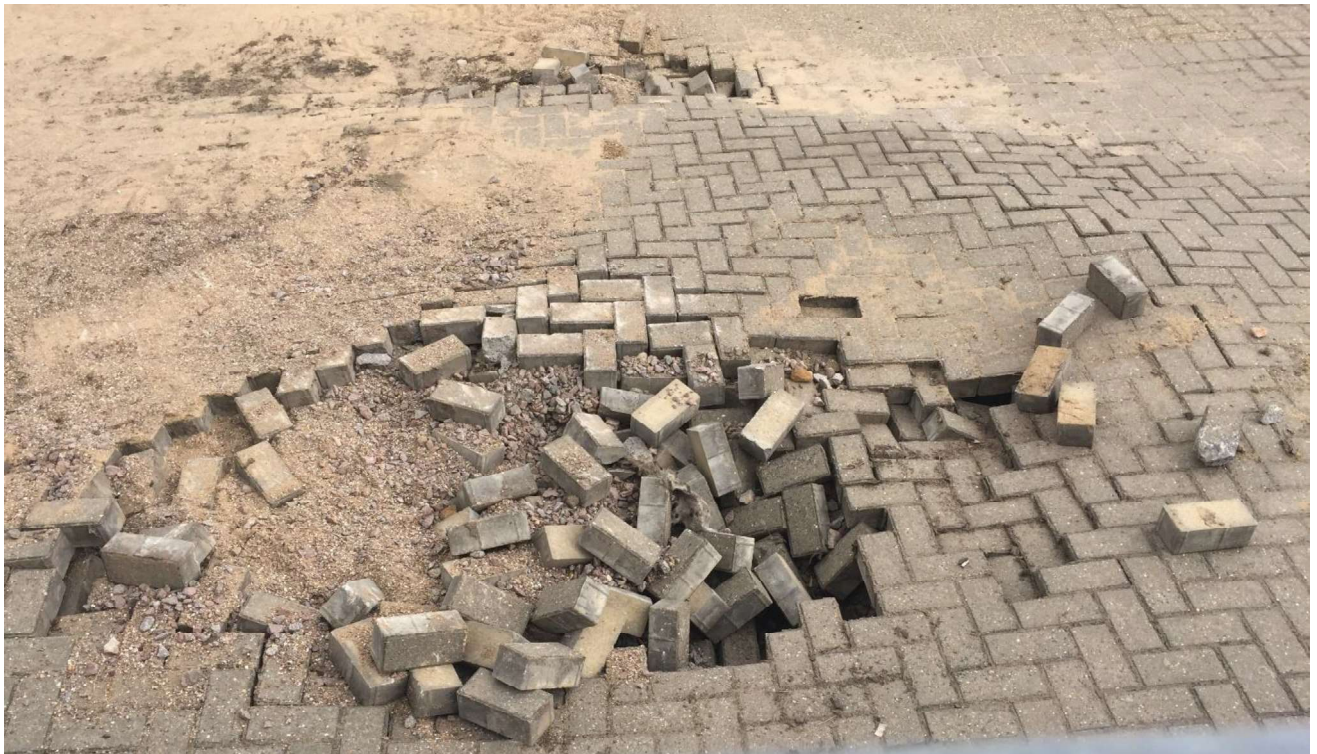
**Figure 14 – Pipe Burst Cairngorm Gate**

- 7.6.1. During the Site inspection of Winterhill, there were indicators of flooding observed. These were mainly associated rack marks on the shop fronts, and with pipe bursts of the surface water drainage network, which resulted in damage to the car parking areas.
- 7.6.2. Flooding was observed:
- Cairngorm Gate retail units (pipe burst on Anglian Water Sewer)
- 7.6.3. Within the retail park evidence of flooding up to 300 mm deep within the retail units was observed, a number of the stores were in the process of cleaning up the damage, which was across the ground floor areas of the retail units. From the inspection it was noted that flood waters would be impounded by the railway embankment.

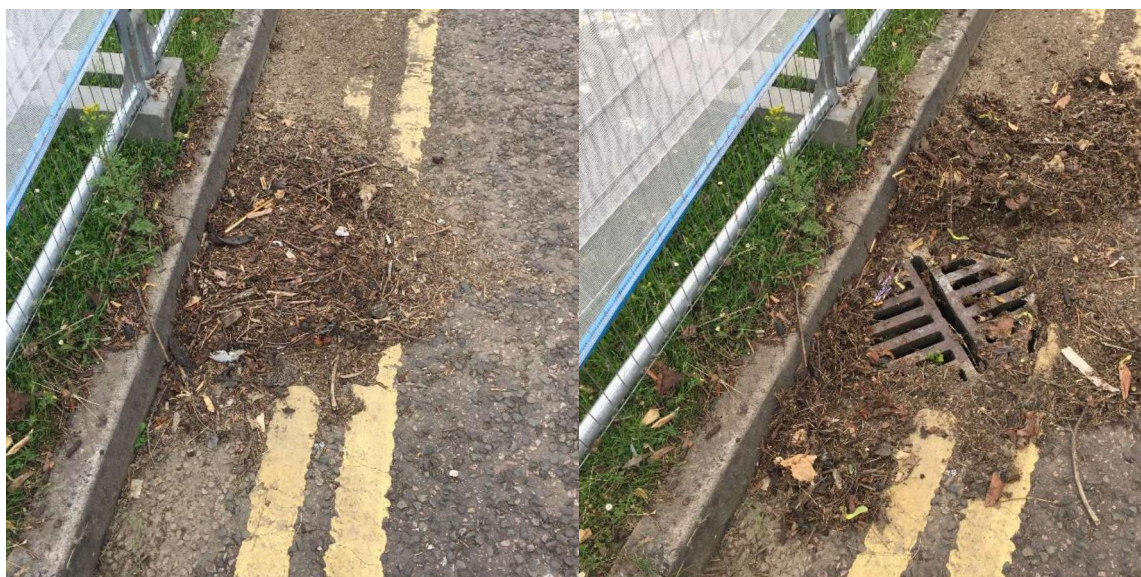
**Figure 15 – Road Gully covered in leaf litter and detritus, and uncovered (Cairngorm Gate)**

- 7.7.1. During the Site Inspections a number of road gully covers were observed to be covered by leaves and other detritus, which may have reduced to capacity of the gullies. It is not obvious if the road gully inlets were blocked, before, during, or after the flood event. However, it is reasonable to assume that some of the road gully covers may have been blocked or partially blocked.

- Debris was observed on gully inlets, indicating that the storm event is likely to have mobilised a significant volume of leaf litter and other detritus. It is unclear if this occurred, before, during or after the event. This may have restricted the functioning capacity of the gullies. On clearing the gully grates, the internal gully was observed to be clear.

- 10.2.1. This preliminary report has been based on information available at the time of writing, and further information needs to be obtained before any conclusions can be reached. As such the following next steps are recommended:
- A joint Drainage Service Review should be undertaken, involving Milton Keynes Highway and LLFA functions, Anglian Water, and other stakeholders with drainage assets. This review should seek to rationalise responsibility and maintenance functions.
  - Review of street-cleaning / grass cutting operations to reduce the amount of material that could cause blockages to the drainage system.

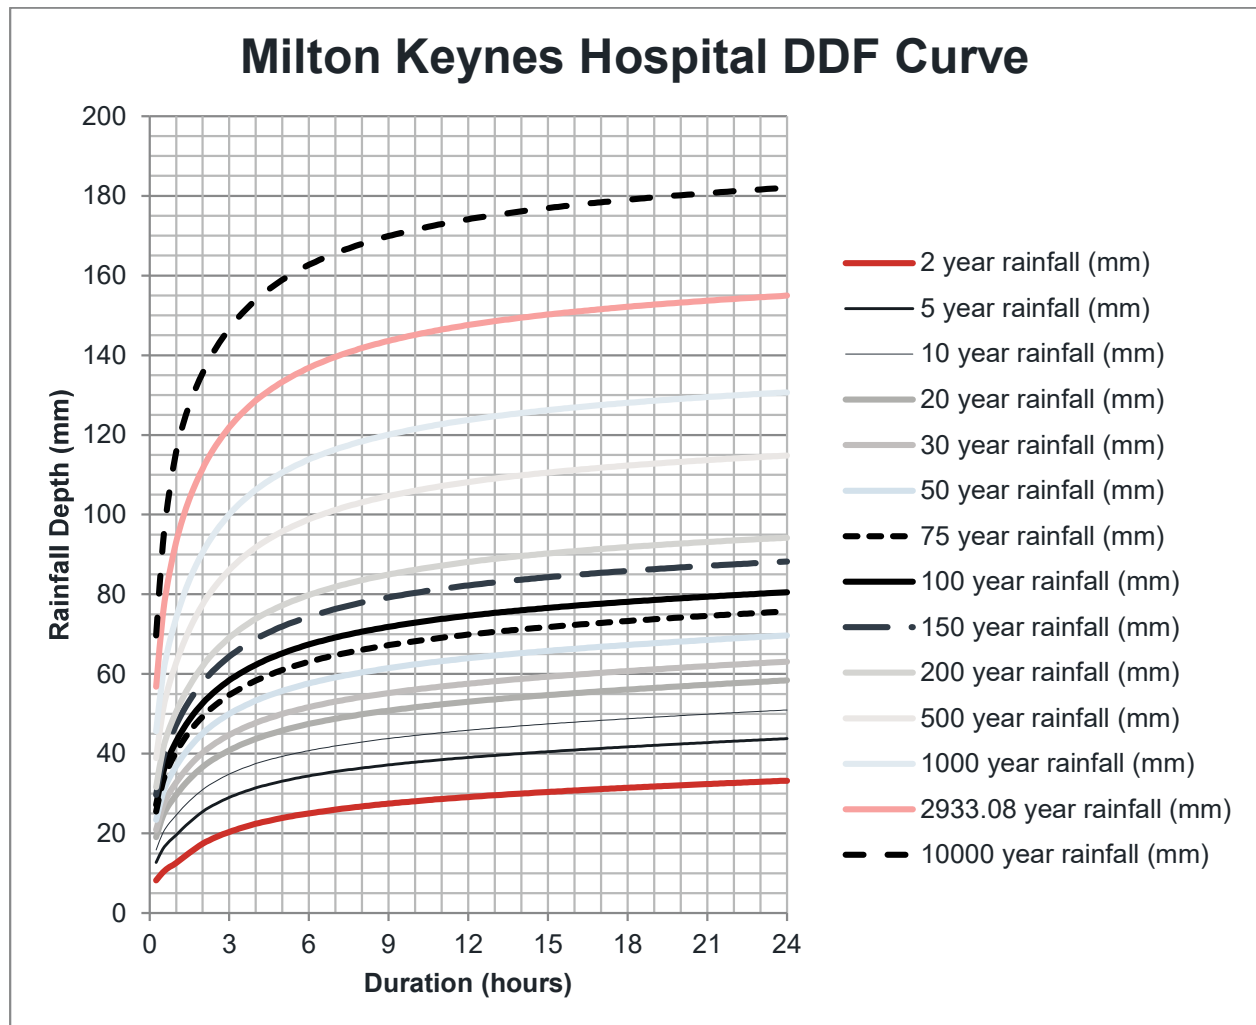
## Milton Keynes Hospital DDF Curve

- 8.1.8. Based on the available data, witness evidence, and the indicators of flooding noted, it is considered very likely that the rainfall event experienced was significantly in excess of the 1.0% Annual Probability Event, with some areas affected by rainfall in excess of the 0.5% Annual Probability Event.
