Castlethorpe Conservation Area Review

December 2021
Conservation & Archaeology

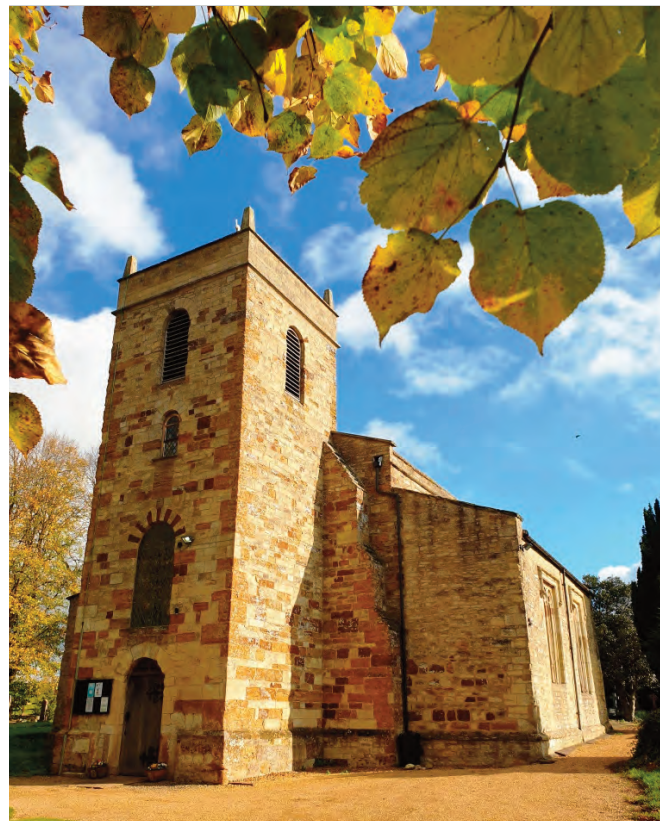
Church of St Simon and St Jude built in honey hued local stone. The tower is evidently a rebuild but still handsome.

The church of St Simon and St Jude’s earliest upstanding feature is the north arcade of two bays, the manner of their construction pointing to a time circa 1200, though a 1975 watching brief suggested the existence of an earlier Norman or pre-Norman church. The church continues to occupy an elevated, central plot in the historic core of the village and although not as conspicuous as some in the borough, it remains a key feature of the village.

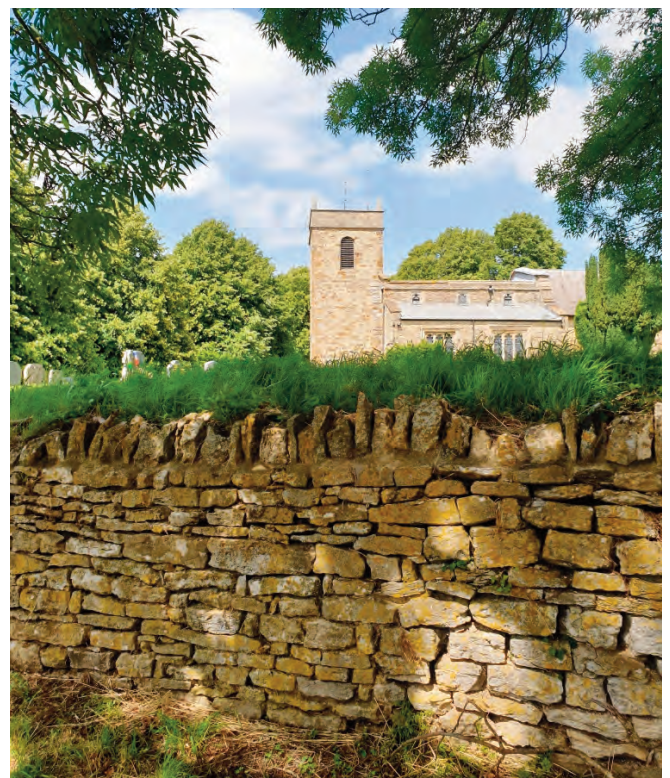
Local limestone an unpointed retaining wall on North Street with a view of the church of St Simon and St Jude beyond

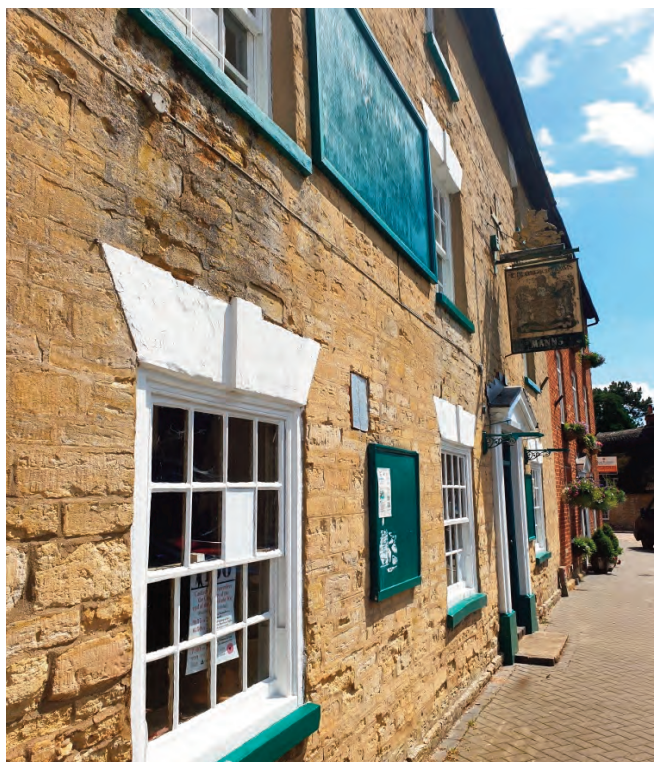
Carrington Arms with painted stone lintels over eight over eight pane timber sash windows. The windows are flush with the wall suggesting a mid, rather than late 18th century date after which windows were pushed back into their openings to discourage the spread of fire. The glass is puttied into structural timber glazing bars

than being bedded flat as is the norm. Such work tends to be indicative of Victorian romanticised visions of rustic rural buildings. The stone dressing detail around the windows and quoin stones at the corner further heighten the sense that this a more knowing and considered composition of late Victorian or Edwardian origins. Reference to the Milton Keynes Heritage Association web pages confirms the premises were once Gregory's stores built in 1908 before being slightly clumsily converted into four flats after closing in 1977

The Carrington Arms and nearby No 5 South Street are unusual for Castlethorpe in that they have ornamental gauged stone flat arches above the windows whereas all other buildings of preVictorian origin have timber lintels. That these may be later variations is suggested by the unorthodox treatment of the upper floor stonework of Number 5 which is laid to chevron pattern with upright stonework rather

Curiously, the Carrington Arms is lent further visual stature by being a an almost symmetrical composition but for an off centre door where one might normally have expected a central location. This may be a later modification perhaps alongside a 'facelift' replacing casement windows for sash windows with stone lintels above. However early photographs suggest this arrangement has existed since the early 20th century and there is no evidence other than the age of the building to suggest anything other than sash windows.

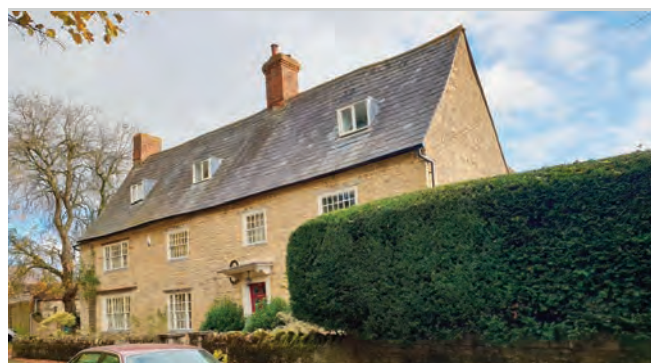
Manor Farmhouse, note the selection of window designs sitting under timber sashes rather than stone lintels. The roof is slate but the steep pitch suggests it was once thatched

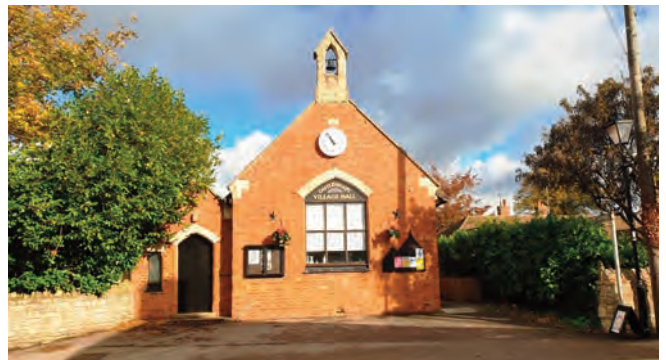
The village hall, brick with stone detailing. The brickwork is in English bond (alternating courses of headers and stretchers)

The village hall is built using English bond (alternating courses of headers and stretchers) whilst Laburnum House and the chapel are in standard Flemish bond. The census return of 1841

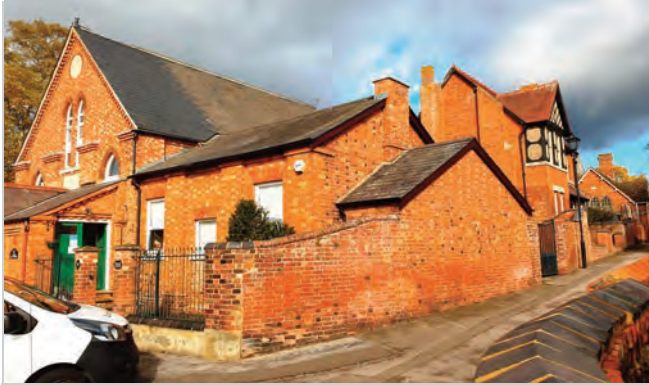
The Wesleyan Chapel and School House. The brickwork is of Flemish bond where headers and stretchers alternate. A chequer board pattern can emerge if alternating colours are used. In the flanking boundary wall and outbuilding the pattern has broken down and appears pockmarked with burnt black headers

The Wesleyan chapel, now extended and altered, is similarly reserved with only brick pilasters and gauged brick gothic and flat headed arches to various

windows, and a dentilation pattern under the gable rooflines giving the building additional expression.

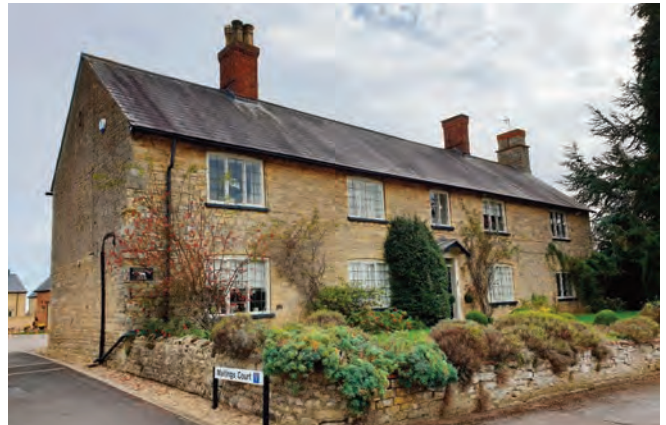
Malting farmhouse still retains a stone chimney stack, minus pots. Notice the tripartite side hung casement windows with lead comes gripping the small panes of glass into place

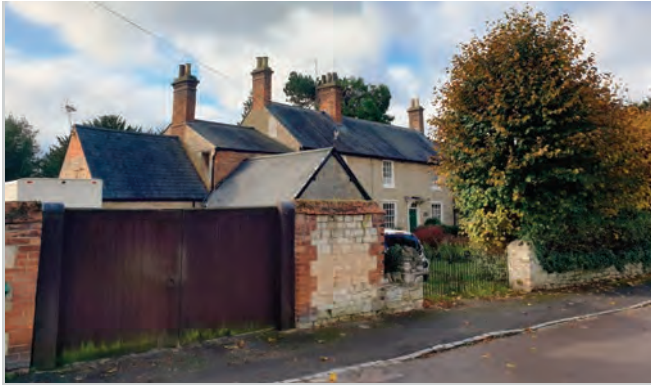
At Lime Trees farm fi red brick is used to edge walls, cope wall tops and for other incidental purposes

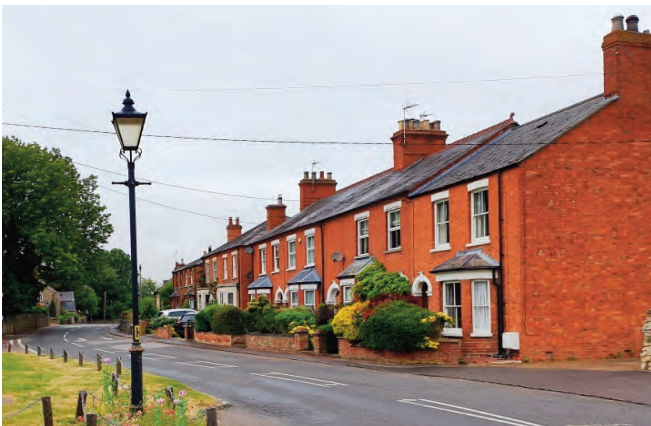
Terraced houses on North Street in red brick, dark grey slate, painted stone and timber

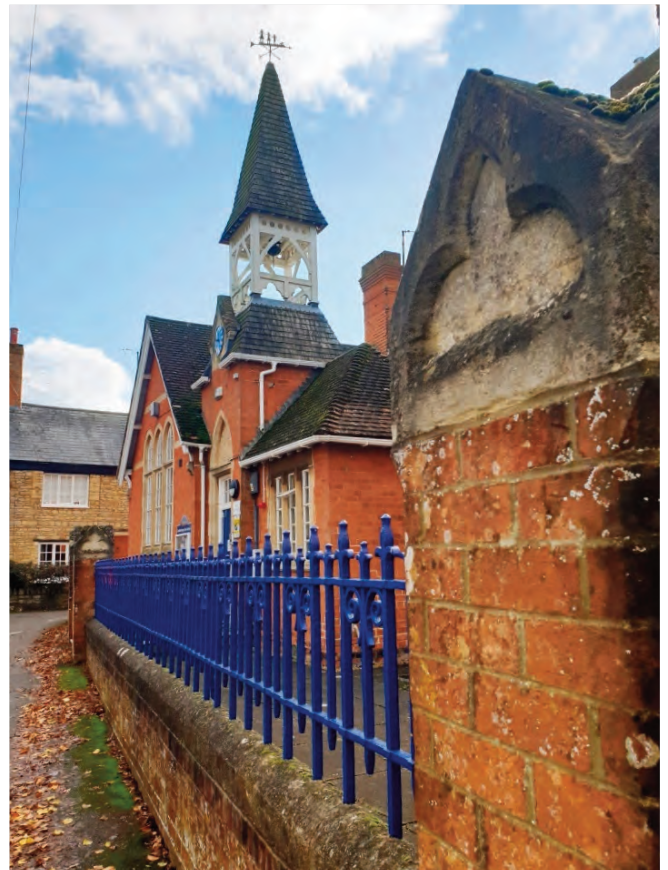
The exuberant school Building. Remarkably, the delicate traceried railings and metal windows survive. Note that the stone is unpainted and has a pleasant pale honey colour

Much more accomplished, distinctive and indeed intact is the school building, a late Victorian composition that is, quite appropriately, playful and cheerfully whimsical. Many original details appear to survive including doors, windows, and, remarkably, the clock tower topped by a newly reinstated weathervane, itself surmounted by children holding hands. The detailing is economical but highly effective. The same can also be said for the adjacent School House which is also an erudite essay in the combined use of brick, stone dressing and applied timber ornament. Adding to this to create a very important grouping of outwardly unaltered buildings is 3 School Lane with chequerboard brick 'diaper work' detailing. None of these buildings are listed but they contribute much to the distinctive character of the locality.

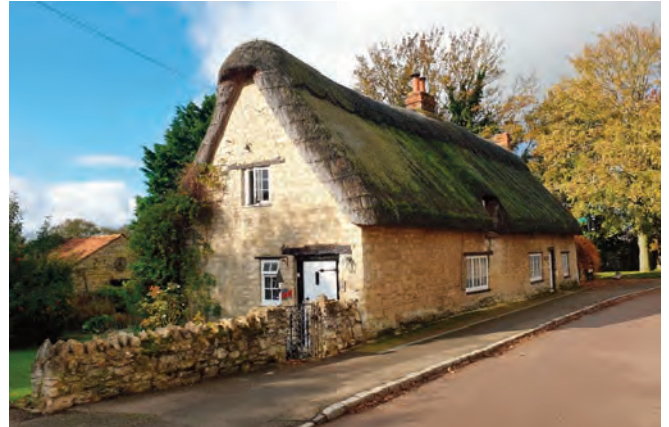
Thatch, this cottage on South Street appears to be thatched in traditional long straw thatch with its distinctive wrap around verge detail. The ridge detail is not usual for long straw and the roof would have to be sampled to confirm that it is not a hybrid form of thatching

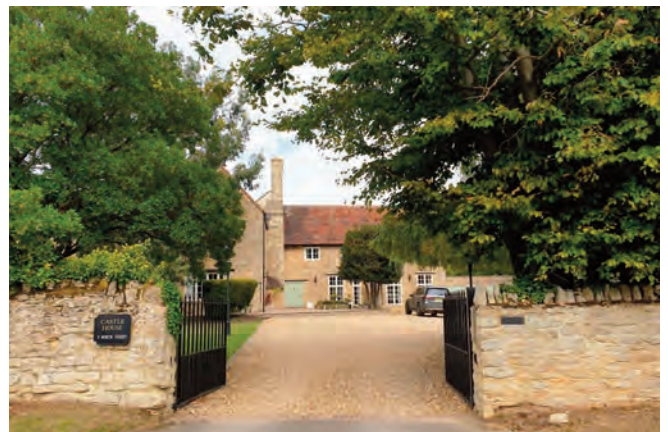
Clay tiles at Castle House, North Street. Also note the width of the front door in relation to its height

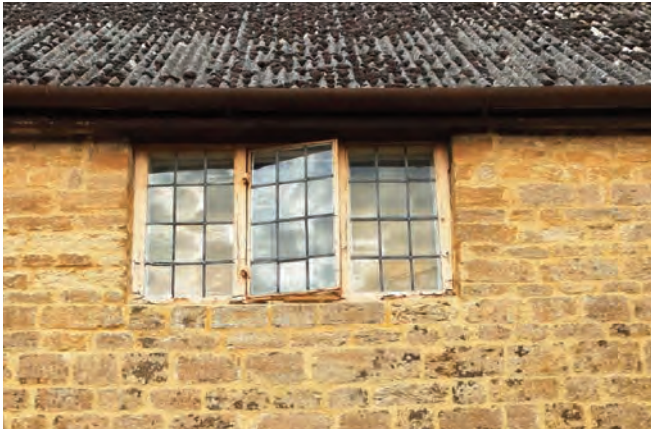
Metal casement window with a central flush fitting casement. The casement has distinctive pintle hinges. The window has no cill and sits flush with the wall exterior

Early windows tend to be side hung flush fitting casement variety but few of genuine examples now survive. At first they combined small pieces of glass held in place by lead 'comes' but evolved to have larger panes of glass fixed by putty into timber frames subdivided by glazing bars. Cills tended to be absent and the windows placed almost flush with the external stonework. During the 18th century vertically hung sliding sash windows became prevalent. At first these too were flush with external masonry but late 18th century laws aimed at reducing the risk of fire spreading pushed the windows into their openings by four inches. The shadow lines this creates adds expression to later Georgian and Victorian windows.

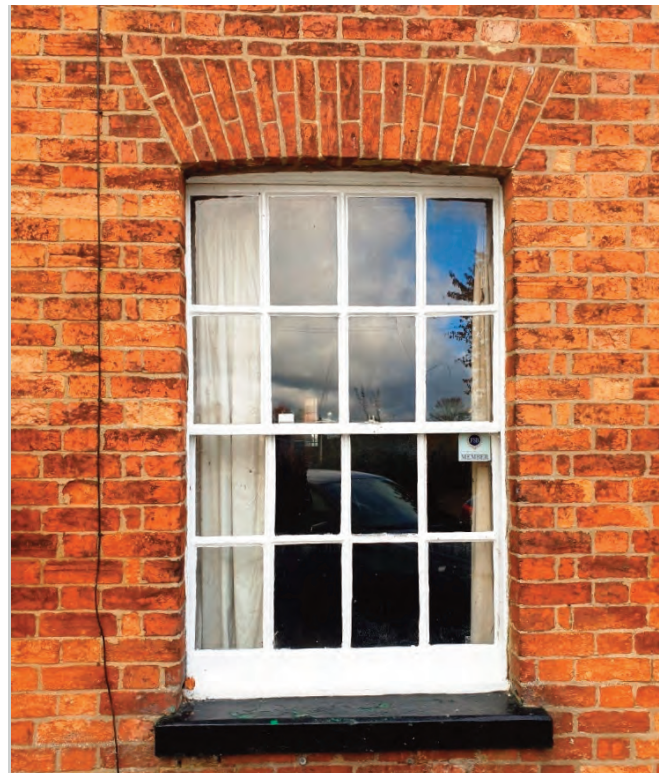
Sash window at 3 South Street under a flat head arch of gauged brickwork

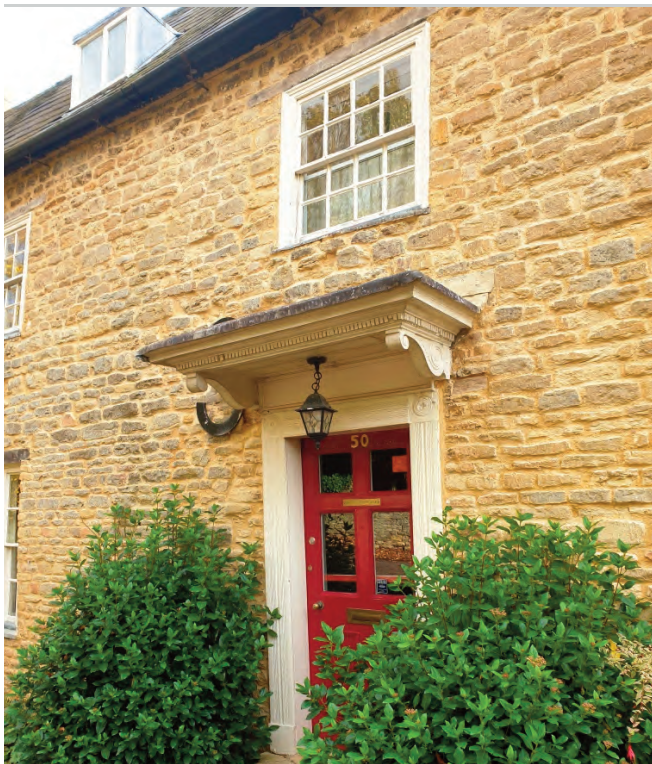
Front door details at Manor Farm adds a sense of occasion to the main entrance

Doors come in a variety of designs from basic plank doors to ornate Victorian and Edwardian designs. In Castlethorpe some Victorian or Edwardian era doors survive. They typically comprise vertical stiles and horizontal rail frames further divided vertically by muntins into which wood panels or glazing is placed. Fanlights, where present, are invariably placed above doors and never incorporated into them. Polished brass knobs, rather than lever handles, were used to open doors. The doors are always painted smooth and woodgrain finish is absent. Georgian and Victorian doors, particularly on higher status buildings often have a door hood supported by brackets. These can be very plain to highly decorated and sometimes accompanied by an ornamental door surround.

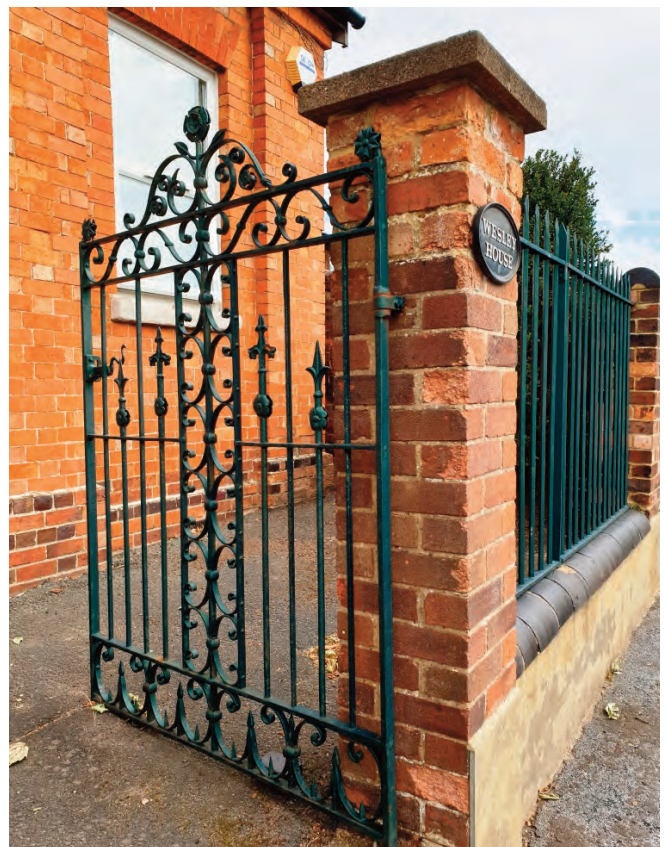
Iron gate at the entrance to the Wesleyan chapel

Iron too would have been in evidence for incidental features and details around the village but not for major structural elements. The presence of iron boot scrapes, bollards and railings is very rare in Castlethorpe now. An exception are the pretty, lacelike railings that sit in front of the school and the gates to the Wesleyan chapel. No iron gutters or down pipes were specifically noted but may still survive here and there.

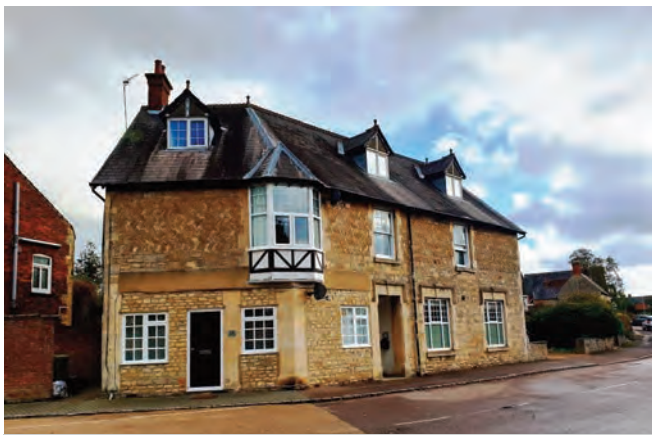
Number 5 South Street was once a shop with unusual decorative chevron stonework and carefully applied detailing to doors and windows. Unfortunately, when it was converted to solely domestic use the detailing was not as conscientiously undertaken and the building's appearance now seems slightly makeshift and unfinished

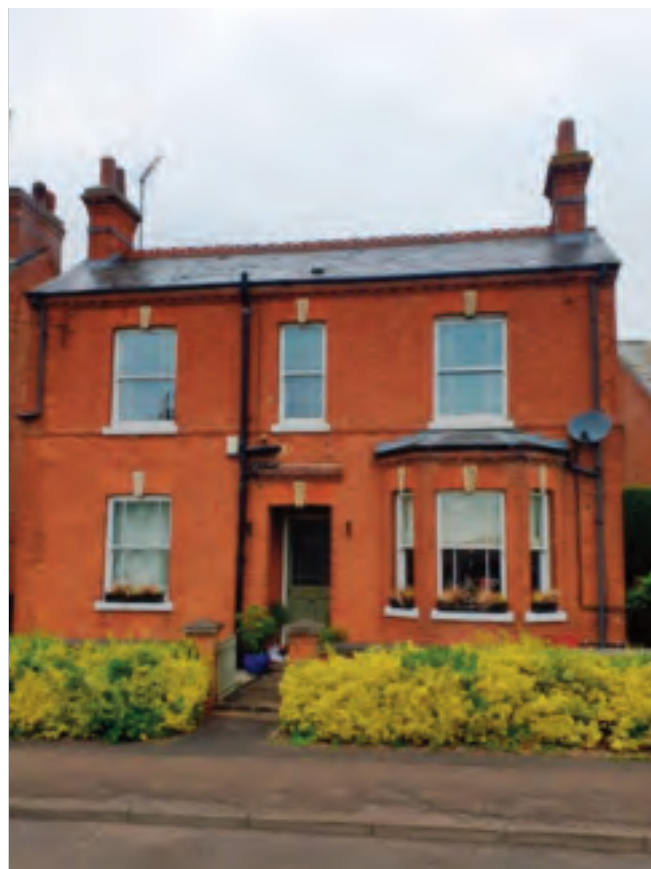
Ivydene, a characterful and unaltered late Victorian house on Bullington End Road is now included in the conservation area.
