Milton Keynes Council

FLOOD RISK INVESTIGATION

Newport Pagnell Section 19 Report

OUR REF. NO. 70082487-WSP-FRM-02-RP-CO-0001

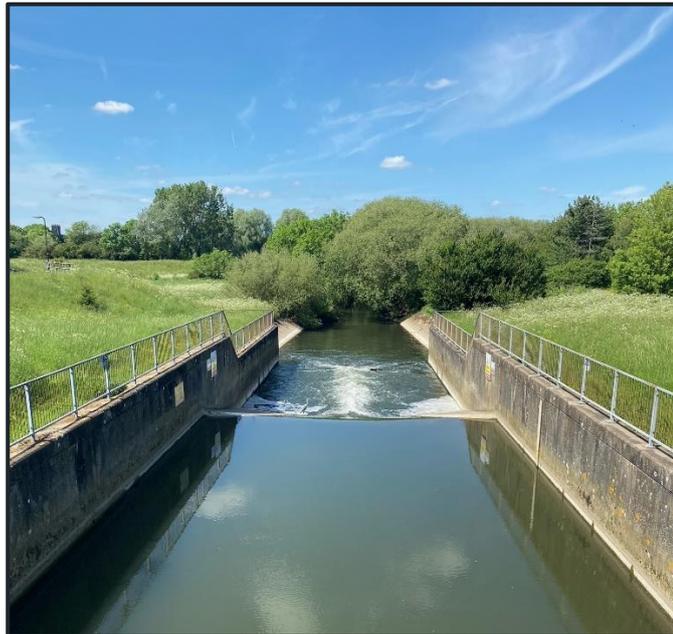
Figure 1-1 - Sluice/control feature for Willen Balancing Lake (owned and managed by Anglian Water).

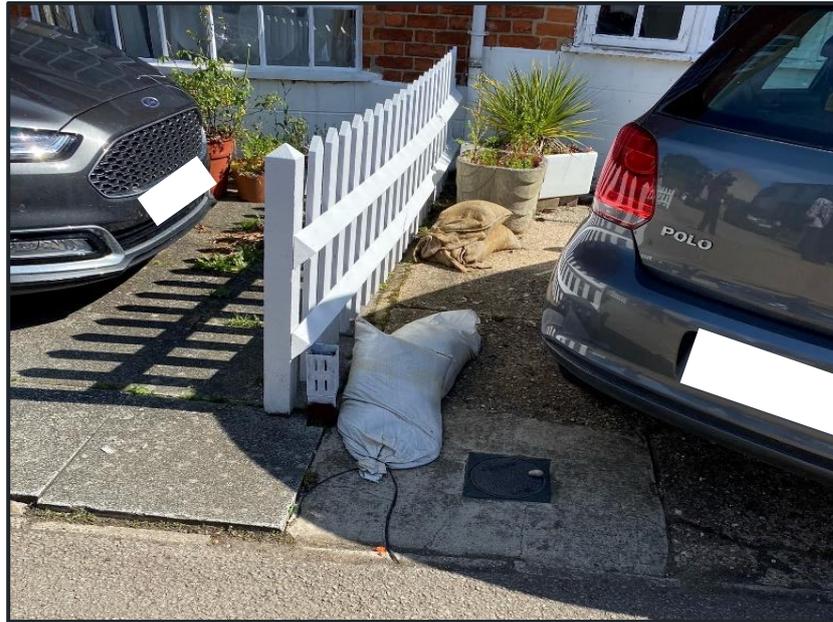
Figure 1-2 – Sandbags present outside property on Mill Street which experienced flooding during the flood event.

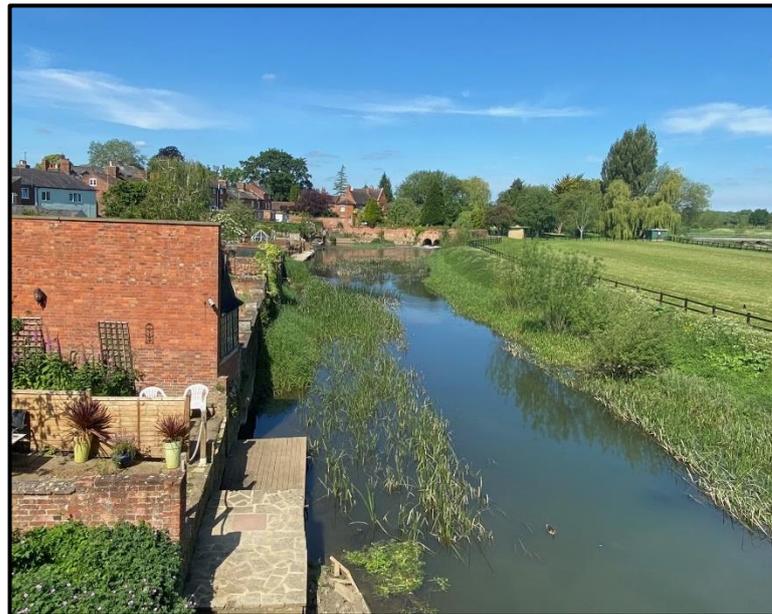
Figure 1-3 - Section of the River Great Ouse near The Mill House, Mill Street.

- 1.5.4. The River Great Ouse was reported to have had high water levels during the flood events of interest, with these reaching the back gardens of several properties. Newport Pagnell Main Gauging Station and Newport Pagnell Mill Gauging Station are located on this reach, both owned and maintained by the Environment Agency.

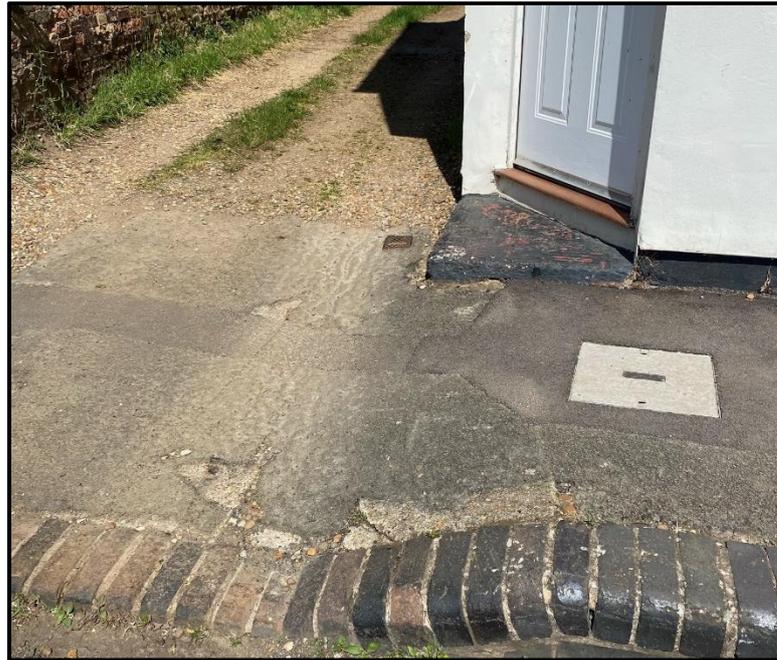
Figure 1-4 – Kerb on Priory Street

- 1.5.5. Flooding impacted a number of properties on Priory Street during the flood events of interest. Evidence of low kerbs and potential flow path next to a property that was flooded on December 24th 2020.

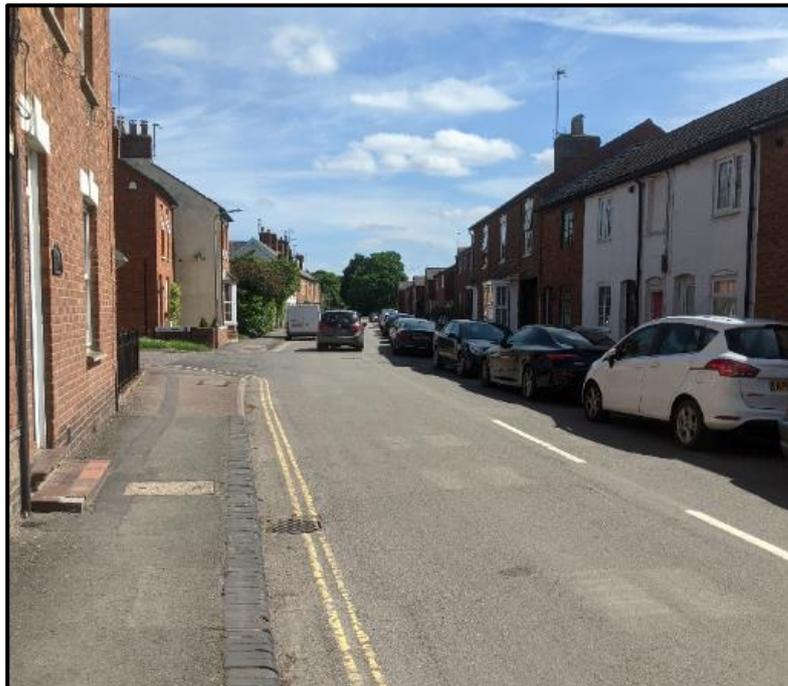
Figure 1-5 – Priory Street

- 1.5.6. During the flood event of interest witnesses reported surface water sewer surcharging from the drains at Priory Street.

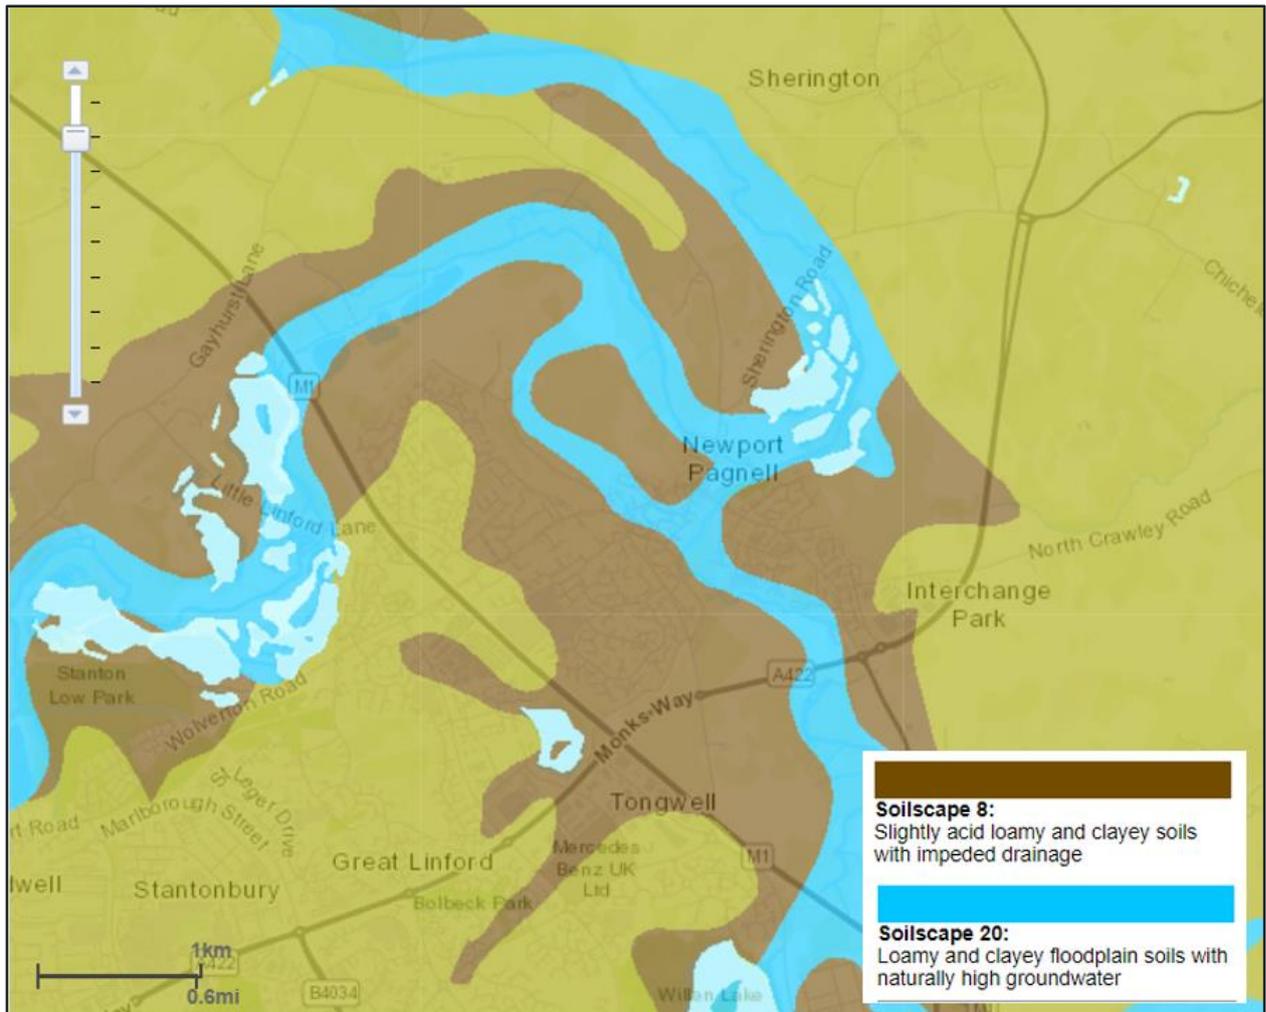
2.5.1. The land within the study area is defined by the Cranfield Soil and AgriFood Institute (CSAI)⁴ as Soilscape 8- “Slightly acid loamy and clayey soils with impeded drainage” and Soilscape 20 - “Loamy and clayey floodplain soils with naturally high groundwater”. Another characteristic of Soilscape 20 is “Water” is also present and depicts the water bodies located within Newport Pagnell. The area is also heavily urbanised with a high proportion of impermeable surfaces likely to increase runoff volumes.

Figure 2-3 – Extract of Cranfield Soil and AgriFood Institute map

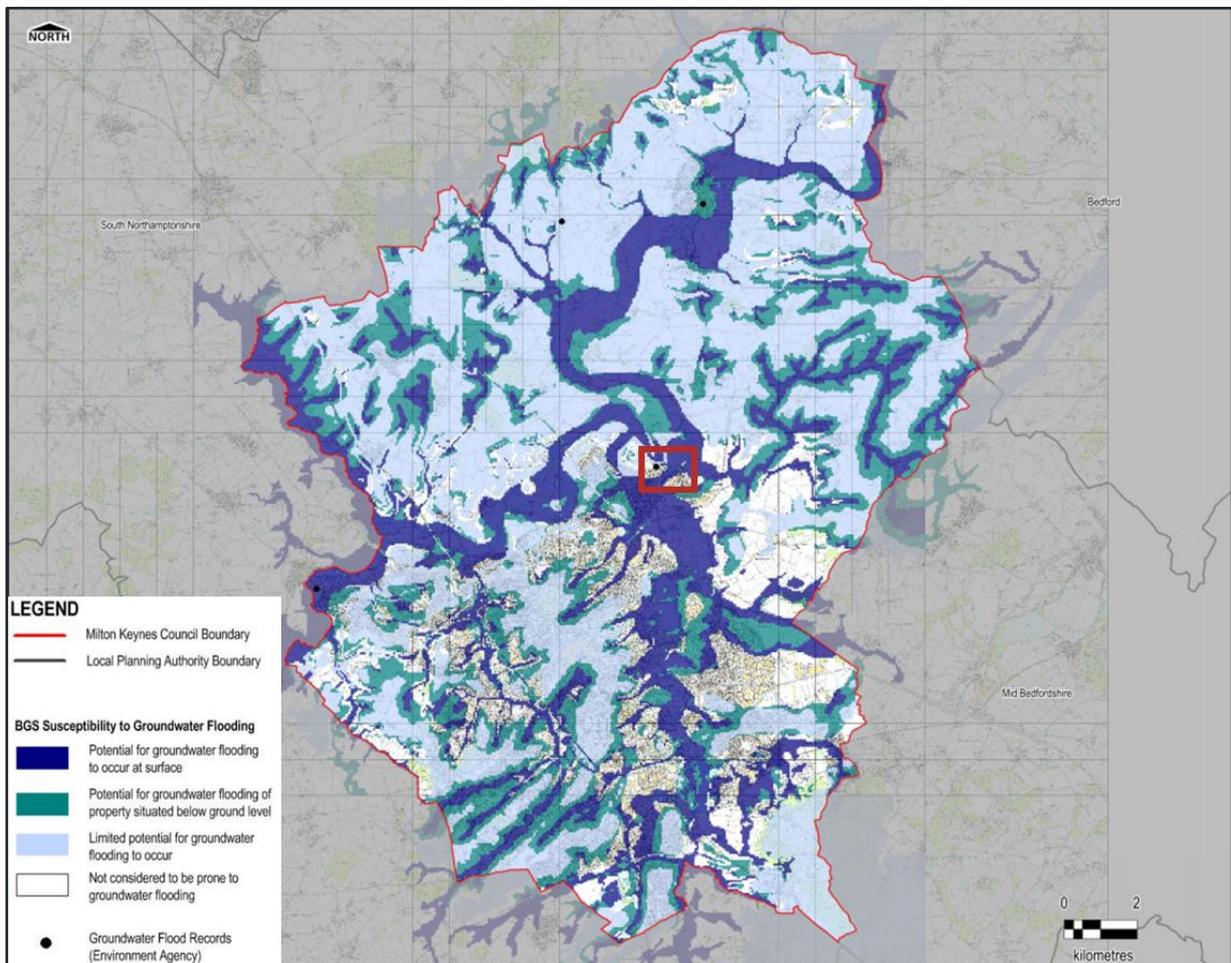
- 2.6.6. In regard to groundwater, the BGS Areas Susceptible to Groundwater Flooding map shown in Figure 2-4 identifies areas within Newport Pagnell which are classified as 'Potential for groundwater

flooding to occur at surface’ and ‘Potential for groundwater flooding of property situated below ground level’. This mapping provides an indication as to where there is the potential for groundwater flooding and should be considered alongside other sources of flooding.

Figure 2-4 - Susceptibility to groundwater flooding. Source: [Milton Keynes Council Local Flood Risk Management Strategy, AECOM 2016](#)

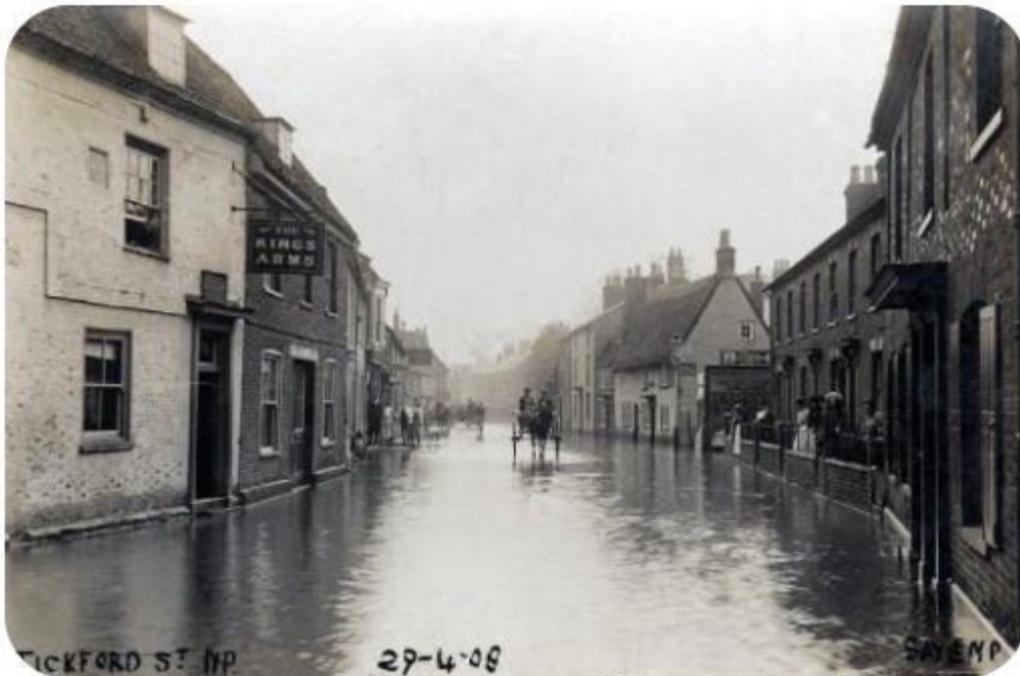
Figure 2-5 – Tickford street flooding, 1908. Source: © Pinterest 2021

- 2.7.1. There are a number of historic flood events that have been occurred in Newport Pagnell prior to the event on the 24th December 2020. Figure 2-5 shows flooding at Tickford Street on 1908. Newport Pagnell was affected by the 1947 flood event with flooding recorded in Tickford Street, Silver Street, Caldecotte Street and Priory Street to a maximum depth of approximately 1.0m, as well as Lakes Lane and Willen Road with the latter recording a maximum depth of approximately 0.75m. The peak water level reported at the Newport Pagnell cemetery gauge was 55.12m AOD. In 1992 a flood event resulted in 9 residential and 6 industrial premises recording flooding, with a further 101 residential and 3 industrial properties suffering access disruption. After the 1998 flood 78 residential properties and one non-residential property were reported as flooded. Of the 78 residential

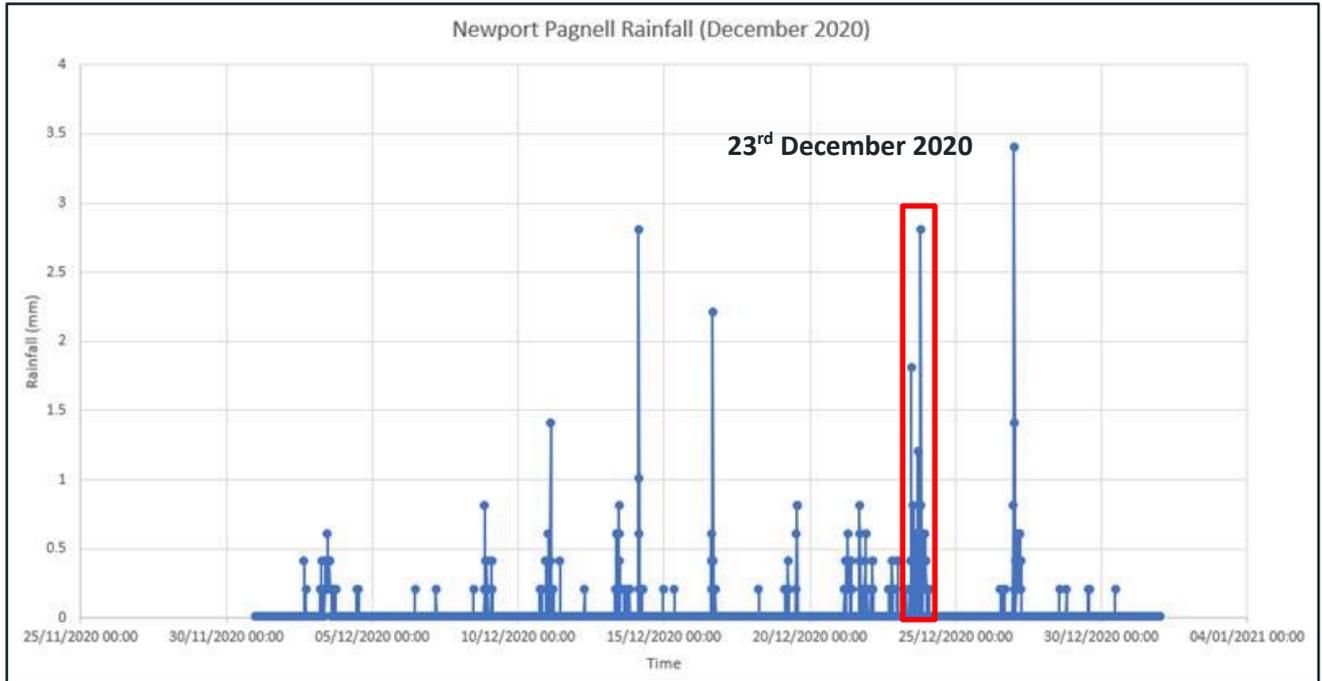
Figure 3-1 - 15min rainfall (mm) recorded at Birchmoor E22231

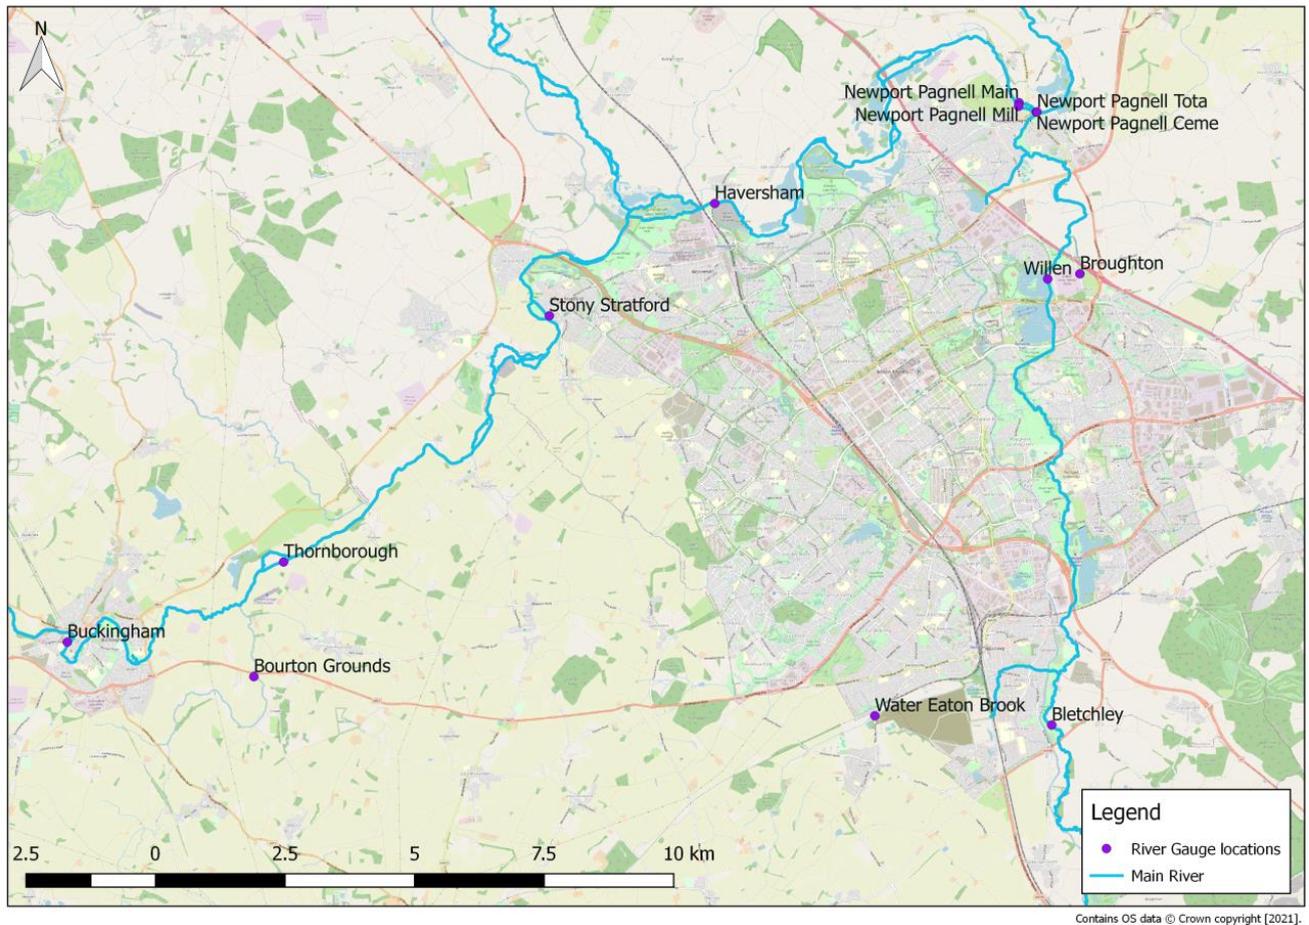
- 3.2.1. There are several river gauges along the River Great Ouse and the River Ouzel. There are four river gauges located within Newport Pagnell on the River Great Ouse; Newport Pagnell Main, Newport Pagnell Mill, Newport Pagnell Cemetery and Newport Pagnell Total (see Figure 3-2).

Figure 3-2 - Location of river gauges at Newport Pagnell

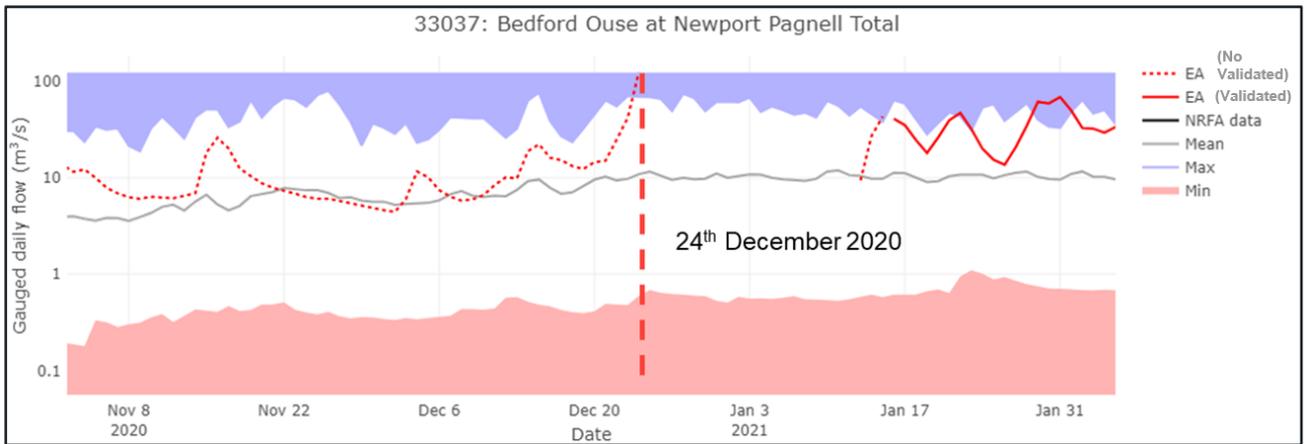
3.2.2. Data obtained from the National River Flow Archive (NRFA)¹⁵ for the 24th of December 2020 at the Bedford Ouse at Newport Pagnell Total flow gauge is shown in Figure 3-3. This figure clearly indicates a steep rise in river flows on the 24th of December as a result of the heavy rainfall from approximately 20th December. A sharp peak of flow on the River Great Ouse is evident with estimated values above 100m³/s resulting from the heavy rainfall. This graph also indicates a discontinuity in the river flow data from 24th December 2020 to 13th January 2021. It might indicate that the dip tube within the river gauge was flooded during this event stopping the operation of the gauge.

Figure 3-3 – Long term gauged daily flow at the Bedford Ouse at Newport Pagnell Total gauging station.

Key: Red and blue envelopes represent lowest and highest flows on each day over the period of record. Source: National River Flow Archive (NRFA)

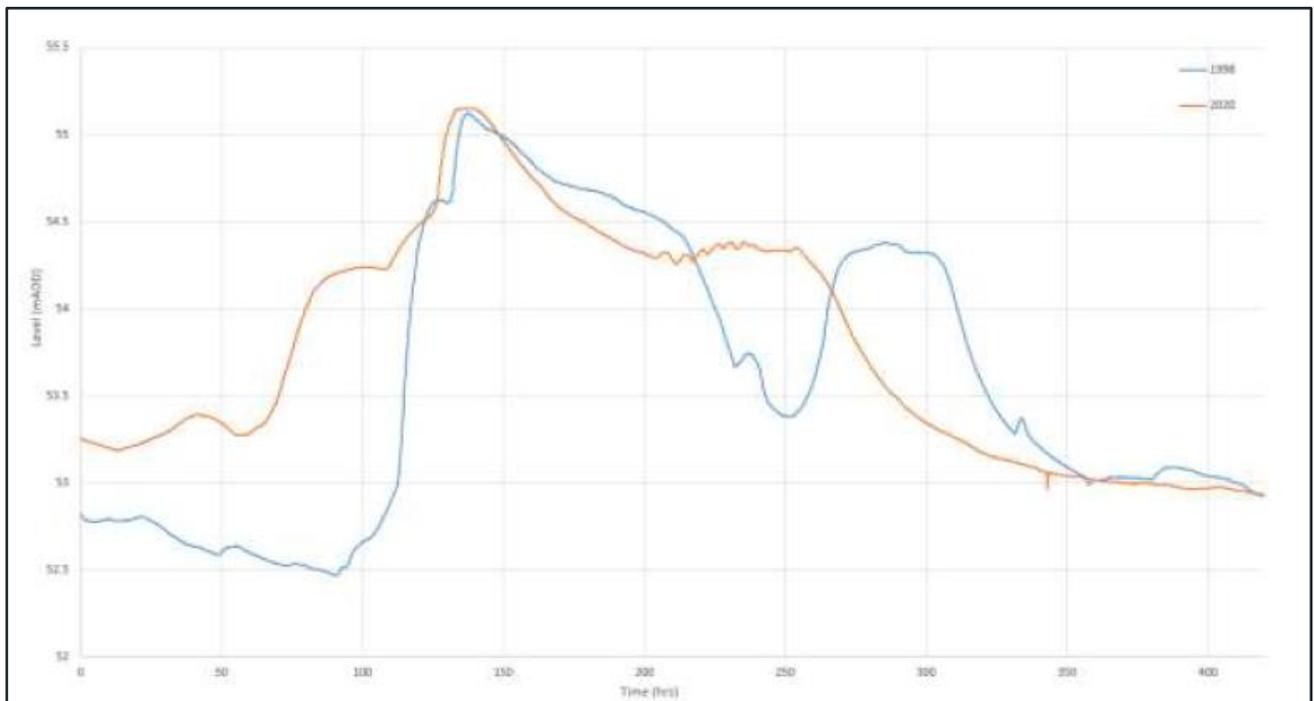
3.2.3. Figure 3-4 shows water levels for the River Great Ouse for both the April 1998 and December 2020 flood events. The graph indicates that the December 2020 flood (orange line) had a much higher initial water level than April 1998 (blue line). Water levels were already at approximately 54.25m AOD prior to the main rainfall event on the 23rd December. The difference in initial water levels between 1998 and 2020 is 1.75m due to a smaller rainfall event that took place a week before this flood event. This initial high-water level could have played an important role in the magnitude of the December 2020 flood event, where river levels reached record river levels above 55m AOD in this location.

Figure 3-4 - Comparison of water levels for the April 1998 and December 2020 flood events from Newport Pagnell Cemetery river gauge. Source: Environment Agency (EA) - Newport Pagnell winter flooding initial analysis (May 2021)

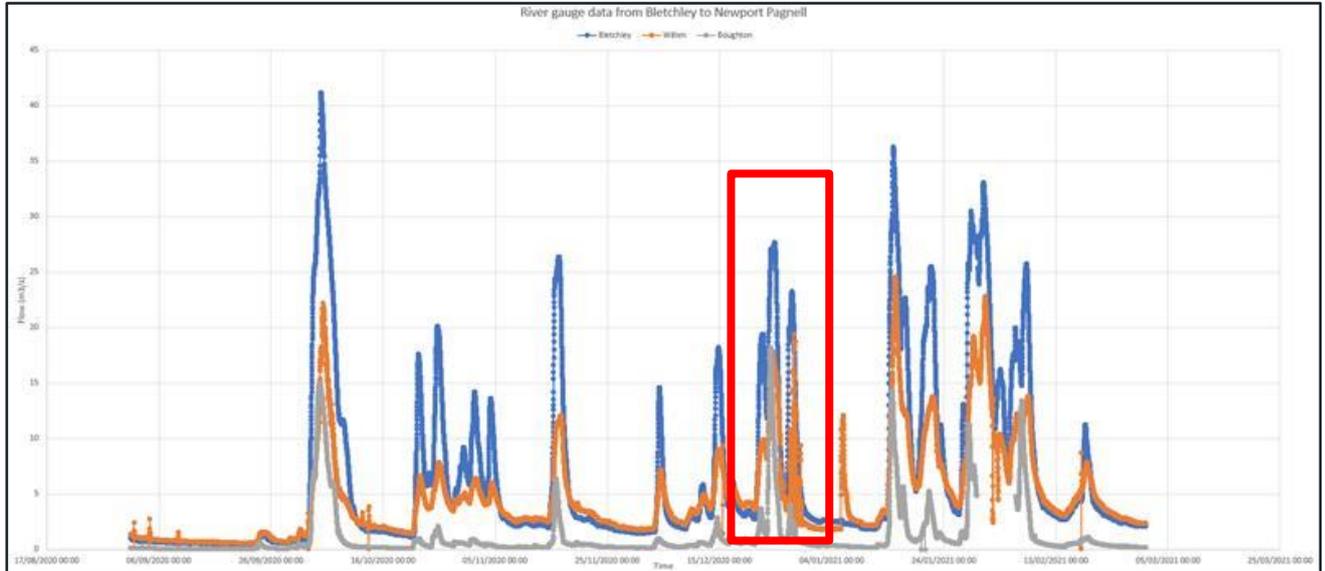
Figure 3-5 - River flows from river gauges between Bletchley and Newport Pagnell (Bletchley Willen and Boughton)

thresholds at Willen and Bletchley river gauges were not triggered due to the absence of relatively high water levels in the River Ouzel. Figure 3-5 indicates that the flow of the River Ouzel from Bletchley to Newport Pagnell although peaked on the 23rd of December recording a maximum flow of 27.7m³/s at the Bletchley gauge, this was not high enough to trigger the Ouzel mode at the balancing lakes as indicated in Table 2-1. A drop in river flow is observed on the 25th December downstream Willen river gauge when the decision was made to manually operate the gates. This drop in the river flows might be reflecting the adjustment of the flows in this location. Therefore, although the balancing lakes worked as designed, there could be a role for them to be used to manage flood flows in the wider catchment which is recommended to be investigated further. Also, this data suggest that Bletchley gauge consistently recorded higher water levels than Willen gauge which could suggest that water was attenuated in the floodplain and that there could be an opportunity to explore this further to manage fluvial flooding in the future. This is something that could be investigated in the lake capacity partnership project.

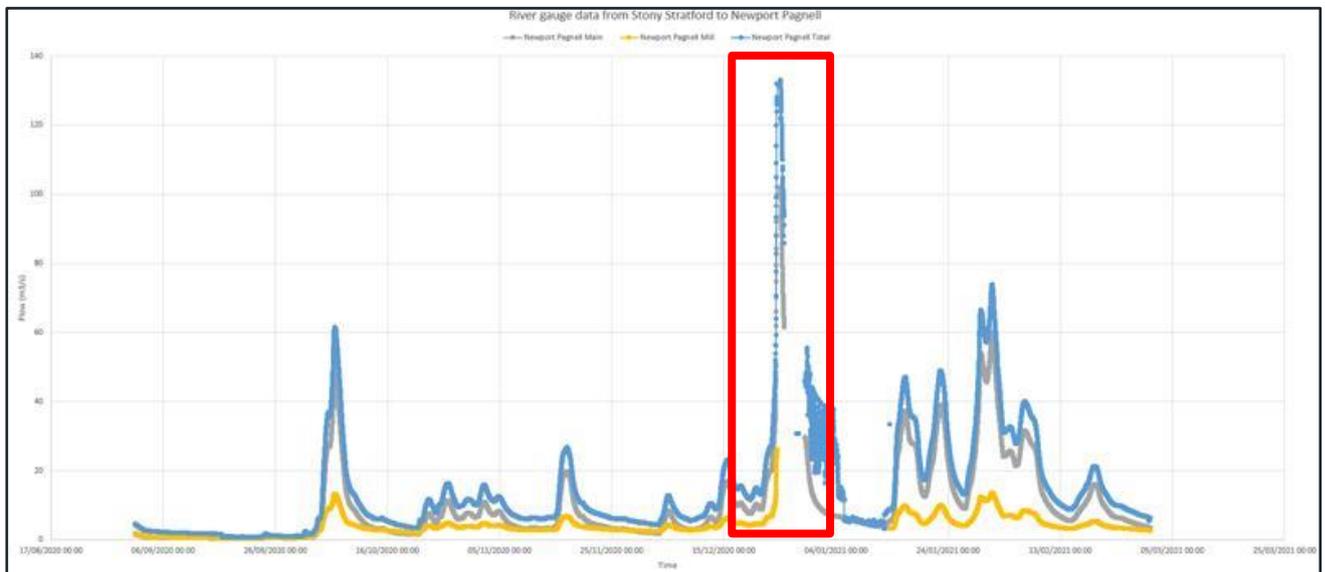
Figure 3-6 - River flows from river gauges at Newport Pagnell (Newport Pagnell Main, Newport Pagnell Mill and Newport Pagnell Total)

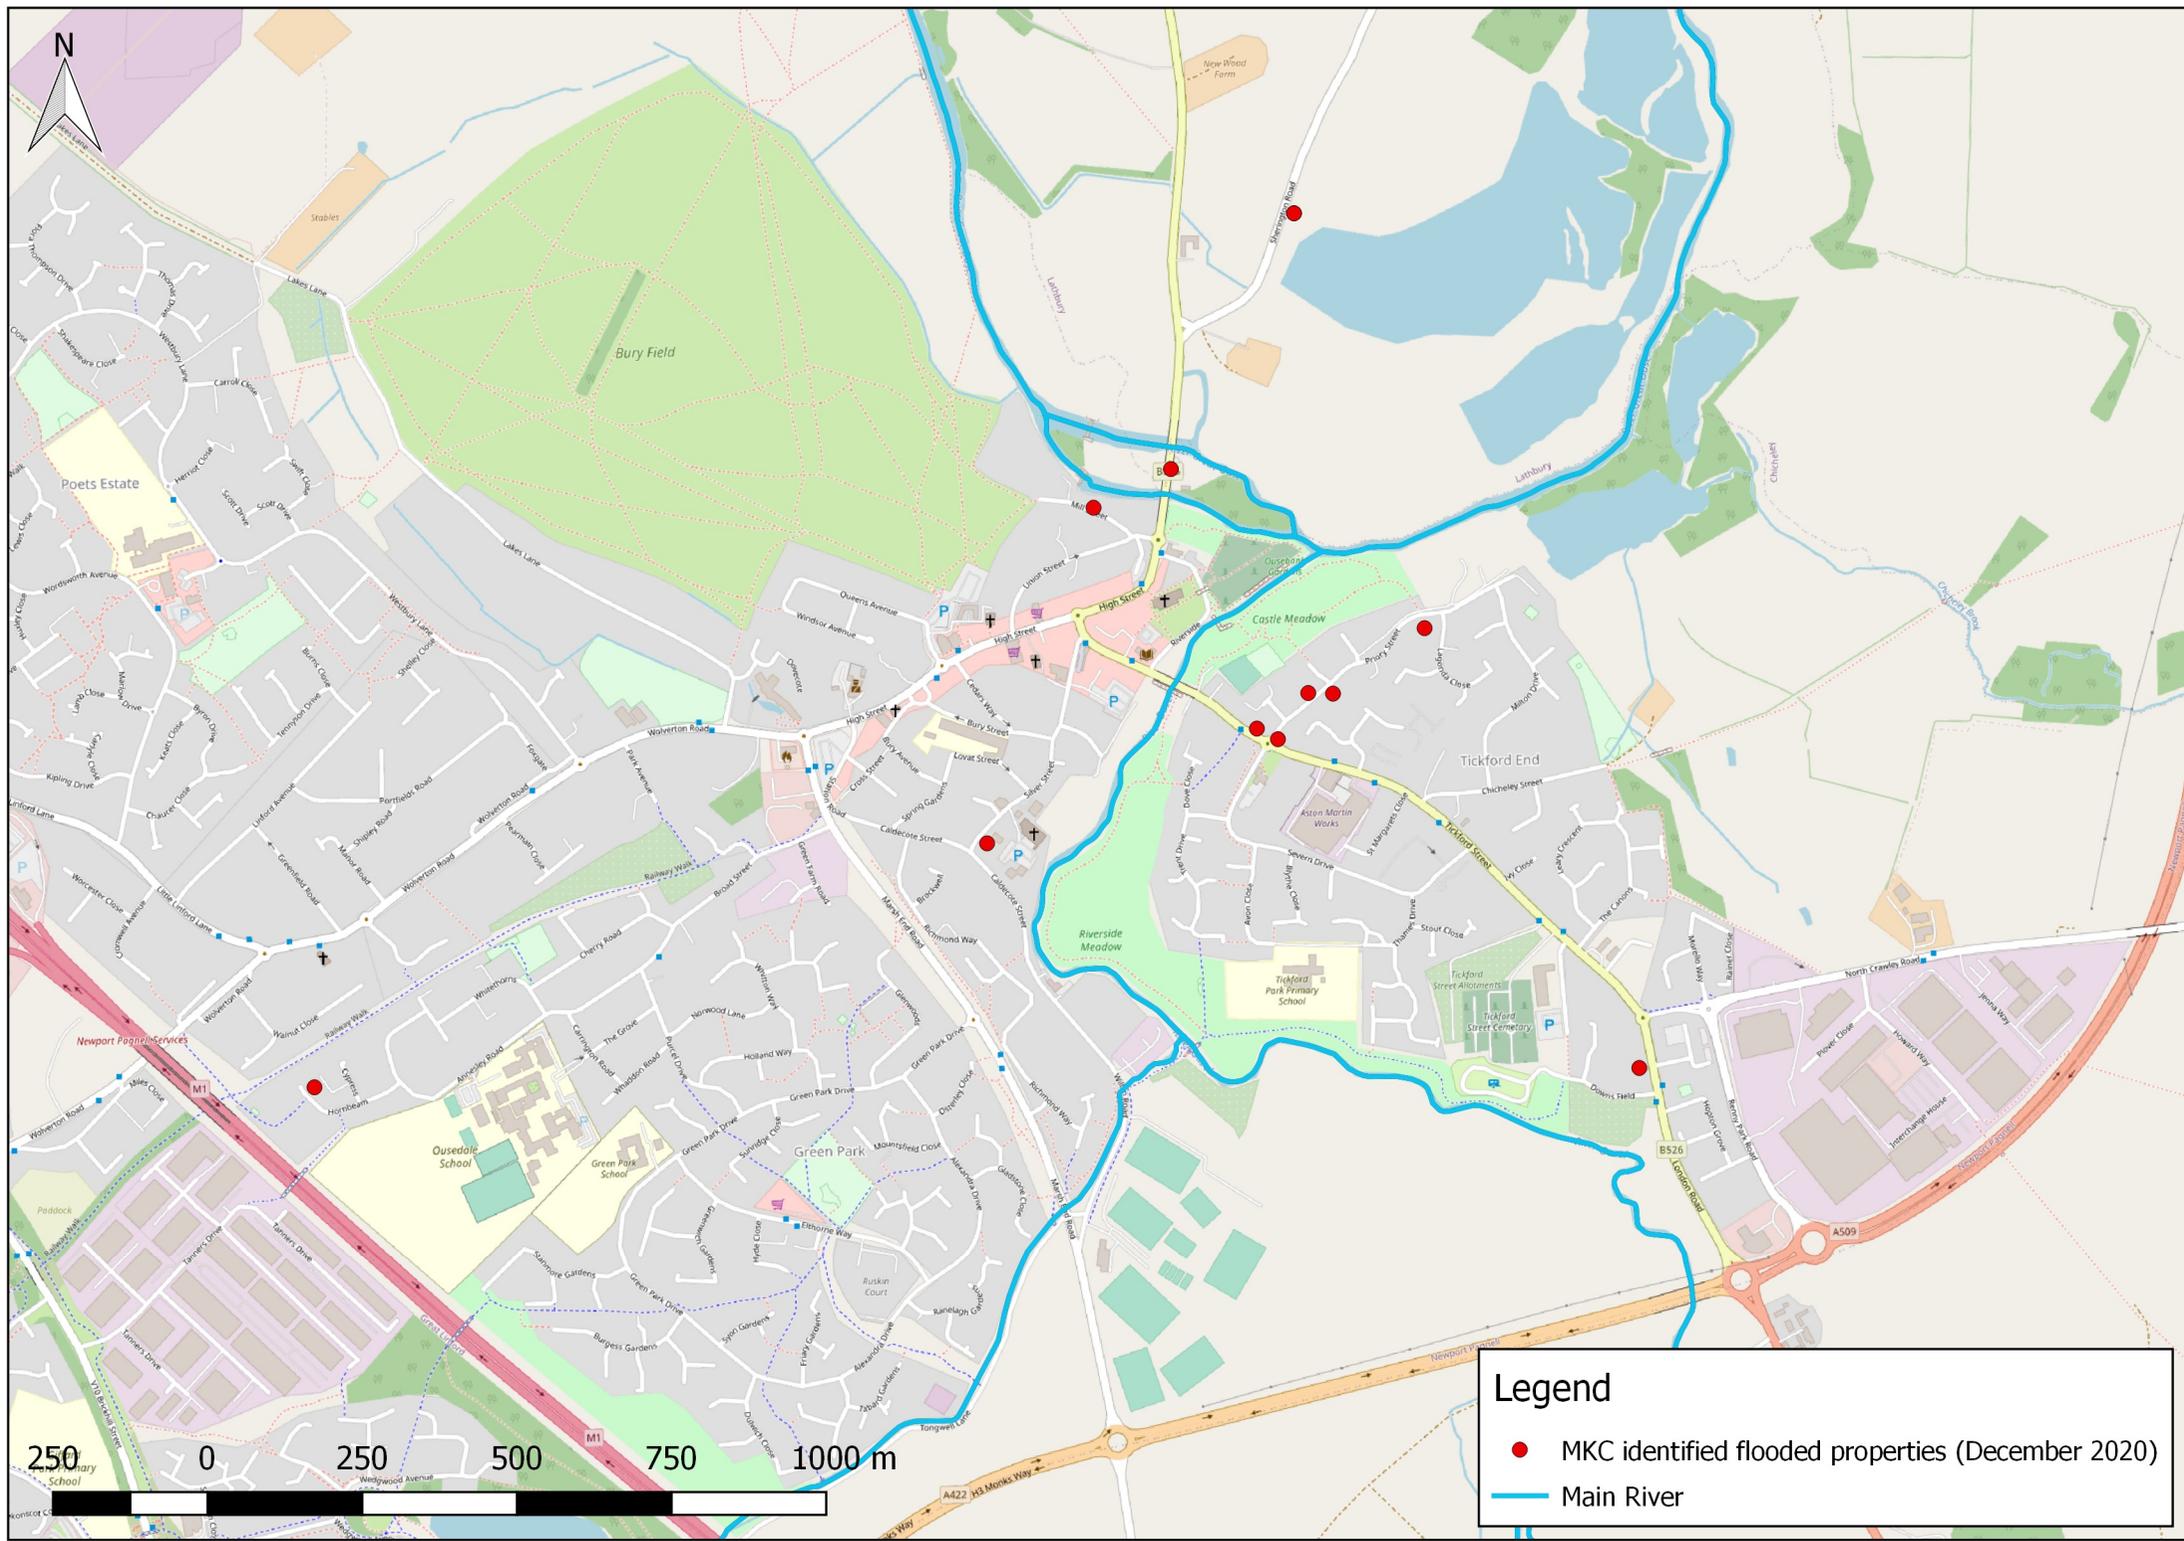
APPENDIX B

- MKC identified flooded properties (December 2020)
- Main River

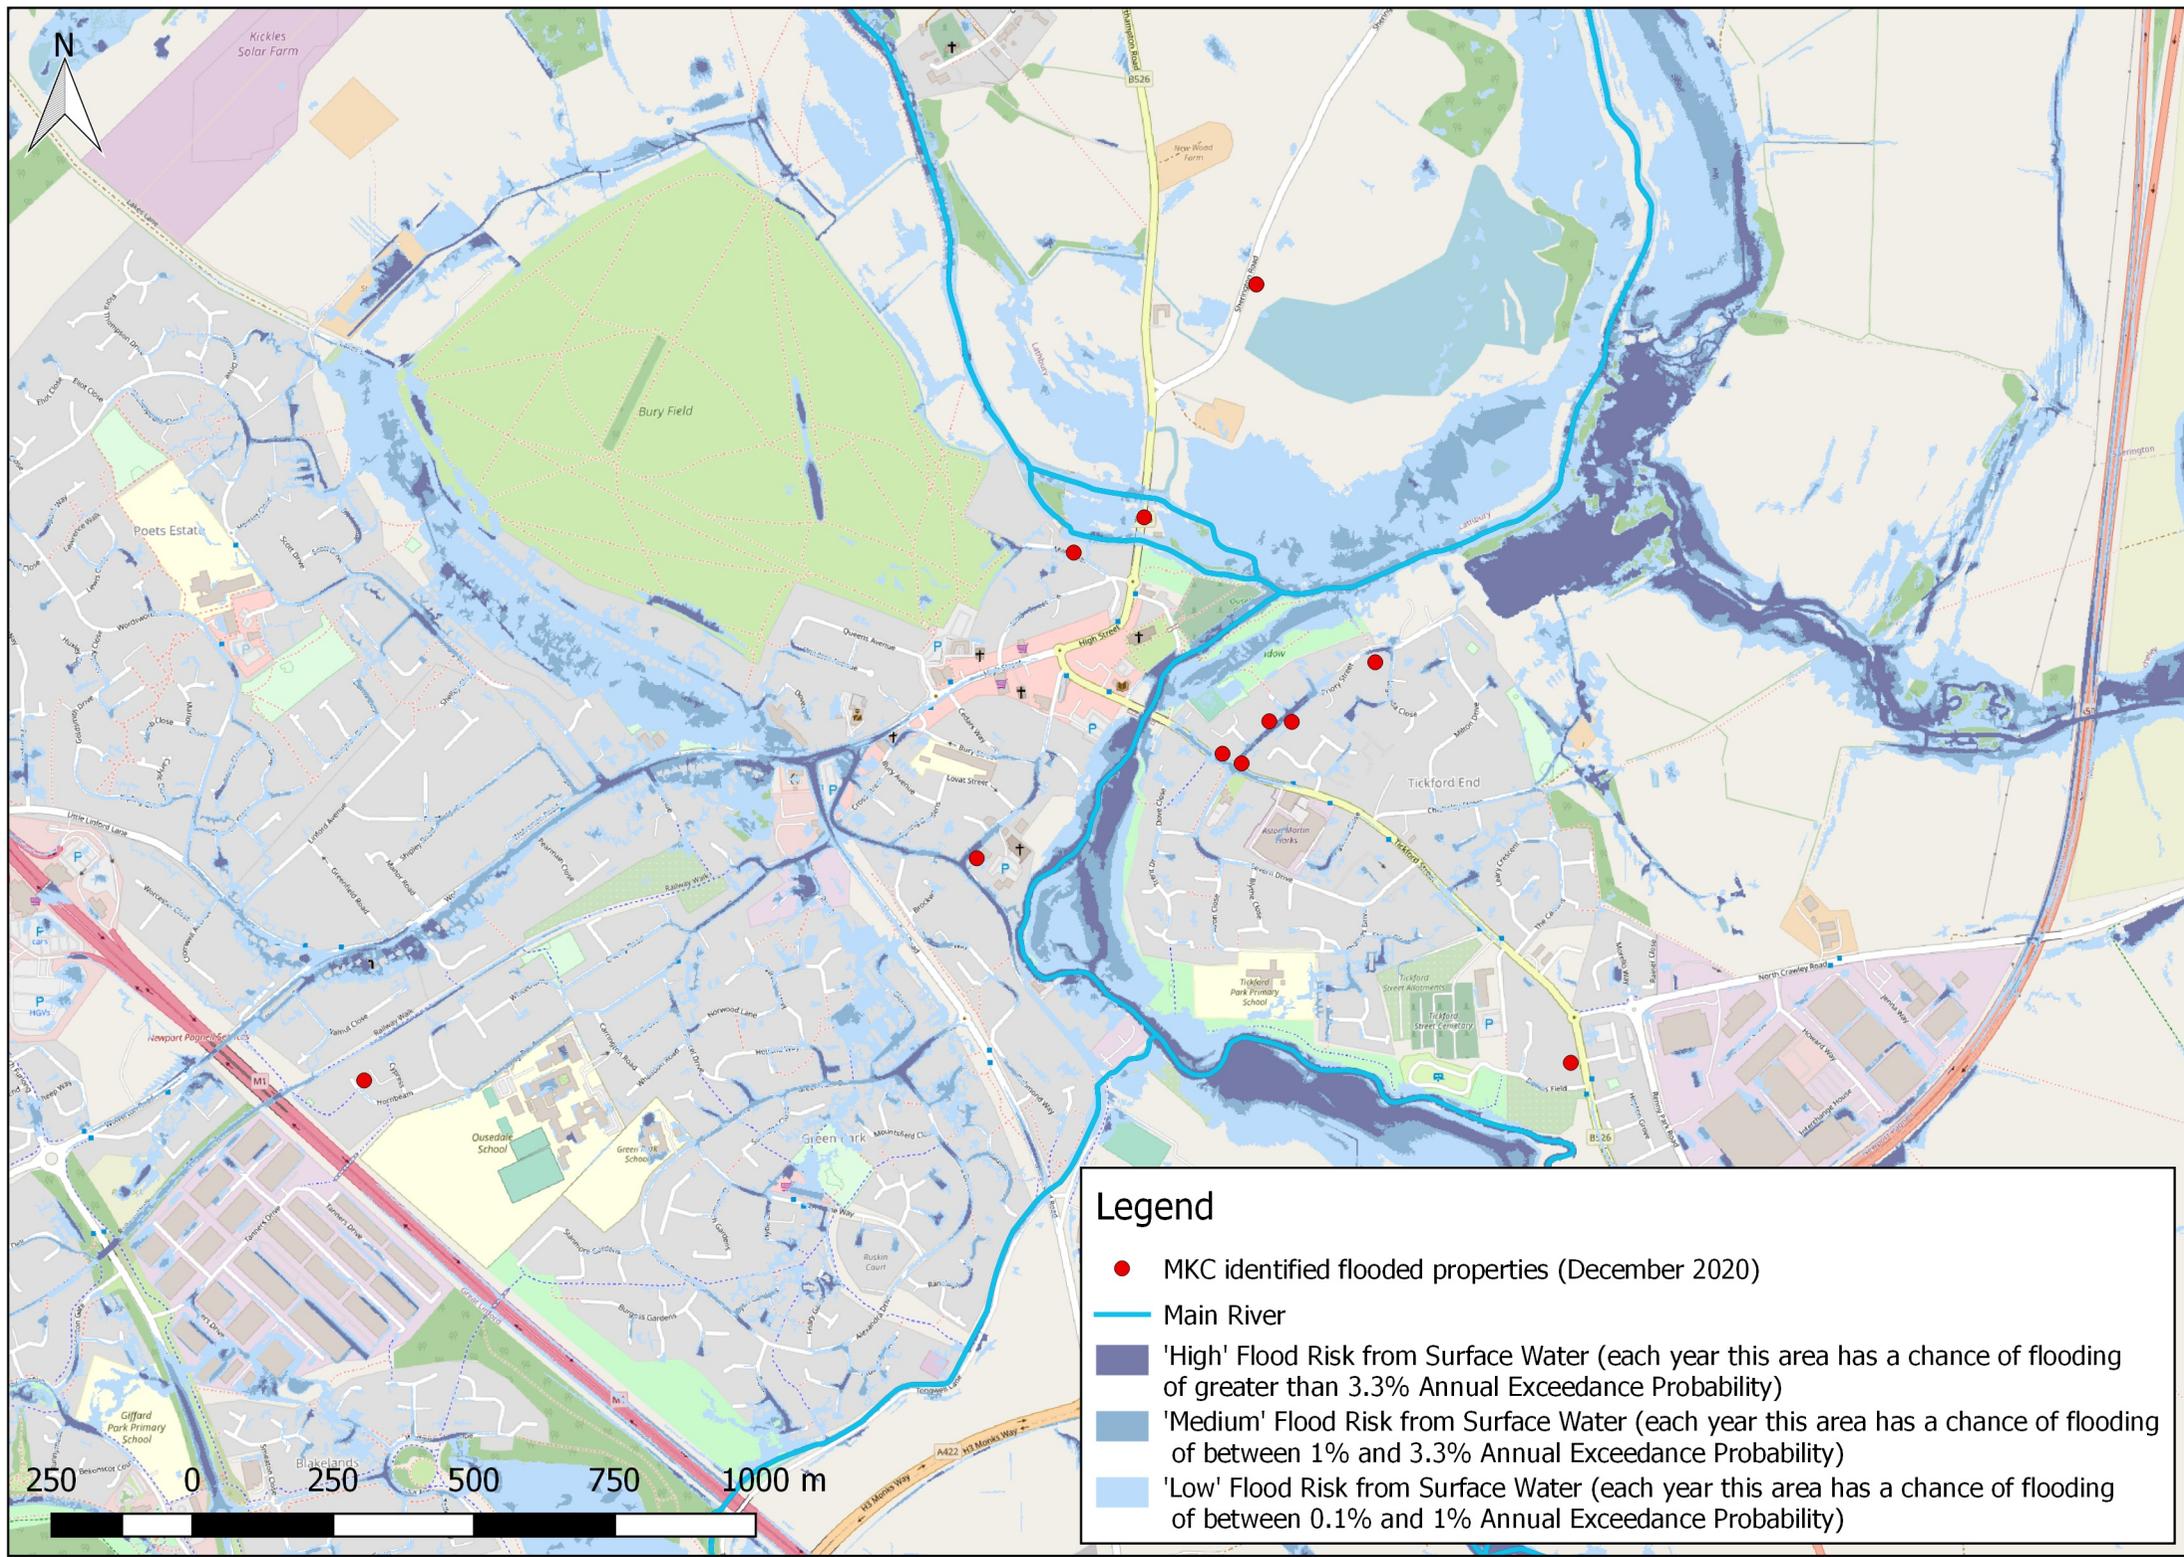
APPENDIX C

- MKC identified flooded properties (December 2020)
- Main River
- 'High' Flood Risk from Surface Water (each year this area has a chance of flooding of greater than 3.3% Annual Exceedance Probability)
- 'Medium' Flood Risk from Surface Water (each year this area has a chance of flooding of between 1% and 3.3% Annual Exceedance Probability)
- 'Low' Flood Risk from Surface Water (each year this area has a chance of flooding of between 0.1% and 1% Annual Exceedance Probability)
