# Independent Flood Review

Milton Keynes – 27<sup>th</sup> May 2018 Flood Event

Project Number: 60592404

Date: September 2019

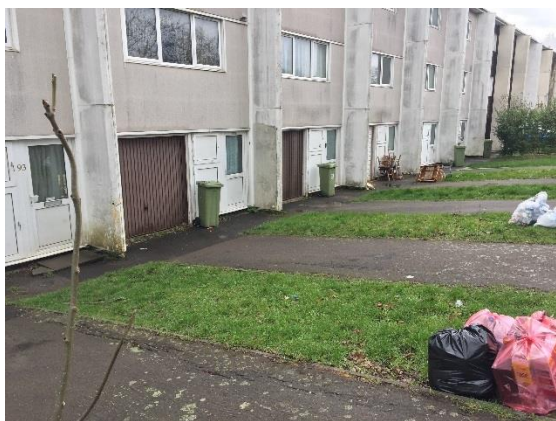
**Figure 4-5: Typical sloping access to property**

- 4.2.29 Housing in the areas of Netherfield, Beanhill, Oldbrook and Tinkers Bridge generally sit below the local road level therefore driveways or access paths slope towards the properties, allowing rainwater to do the same (Figure 4-5). Further exacerbating the risk of flooding is the low property thresholds in these locations, typically observed between 50 – 150 mm (Figure 4-6). This provides very little protection during intense rainfall events and occasions when the capacity of the drainage systems is exceeded.

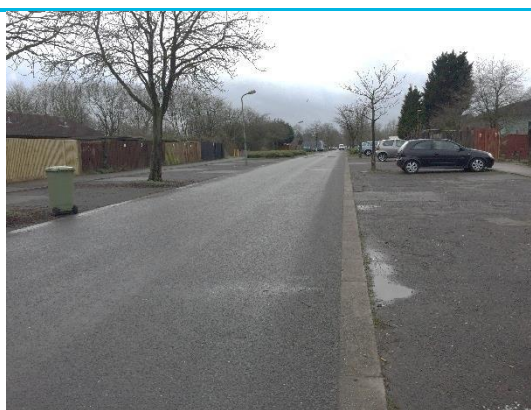
**Figure 4-8: Typical impermeable area**

- 4.2.31 Housing estates were observed to have large areas of impermeable surfacing particularly along local access roads and parking areas. A typical arrangement is shown in Figure 4-8. Areas of impermeable surfaces like this do not manage surface water at source thereby increasing the rate and volume of runoff to the surrounding drainage networks

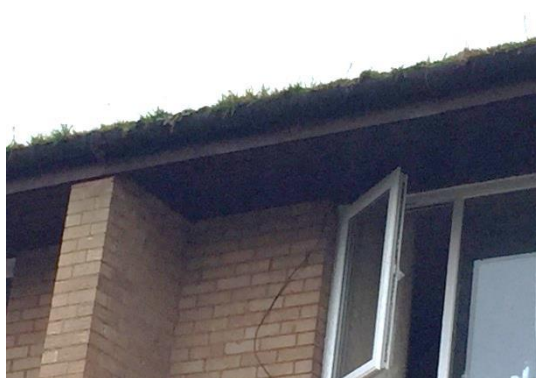
**Figure 4-9: Vegetated guttering**

- 4.2.32 For one property in Oldbrook, the guttering was observed to be heavily vegetated and showing signs of having little routine maintenance (Figure 4-9). This would prevent roof water from being collected efficiently and discharged into the property's drainage system. Whilst this would not usually cause significant flooding, a proficient roof drainage system can only help manage water more effectively within the curtilage of the property.

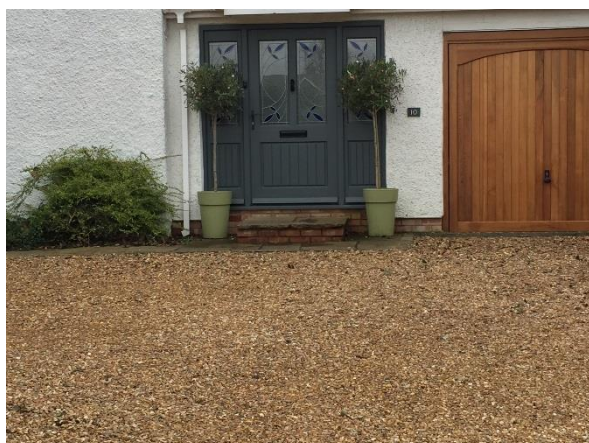
**Figure 4-10: Example of typical threshold levels**

- 4.2.37 The IFR team visited Newport Pagnell and observed the area predominantly around Wolverton Road. Property threshold levels are generally 225 mm above the external ground (Figure 4-10) although some are lower on certain properties. The carriageway is fairly typical in design with a chamber from north to south and gullies in the lowest areas. A concrete channel is present between the rear of the public footpath and private driveways (Figure 4-11). In places this looked unmaintained with siltation and vegetation present. Cleansing and weed spraying of footways is undertaken by MKC's street cleansing team. It is understood that budget restrictions have reduced the frequency of such activities which has led to increased siltation and debris in drainage features.

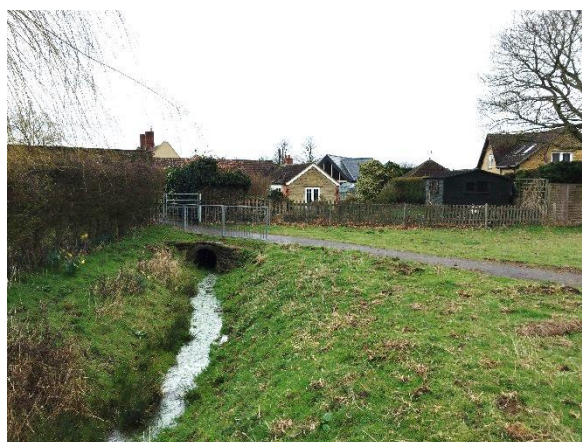
**Figure 4-14: Ordinary watercourse entering culvert upstream of Stoke Goldington**

- 4.2.39 Nearer to the village, one of the ordinary watercourses was observed within channel and providing a land drainage function for this upper reach of the catchment. This then enters a culvert which appeared to flow beneath the properties immediately downstream (Figure 4-13).

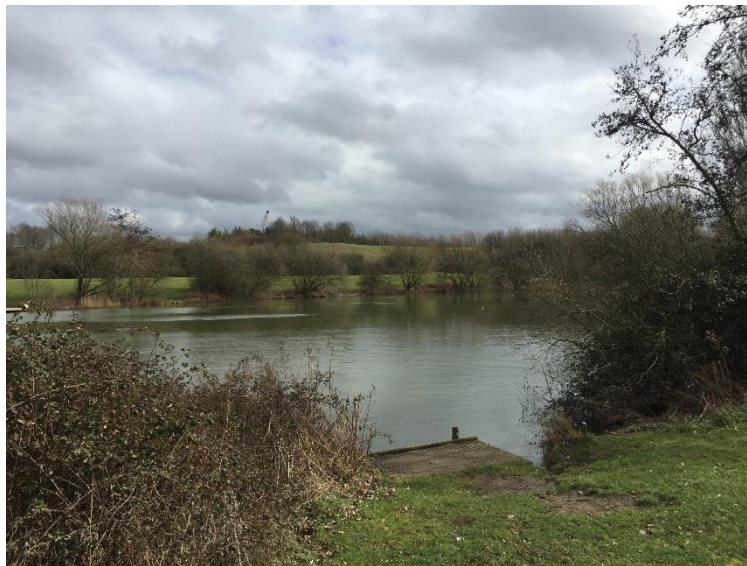
**Figure 7-3: Teardrop balancing lakes**

- 7.4.1 AWS is responsible for maintaining public sewers in its ownership including a number of the balancing lakes (Figure 7-4) within MK. The purpose of these balancing lakes is to attenuate an incoming flood peak to a flow level that can be accepted by the downstream receiving system. It may also delay the timing of a flood peak so that its volume is discharged over a longer time interval.
- 7.4.2 The lakes are listed below and a map identifying their location is included in Figure 7-4.
- Ashlands Lakes (Ashland/Simpson balancing reservoir)
  - Blue Bridge Balancing Lake
  - Caldecotte Lake
  - Furzton Lake
  - Lodge Lake
  - Teardrop Lakes
  - Walton Lake
  - Willen Lake
  - Wolverton Mill Balancing lake
