Milton Keynes Council

FLOOD RISK INVESTIGATION

Bletchley Section 19 Report

OUR REF. NO. 70082487-WSP-FRM-03-RP-CO-0001

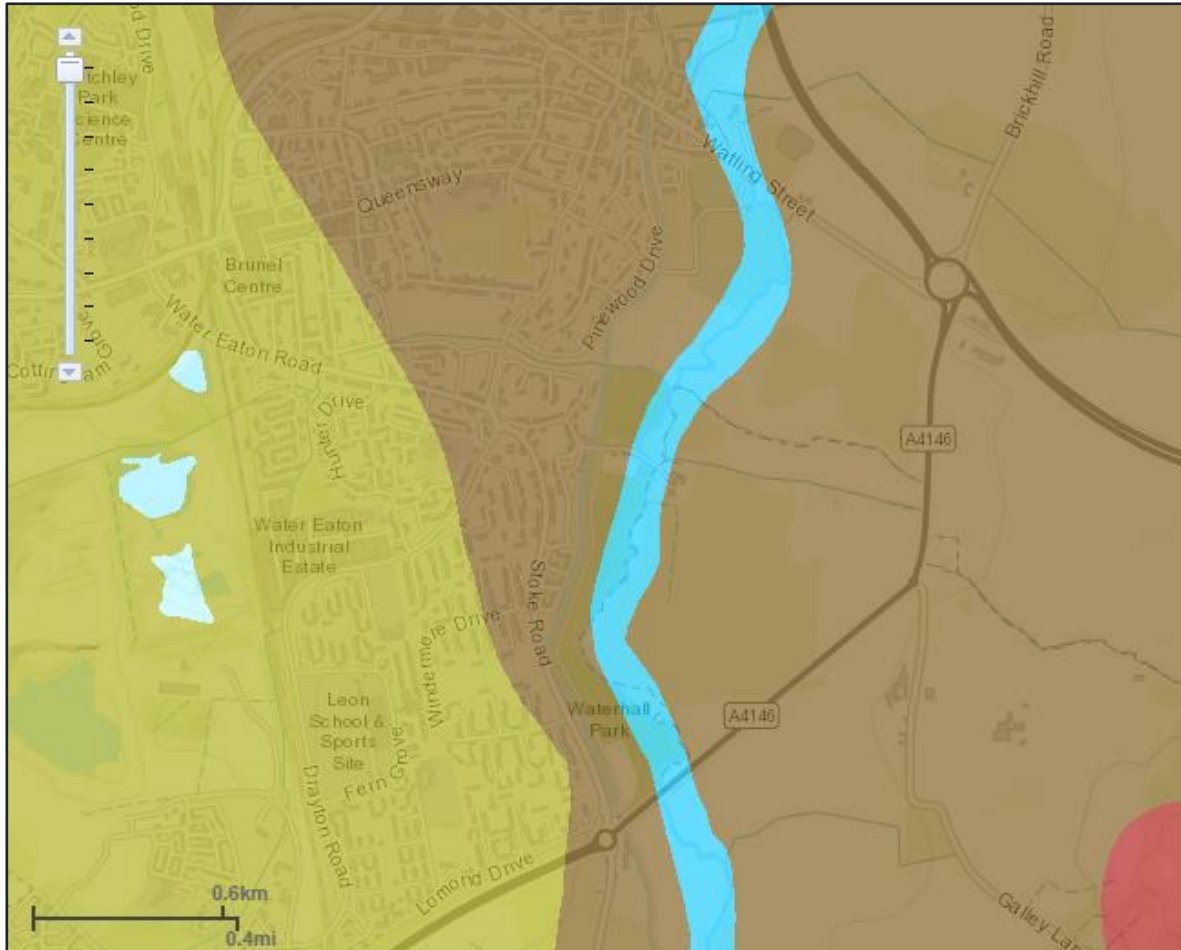
Figure 2-2 – Cranfield Soil and AgriFood map

west of the floodplain is classified as Soilscape 9- “Lime-rich loamy and clayey soils with impeded drainage” while a reduced section to the southeast is classified as Soilscape 10 “Freely draining slightly acid sandy soils”. The area is also moderately urbanised with a proportion of impermeable surfaces such as roads likely to increase runoff volumes.

- 2.4.2. A review of the British Geological Survey (BGS)³ maps indicate that the majority of the underlying soils of flood area comprise Oxford Clay Formation while east of the site comprises West Walton Formation. The areas in the proximity of the River Ouzel have resulted in a covering of alluvium and river terrace deposits.

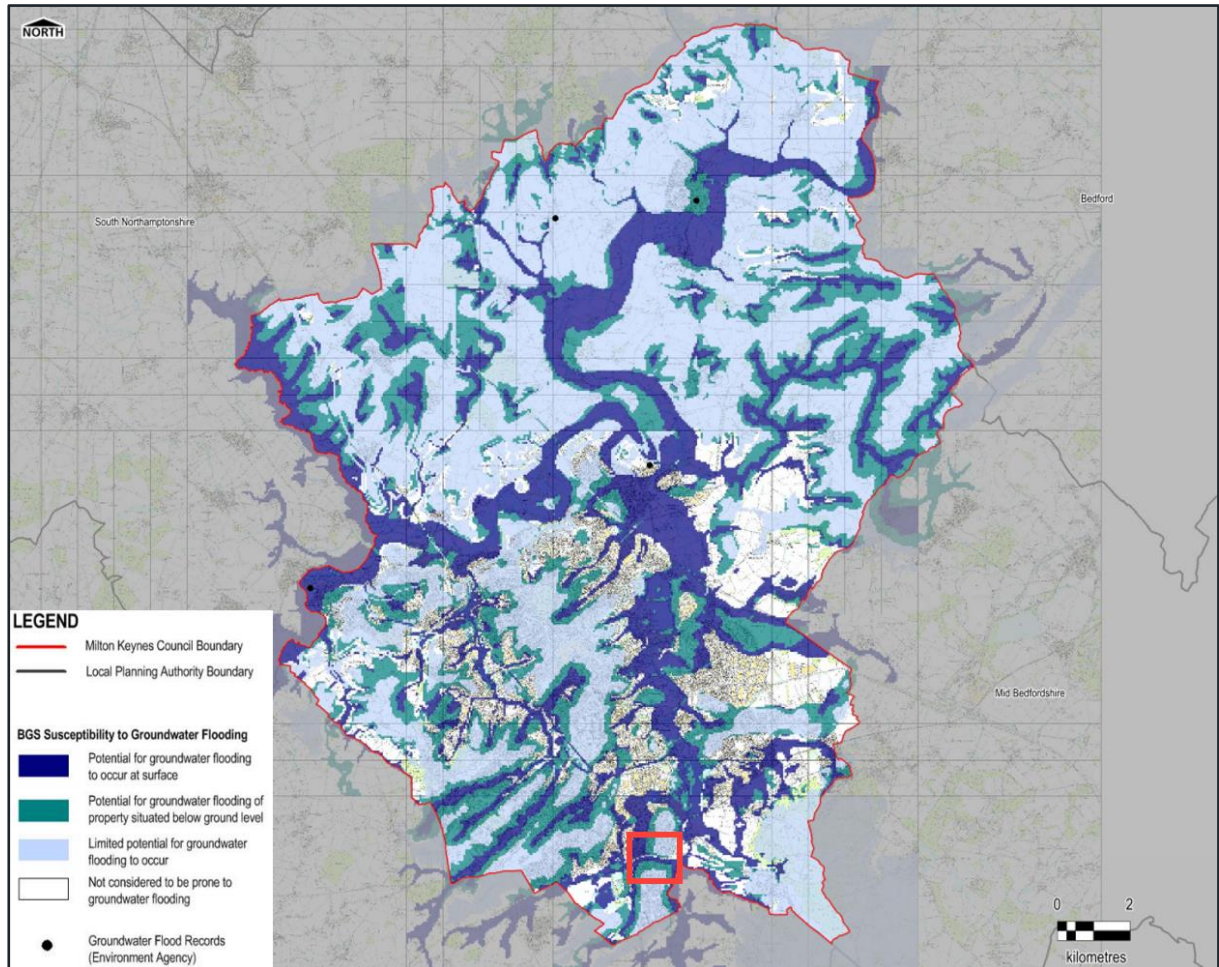
Figure 2-3 – Susceptibility to groundwater flooding. Source: [Milton Keynes Council Local Flood Risk Management Strategy, AECOM 2016](#)

2.5.6. In regard to groundwater, the BGS Areas Susceptible to Groundwater Flooding map shown in Figure 2-3 identifies the area reported as flooded as having 'Potential for groundwater flooding to occur at surface' and 'Potential for groundwater flooding of property situated below ground level'. This mapping provides an indication as to where there is the potential for groundwater flooding and should be considered alongside other sources of flooding.

2.5.7. High groundwater level conditions may not always lead to widespread groundwater flooding; however, they have the potential to exacerbate the risk of surface water flooding and flooding from rivers by reducing rainfall infiltration capacity, and to increase the risk of sewer flooding through sewer/groundwater interactions.

2.5.8. Persistent rainfall on the 14th and 15th January served to raise groundwater levels and saturate the catchment. High groundwater levels can cause seepage into the drainage network, therefore reducing its capacity. However, groundwater mapping in this area is uncertain and there may be disturbance to shallow natural soils and geology due to urbanisation in close proximity to the flooded area.

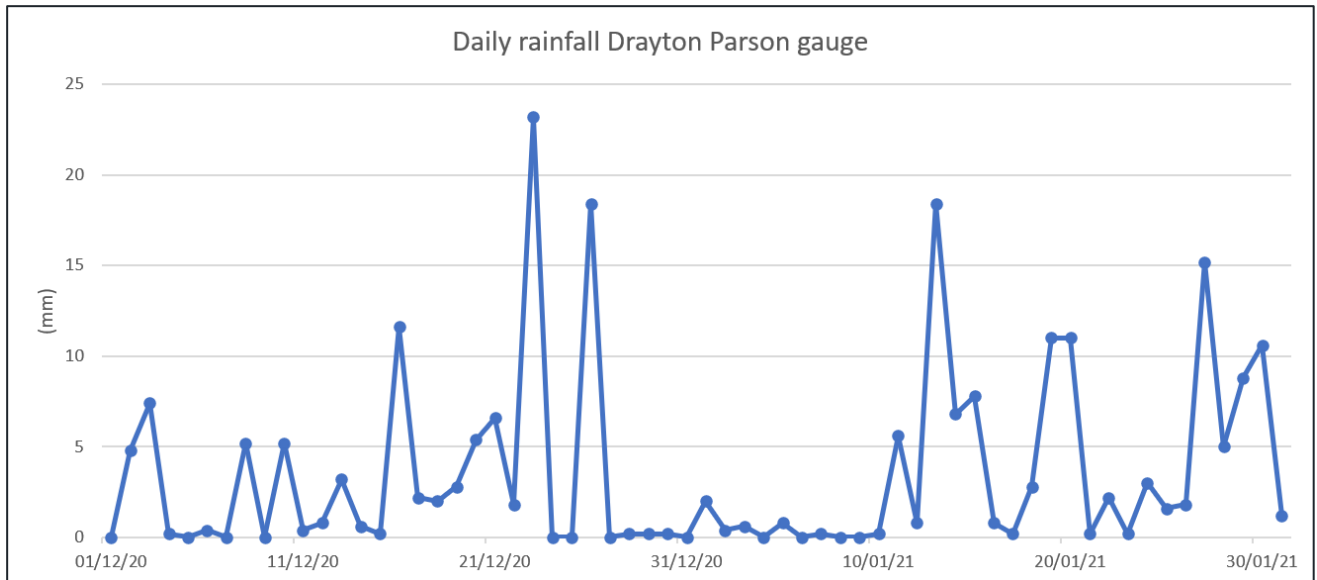
Figure 3-1 - 15 min rainfall (mm) recorded at Drayton Parslow

3.1.1. The nearest rain gauges to the flooded property are located at Drayton Parslow, 6km southwest, and Birchmoor, 6km east. Both rain gauges recorded errors over the flooding period. The tipping bucket gauge at Drayton Parslow reported the error as “12mm blocked water”.

Figure 3-1 shows the results at Drayton Parslow from December 2020 to January 2021. Rainfall over the period of flooding from 14th to 15th January is shown to be less than 10mm, which is unlikely given the increase in surface water over the period. Additionally, reports by Flood Assist Insurance¹⁰ on 14th and 15th January, state that “river levels are rising at the Bletchley river gauge as a result of persistent rainfall. Consequently, flooding of property is expected over Thursday night and into Friday, 15/01/2021. We expect flooding to affect Mill Road, Watling Street and Belvedere Lane in Bletchley.”

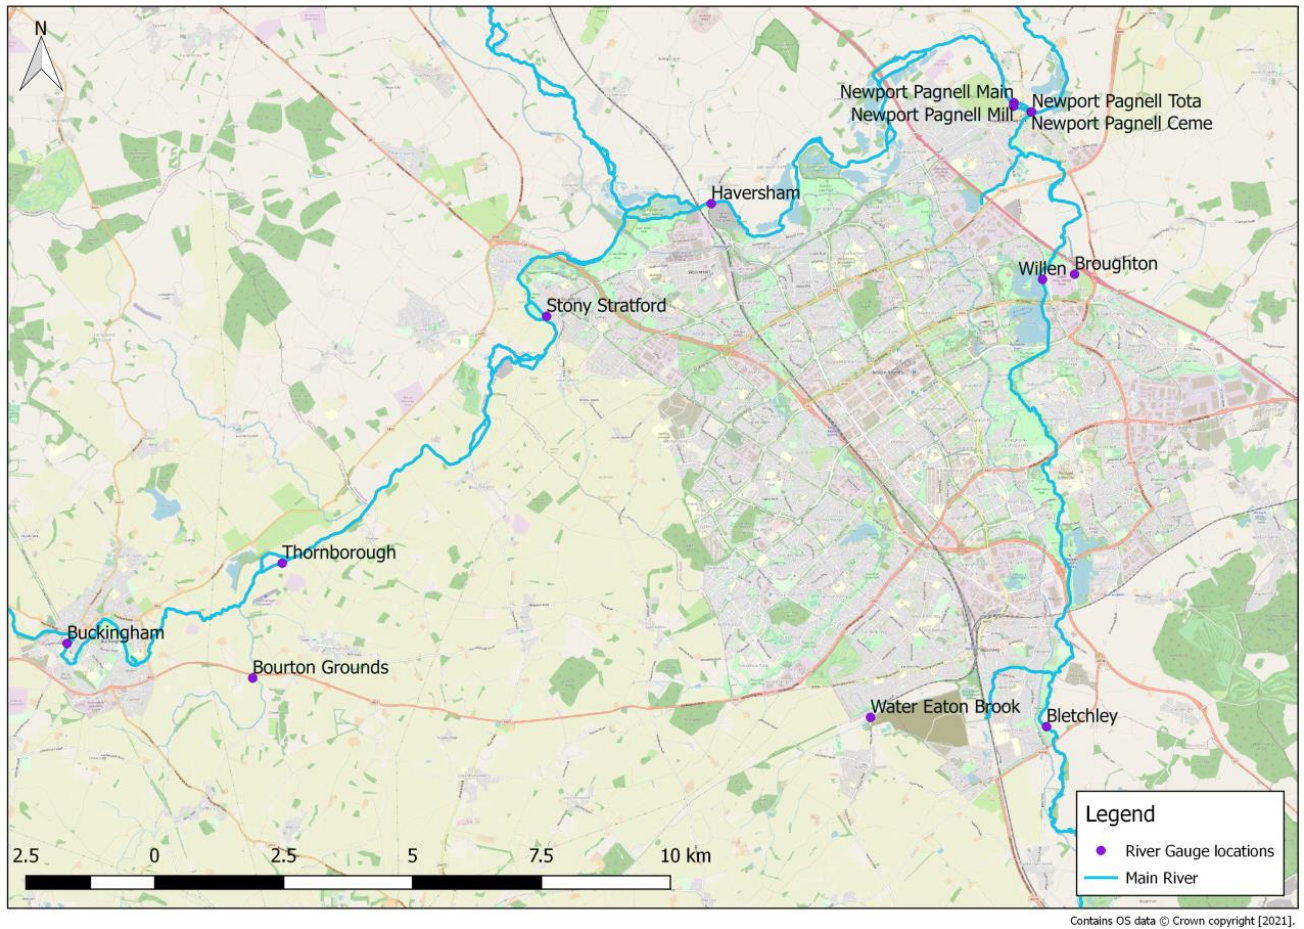
Figure 3-2 - Location of river gauges in Milton Keynes, including Bletchley

3.2.1. There are several river gauges along the River Ouzel. Bletchley gauge is located at the south of Bletchley, 700m upstream of the flooded area (See Figure 3-2). The Environment Agency owns and maintains this gauge.

- 3.2.2. River gauge analysis has been based on gauging station data that has not been validated yet, which means that the outcomes from this analysis may change in future assessments.
- 3.2.3. Data obtained from the National River Flow Archive (NRFA)¹¹ and the Environment Agency for the 15th January 2020 at the Bletchley River gauge at River Ouzel is shown in Figure 3-3. This figure clearly displays a sharp rise in river flows, peaking at 31.2 m³/s on the 14th January, resulting from the heavy rainfall during the 14th and 15th January.
