MHA PSP4 MKCC Section 19 Flood Investigation Report

Section 19 Flood Investigation Report: 21st - 29th September
2024 Flood Event

Project number: 60740209

August 2025

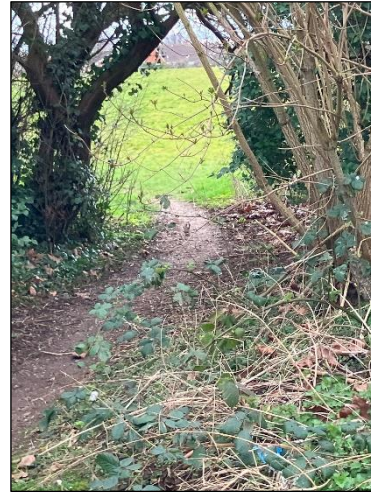
Photograph 2

St Georges Road

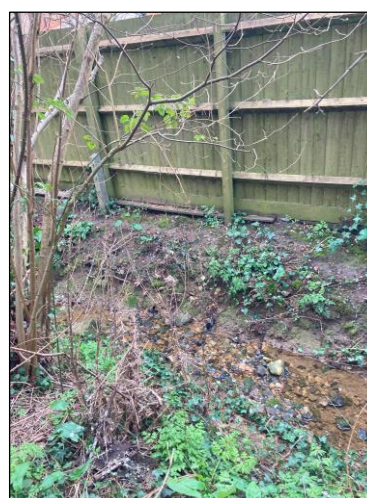
Photograph 18

An unnamed Ordinary Watercourse flows behind properties located in the south section of Castle Road (**Photograph 17**). The size of the channel alongside the intensity of the rainfall event likely led to flooding of the Ordinary Watercourse. The channel had been eroded (**Photograph 18**) and fencing and decking had been damaged during the flood event. As such, it is likely that the channel capacity was exceeded, and water flowed through the back gardens into adjacent properties.

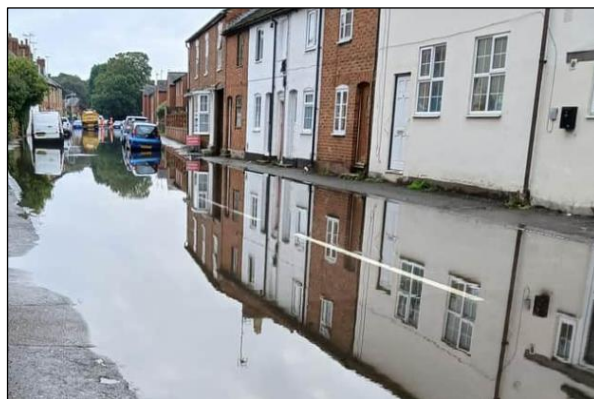
Photograph 22

- **Photograph 22** was taken from Tickford Bridge and shows the extent of fluvial flooding due to the overtopping of the River Ouzel. High water levels in the River Great Ouse prevented the River Ouzel from discharging, resulting in elevated river levels and backwater flooding. Furthermore, the confluence of the Ouzel with Tongwell Brook led to high river level at Tickford Bridge which is downstream of the confluence. Alongside anecdotal evidence from residents, it is likely that the floodwater seeped through the boundary wall which borders the raised properties near Tickford Street. The large impermeable car park likely caused ponding of fluvial floodwater in this area, leading to a rupture of the sewer system at the properties, as noted by residents. The EA FMfP shows fluvial flood extents up to the boundary wall, under a defended scenario, corresponding with site observations.

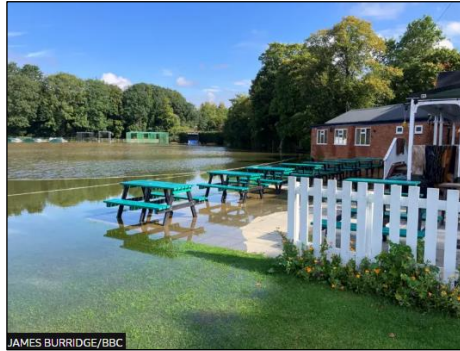
Photograph 28

- Anecdotal evidence from flood records provided by residents to MKCC noted internal flooding at properties along Temperance Terrace due to the overtopping of the River Great Ouse.

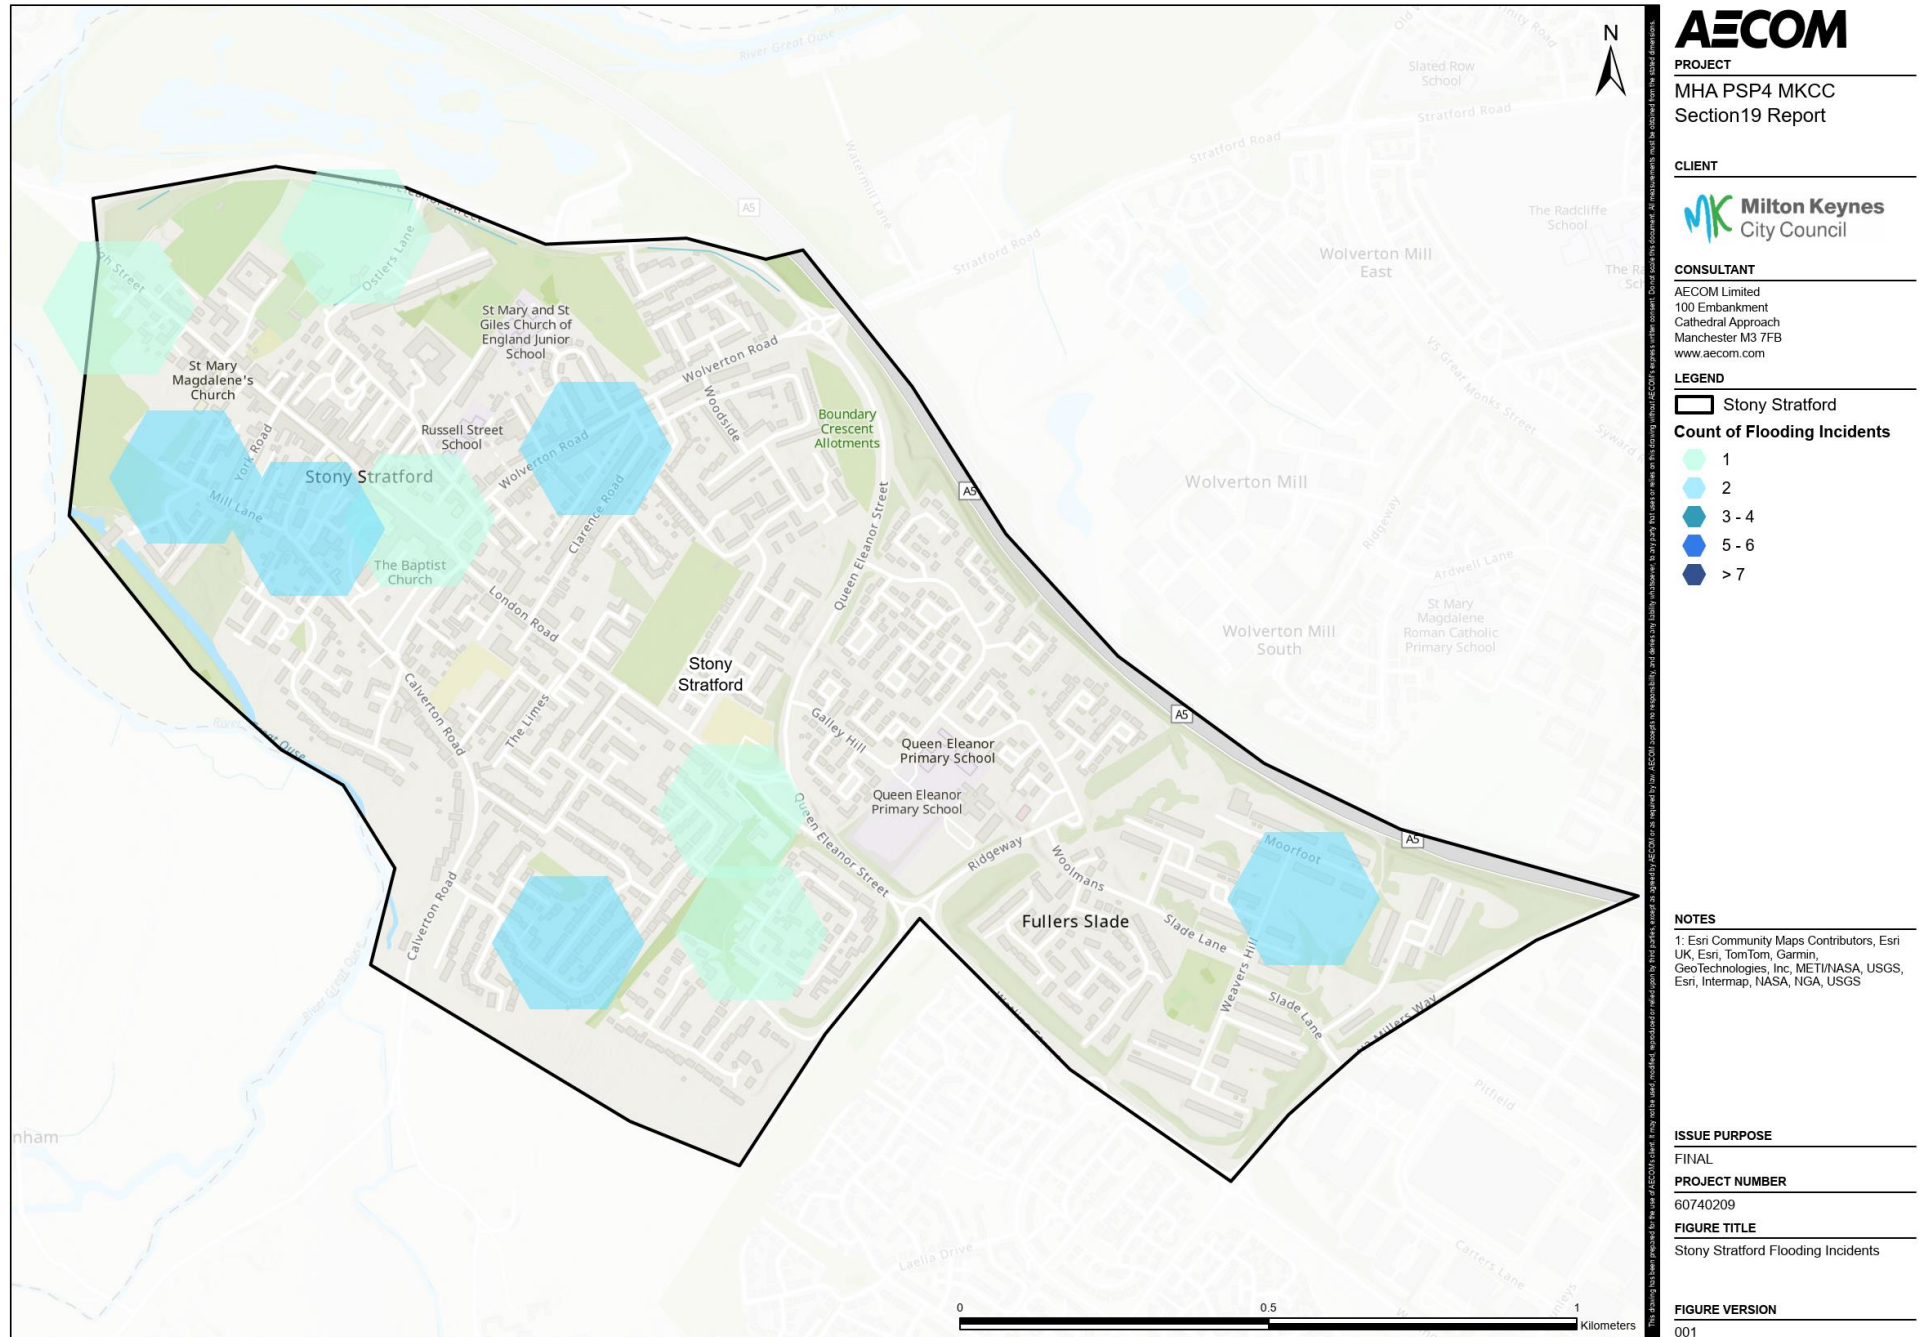
Figure 5-11: Stony Stratford Flooding Incidents

Records indicate 15 properties were affected in Stony Stratford by the flood event in September 2024. 10 of these properties reported internal flooding, 4 external only and 1 unconfirmed as shown in **Table 5-6**. **Figure 5-11** shows the reported flooding incidents within the Stony Stratford hotspot.
