SOUTH WEST MILTON KEYNES

Stage 1 Road Safety Audit and Designer's Response (Junctions in Milton Keynes)

MKC MITIGATION DESIGNS

Stage 1 Road Safety Audit

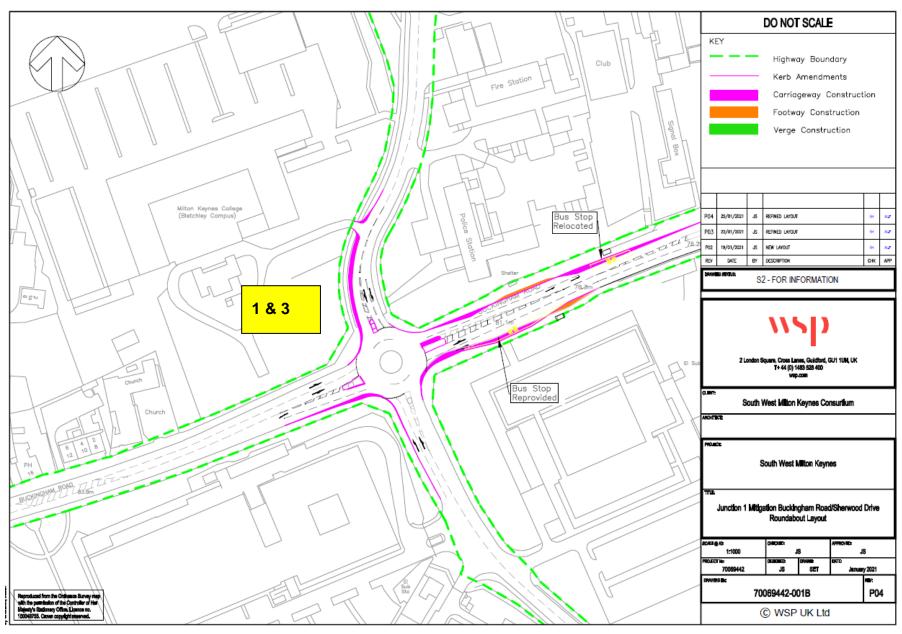
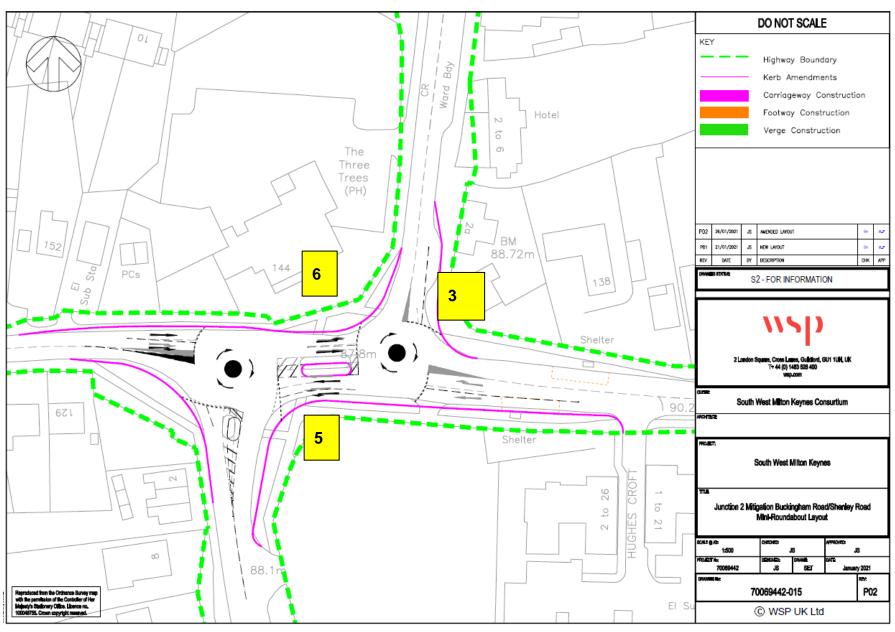
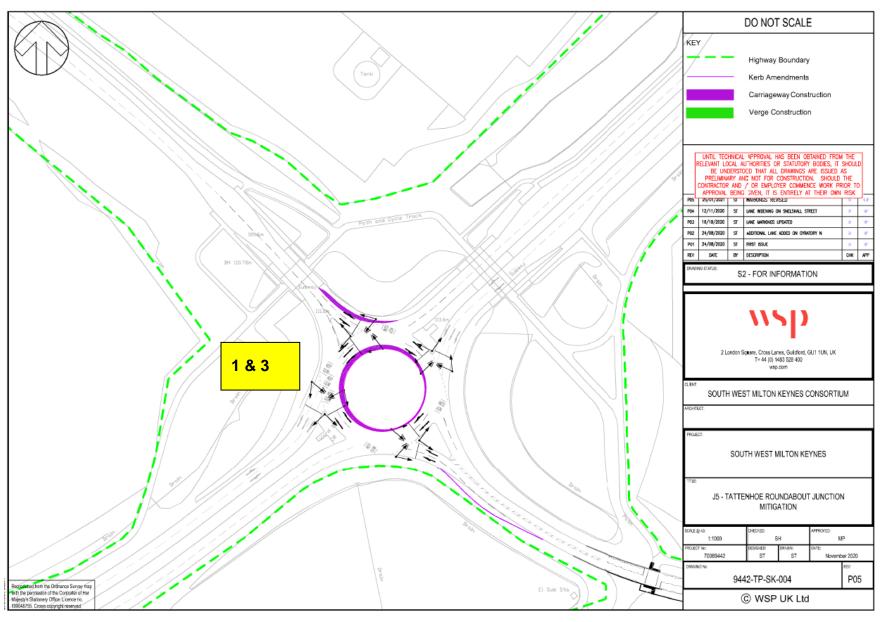
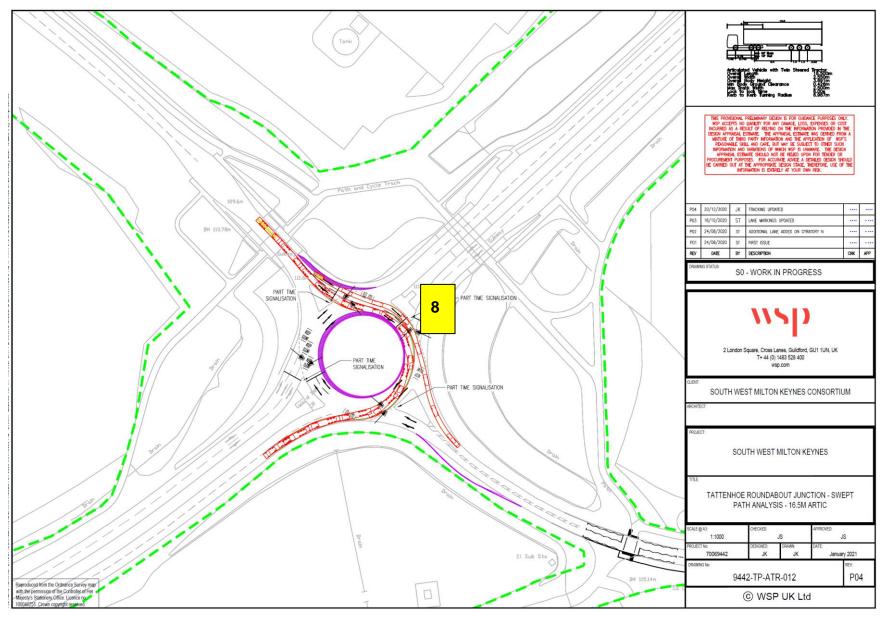
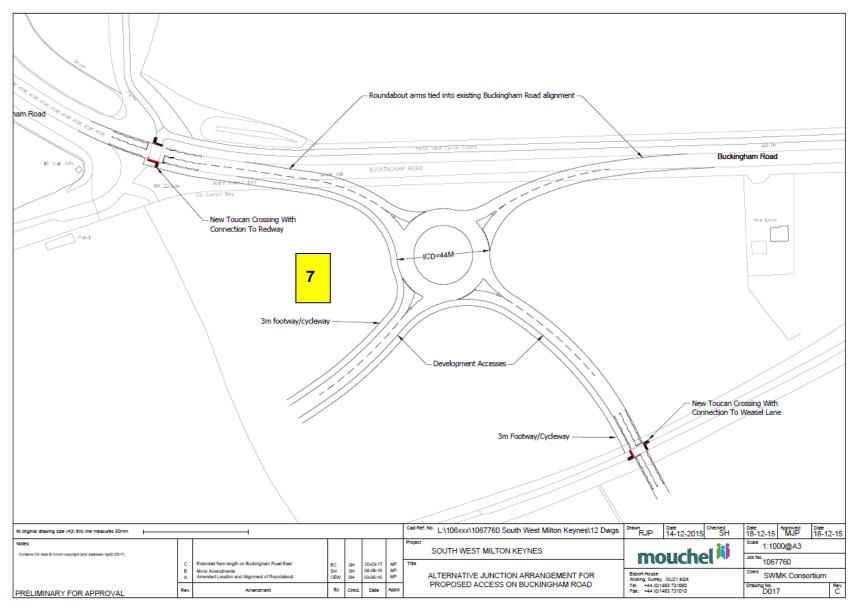
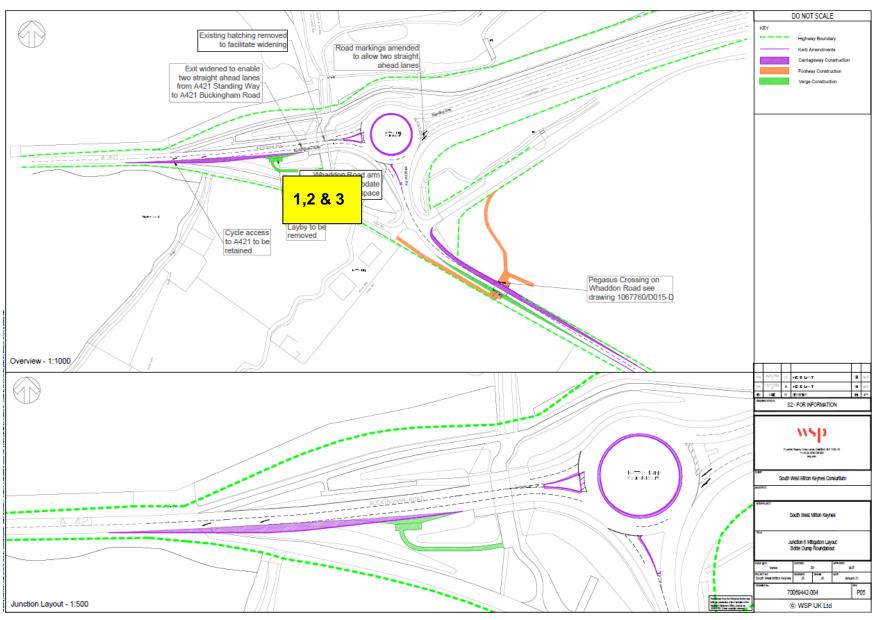
PROBLEM LOCATION PLAN

- 2.1.6. All comments and recommendations are referenced to the design drawings and the locations have been indicated on the plan located in Appendix B.
