LAND SOUTH WEST OF MILTON KEYNES

Interpretative Environmental Desk Study Report

70069442-11578 JUNE 2020

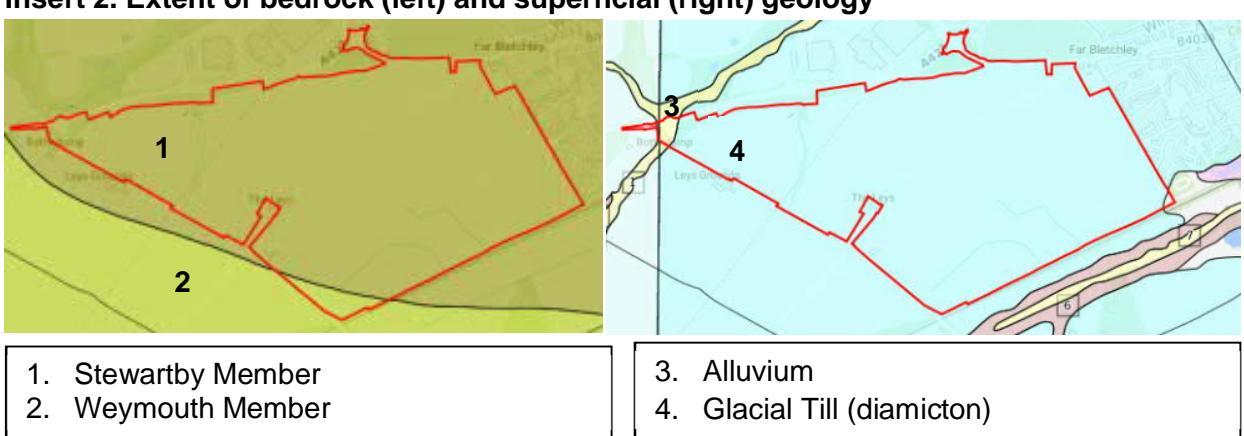
Insert 2. Extent of bedrock (left) and superficial (right) geology

BGS mapping indicates the underlying bedrock comprises mudstone of the Oxford Clay Formation, predominantly of the Stewartby Member, with a small area in the south comprising the Weymouth Member). No faults or linear features are present within the site boundary.

Superficial deposits predominantly comprise Glacial Till (silty, sandy, gravelly clay), with a narrow strip of alluvium (clay, silt, sand and gravel) in the northwestern corner. A very small area in the south east corner records no superficial deposits.

The extent of the superficial and bedrock geology beneath the site is illustrated by **Insert 2** (extracted and modified from the Groundsure report).

The BGS borehole log for borehole SP83SW256 — H8 A421-V1 MK1924A (NGR 482400,232715) is located on site along the northern most boundary (adjacent to Standing Way A421; client Milton Keynes Development Corporation). The log records firm, becoming stiff silty clay with some gravel and chalk fragments to 15.0m below ground level (m bgl). Rockhead was not encountered. This correlates with the published geology indicated in Insert 2 above.

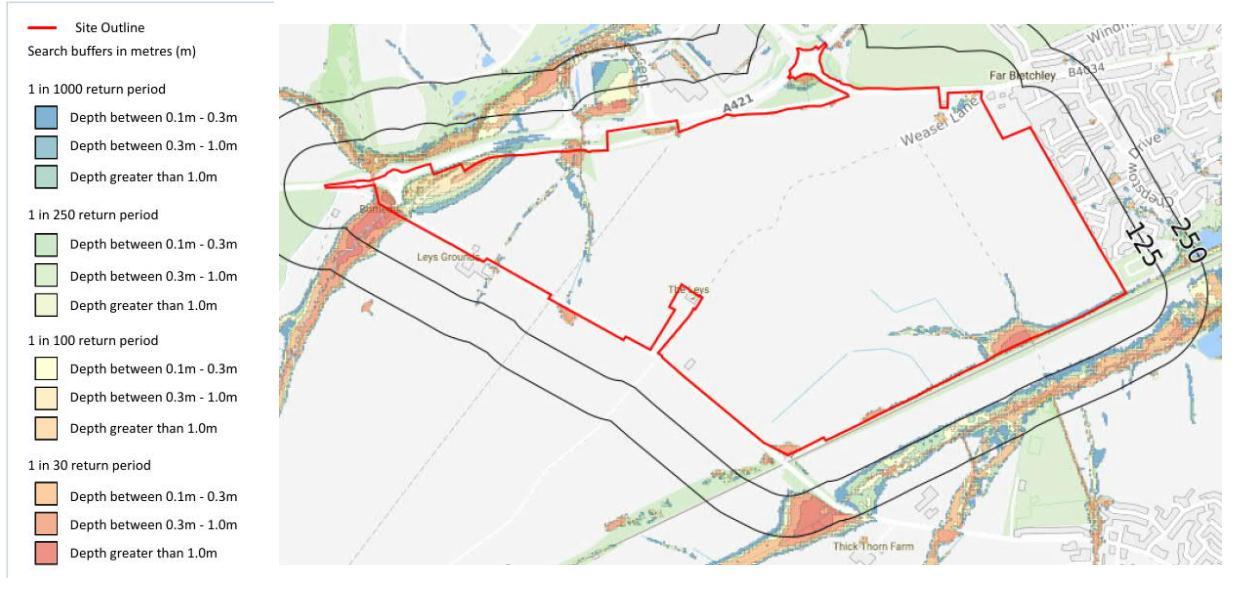
Insert 3. Surface water flooding

There is a greater risk of surface water flooding in the south of the site as a result of extreme rainfall events; a 1 in 30 year return period has been determined, with a depth greater than 1.0m. The risk of surface water flooding across the site is illustrated by **Insert 3** (extracted and modified from the Groundsure report). Although there are no records of historic flood events from rivers or surface water (from 1946 onwards) on site or within 0.25km of the site boundary.
