FLOOD INVESTIGATION REPORT

SHERINGTON

23rd DECEMBER 2020

Milton Keynes Council
Flood Investigation Report
Sherington

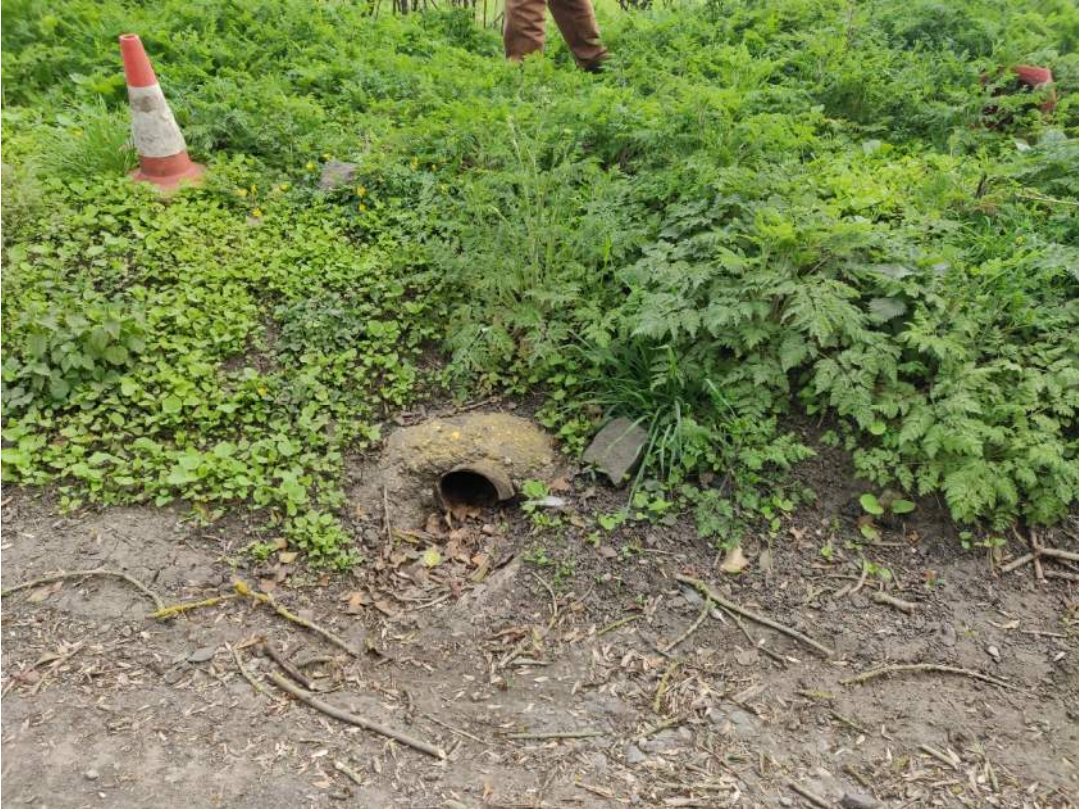
Figure 1: Gun Lane Road Drainage – kept clear by residents

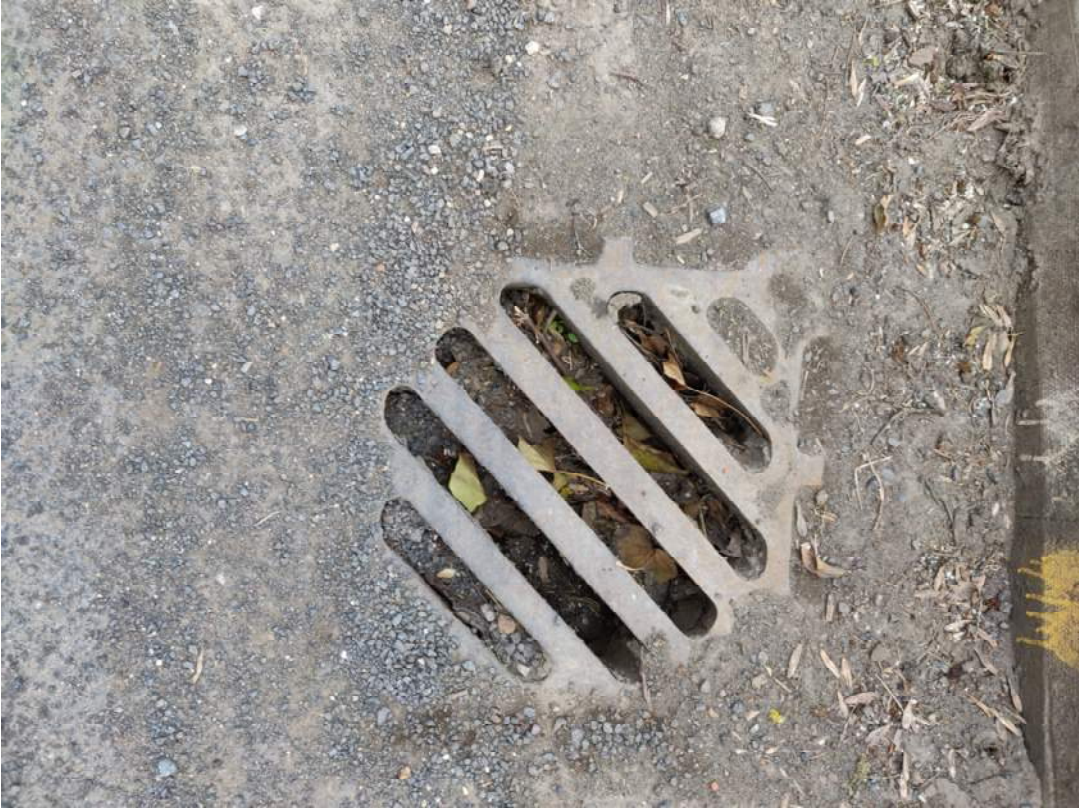
Figure 2 Ditch 2: Gun Lane Gully

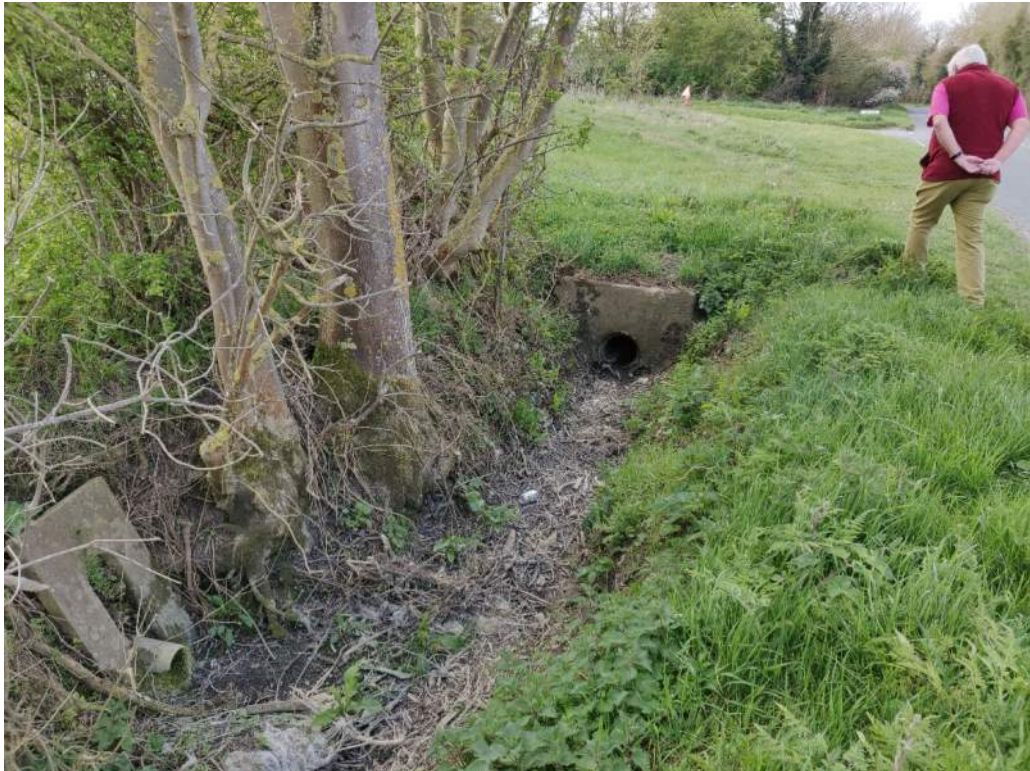
Figure 3: Culvert on High Street under Gun Lane

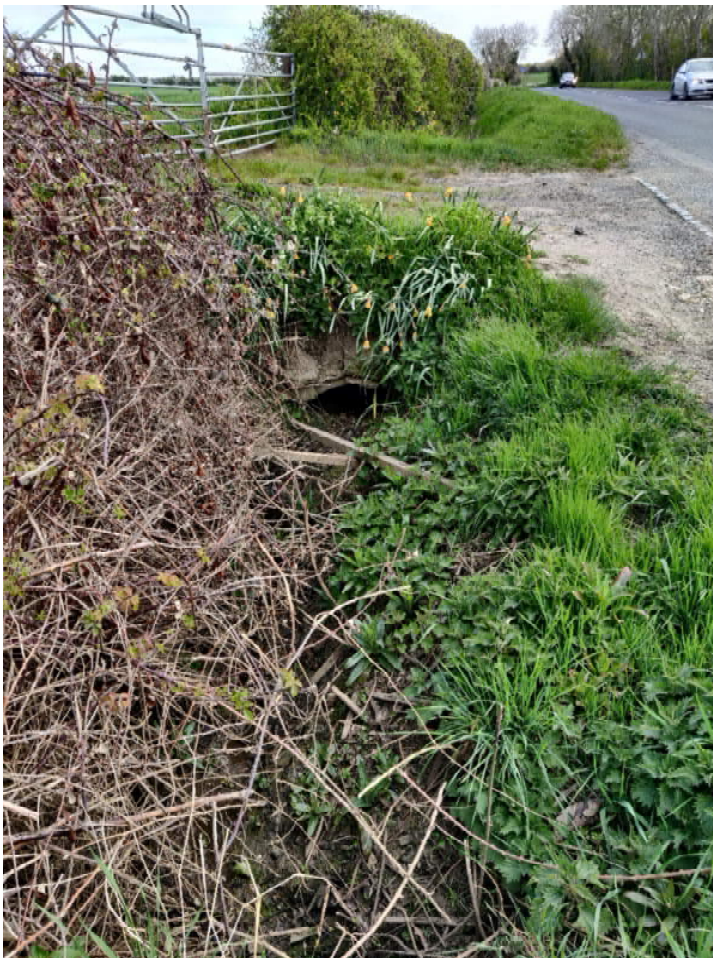
Figure 4: Culvert on west side of High Street near Gun Lane

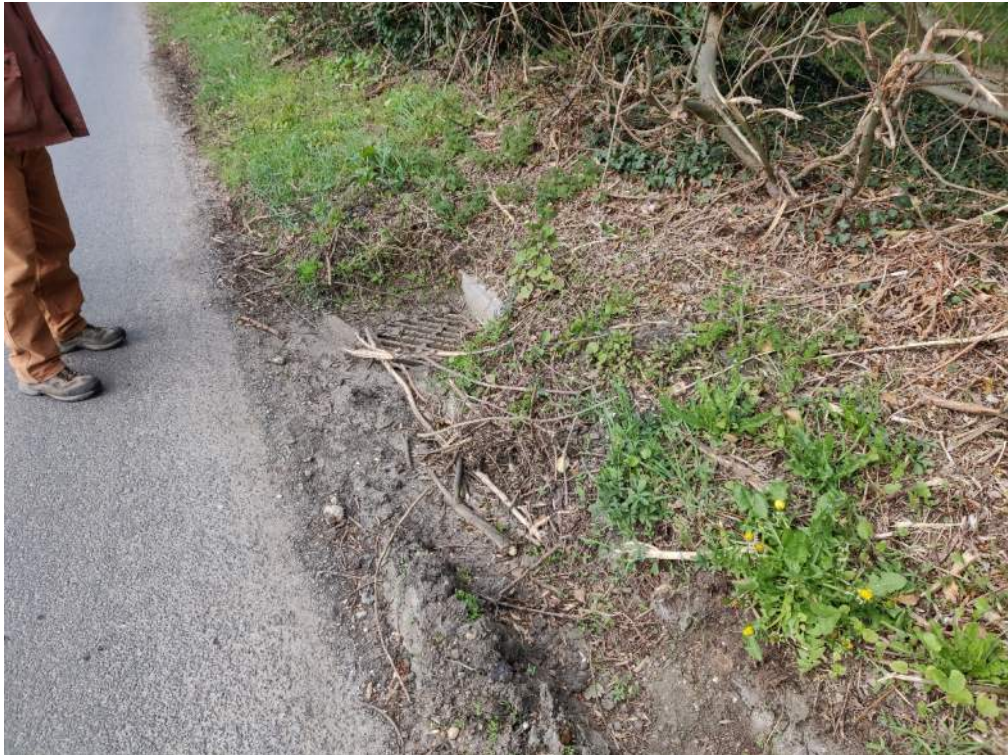
Figure 5: Example of Gully on High Street – some of these features have been cleared by residents

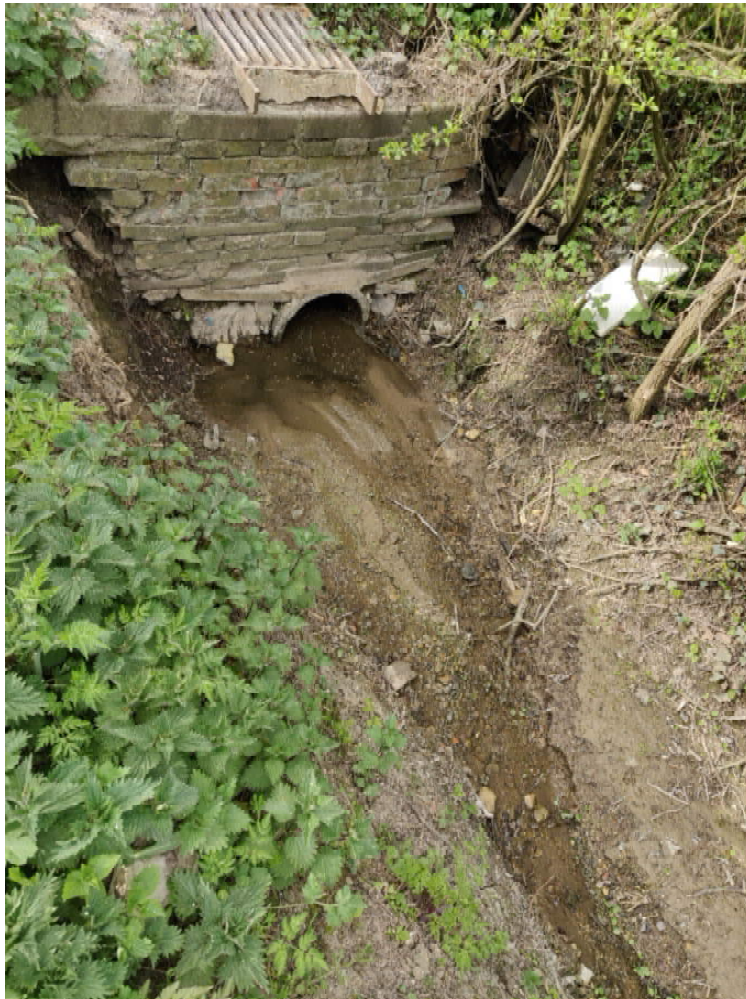
5.2.3.1 There are various culverts along High Street, no one structure appeared to be the cause of the flooding, however, many of the culverts are operating at a reduced capacity due to a build-up of silt.

Figure 6: Silted Culvert on High Street

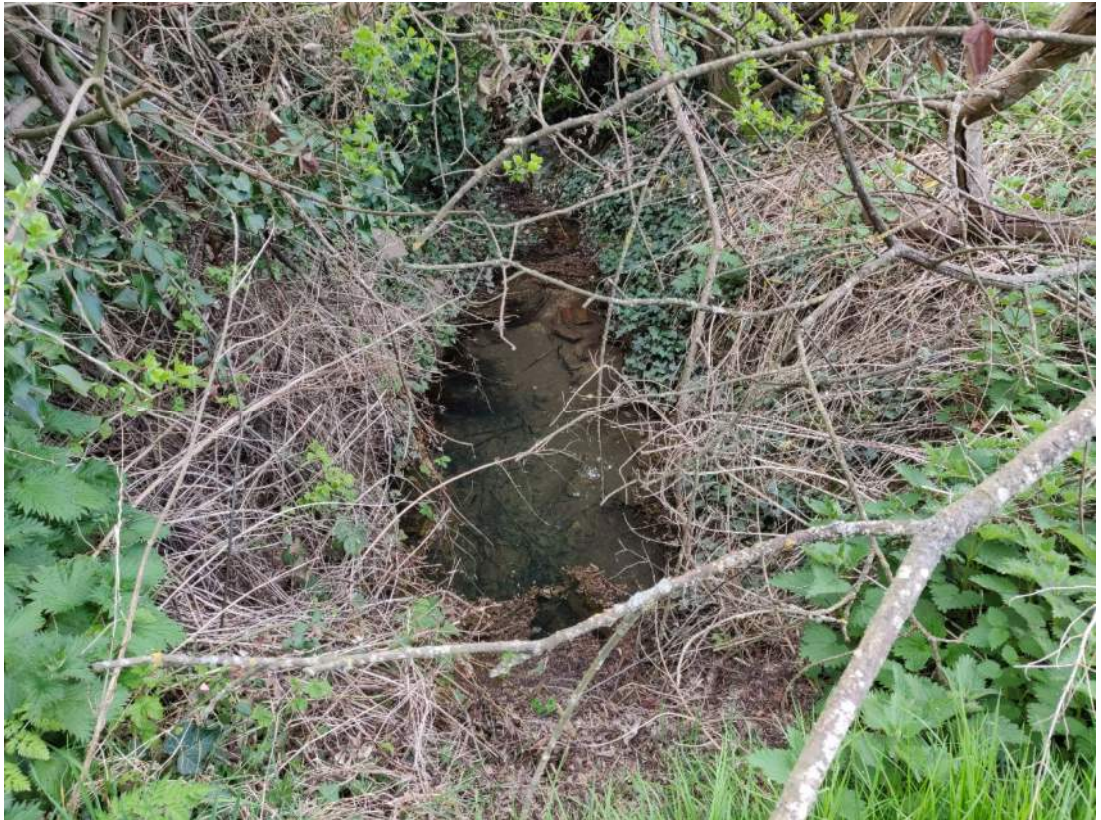
Figure 7: High Street Ditch with Standing Water

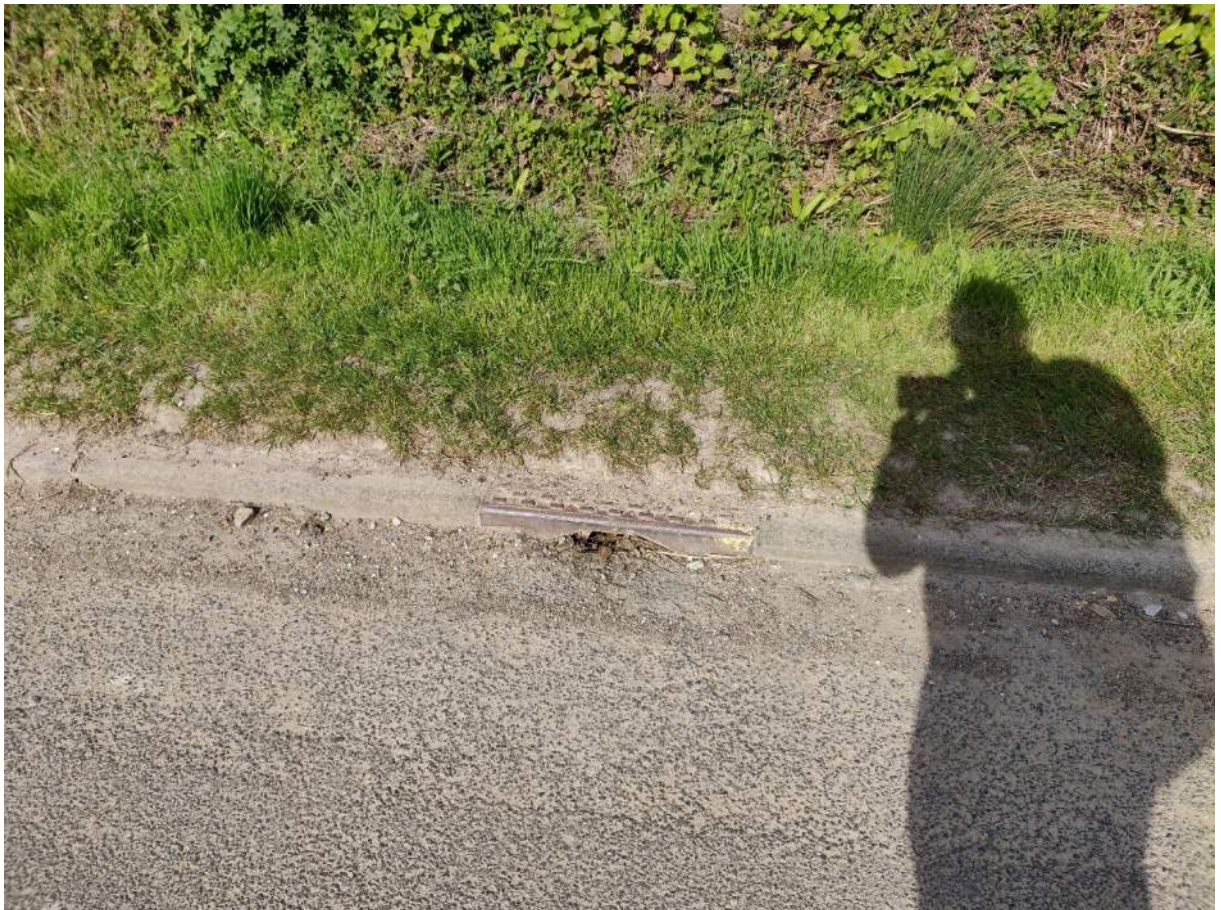
Figure 8: High Street Road Drainage

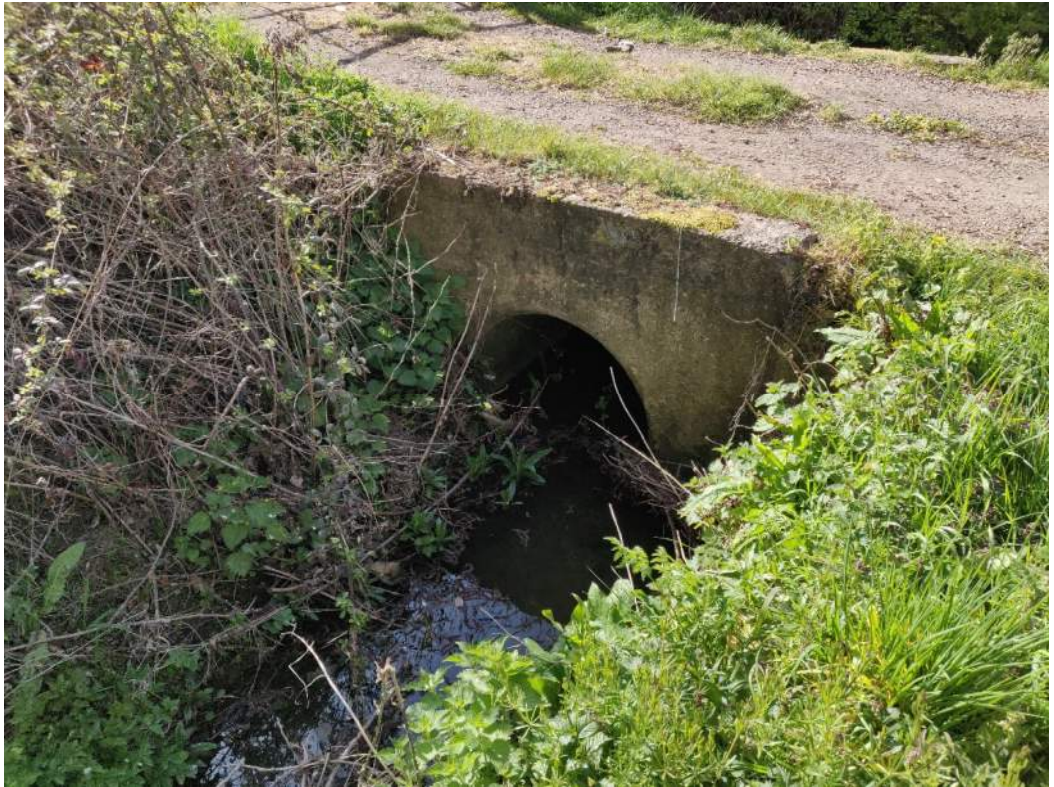
Figure 9: High Street Ditch with Standing Water

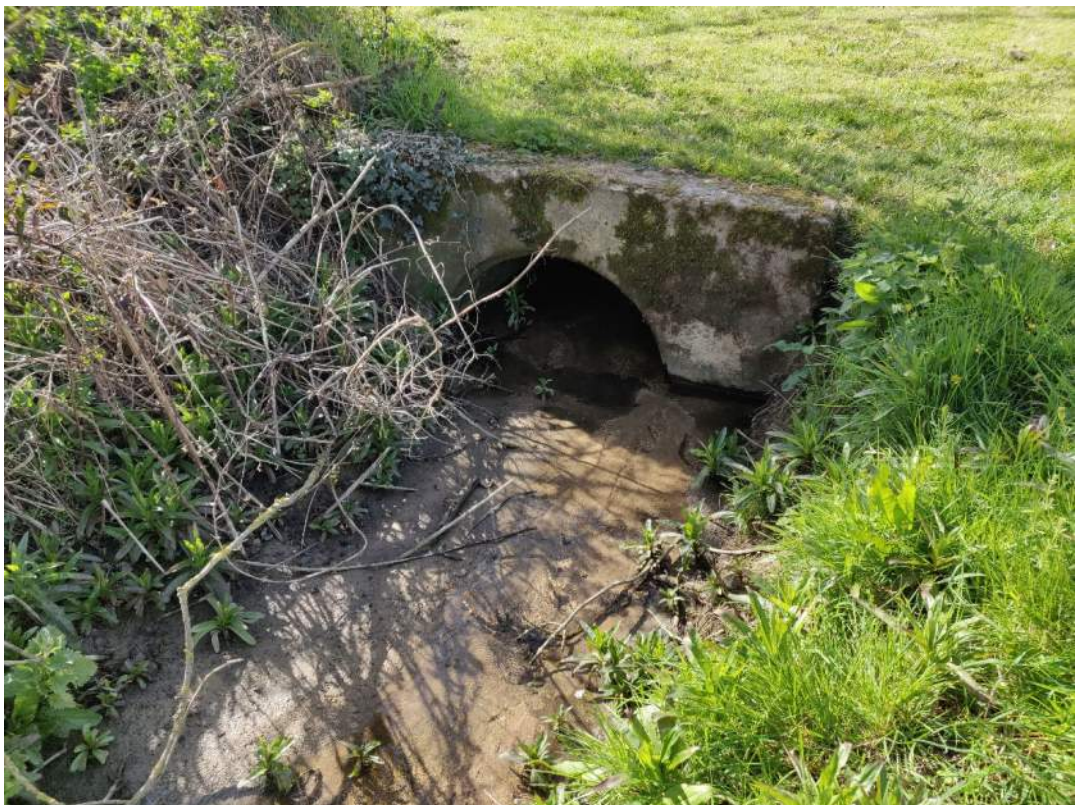
Figure 10: High Street Ditch partially blocked with Silt

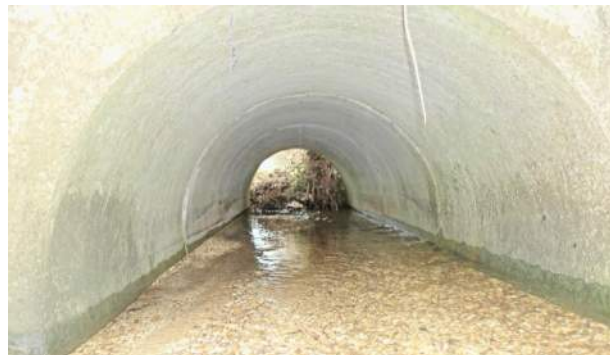
High St East Adjacent to site
Sand in drainage tunnel to ditch

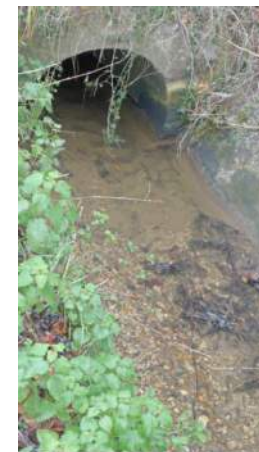
High St East Adjacent to site
Sand in drainage tunnel

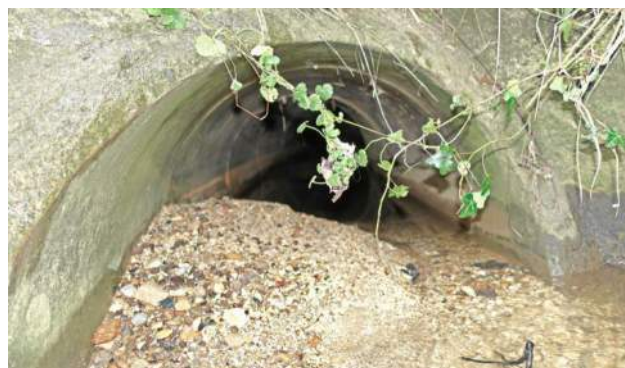
High St East Adjacent to site
Sand in drainage tunnel to west (site)

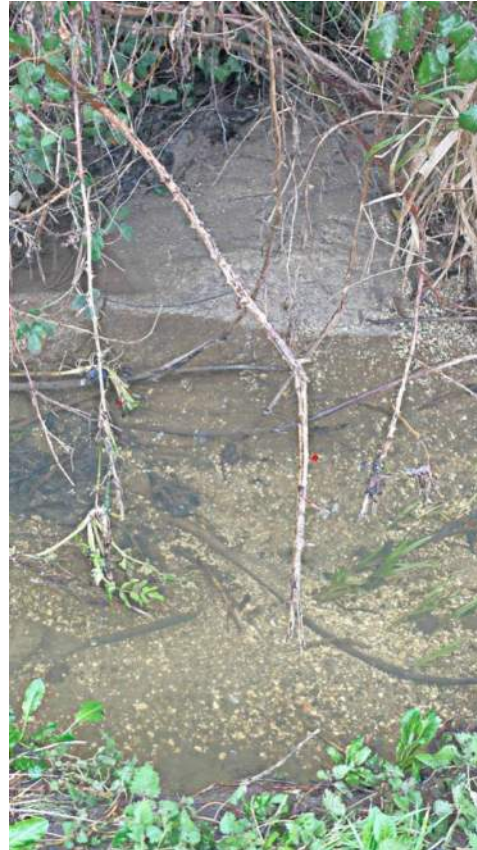
High St East
Sand in ditch

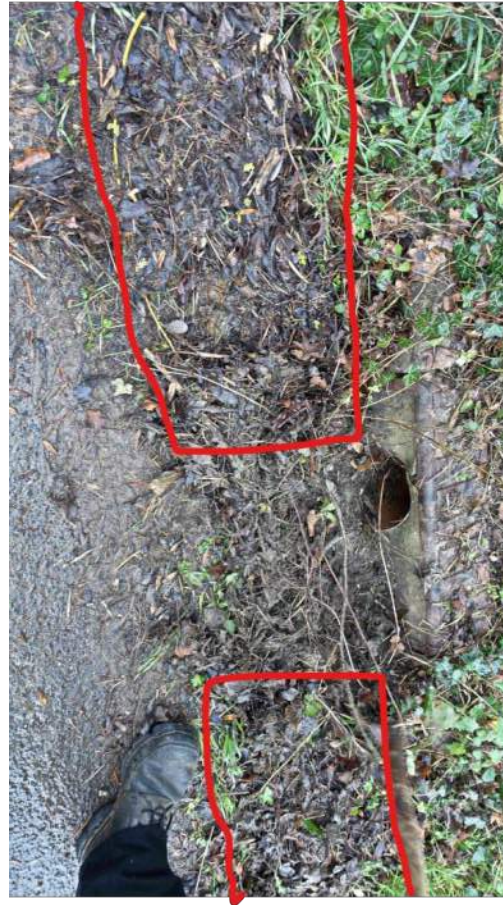
High St East – recovered drain –
note overgrown vegetation (>300mm)

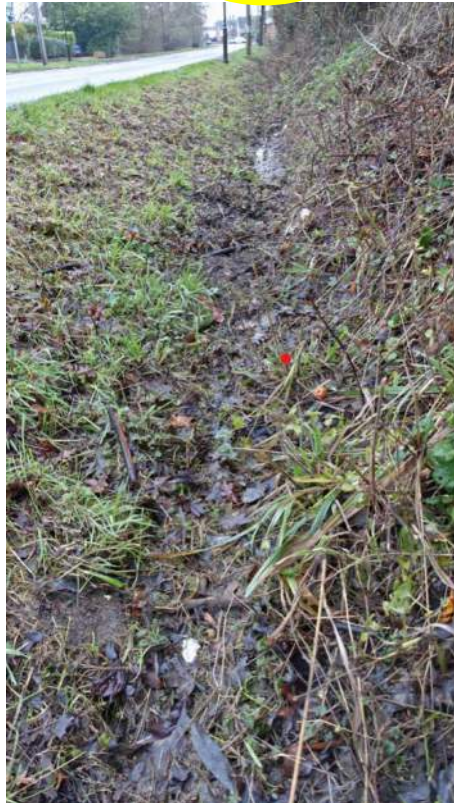
3a

High St West North
Overgrown ditch
(New Estate)

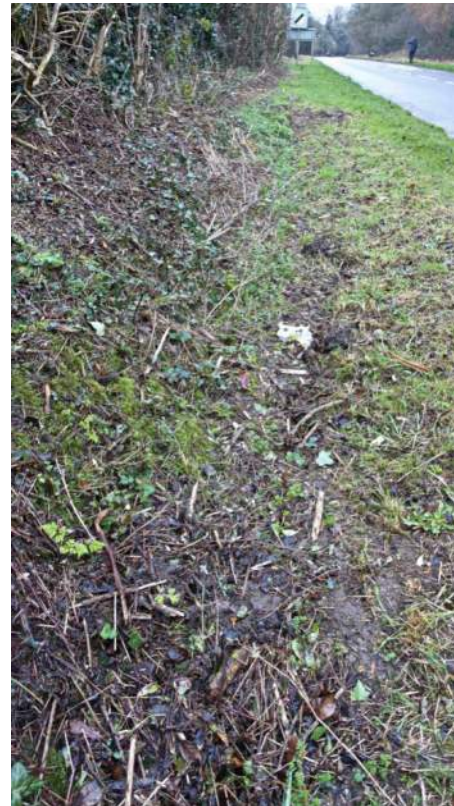
3b

High St West South
Overgrown ditch
(New Estate)

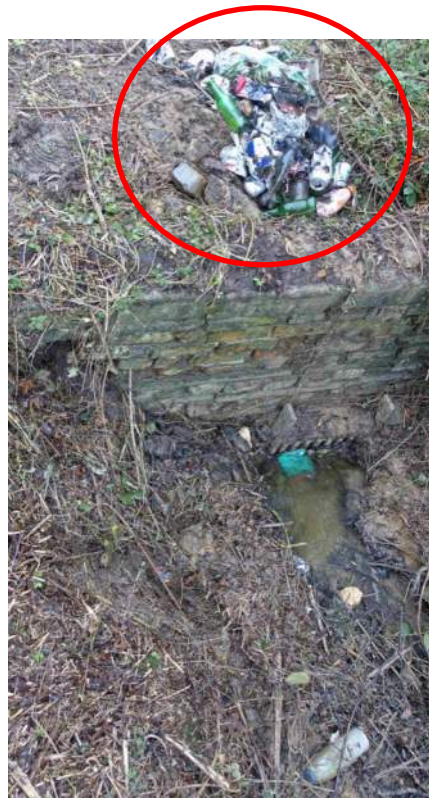
Rubbish removed on 24th Dec

High St West
Partially Blocked Drain
(New Estate)

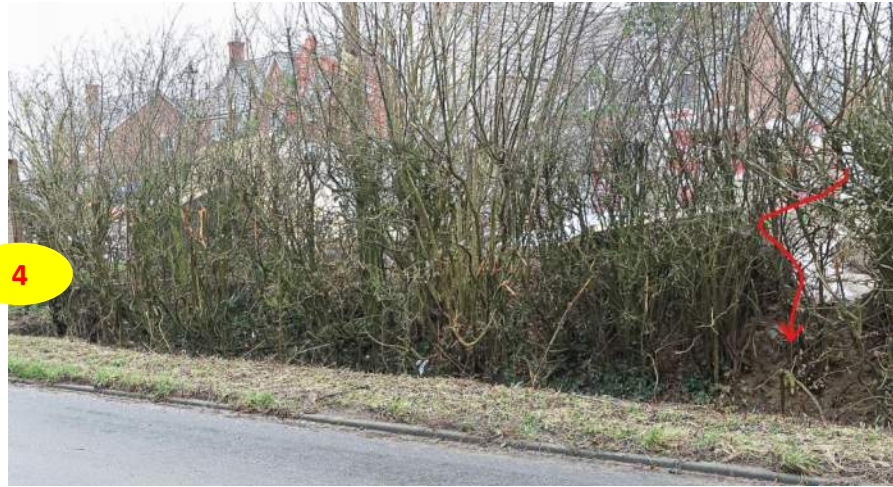
5

High St West
 RED LINE indicates the channel cut to force the site run-off into the ditch
 Runs as far as partially blocked culvert – and partly transfers onto the road

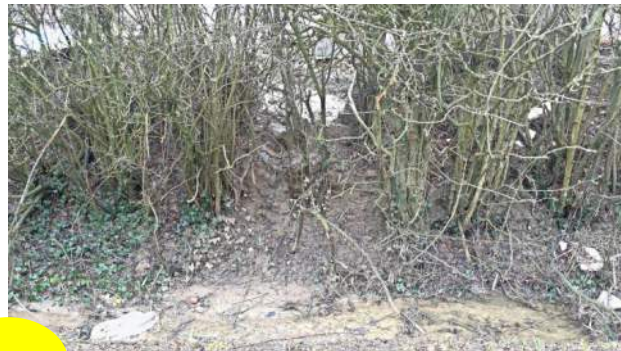
6

High St West
 Water channel from site

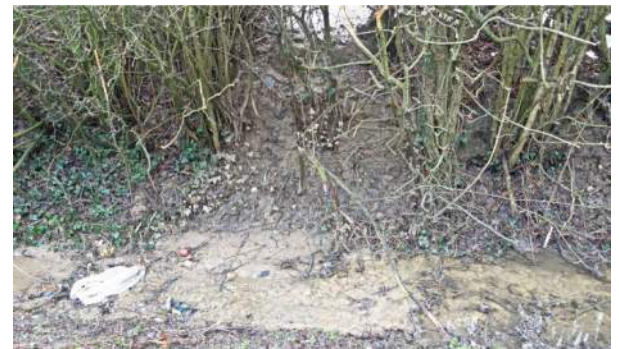
High St West
 Sand in ditch from site

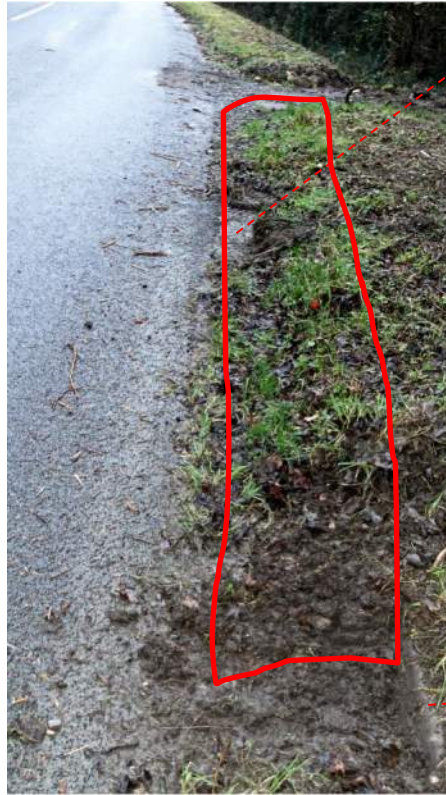
High St West
Recovered Drain
Recovered Kerbside
Road Loss to
overgrown vegetation

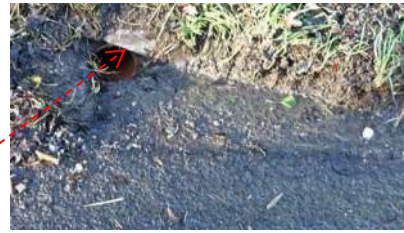
High St West
Recovered Drain

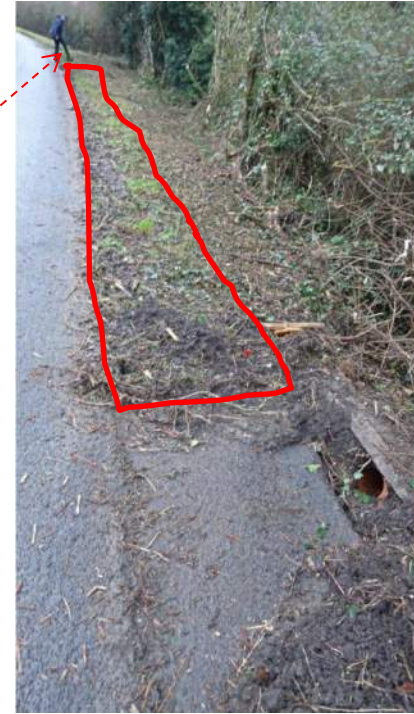
High St West
Recovered Drain
Road Loss to
overgrown vegetation

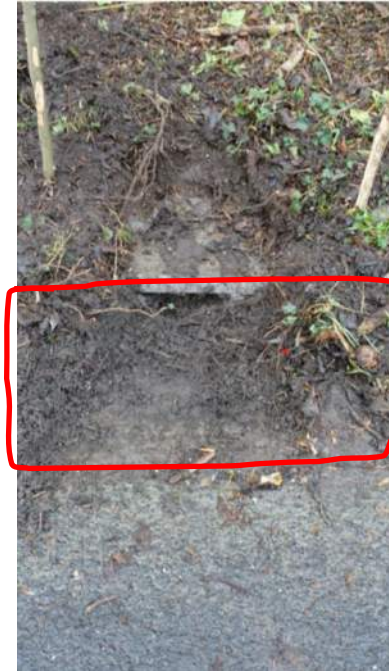
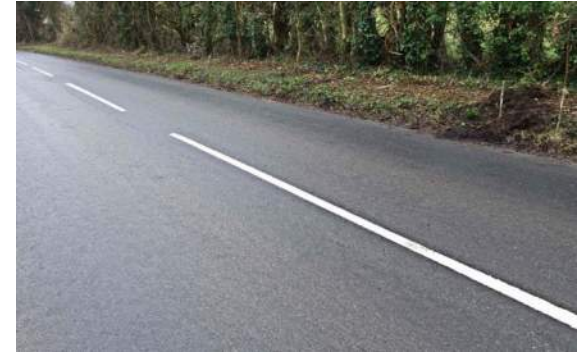
High St West
Recovered Drain
Road Loss to overgrown vegetation

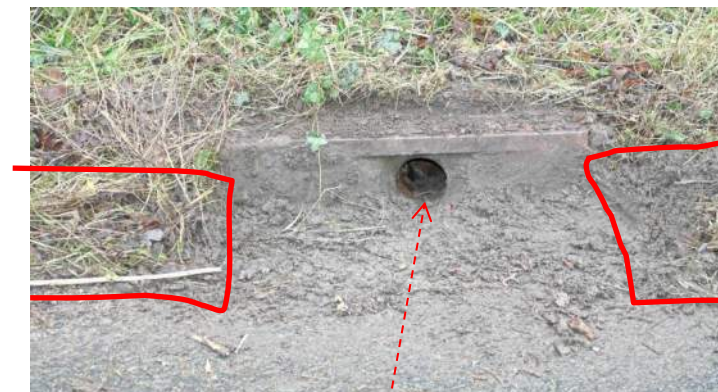
High St East, Cleared kerb drain
Vegetation overgrown

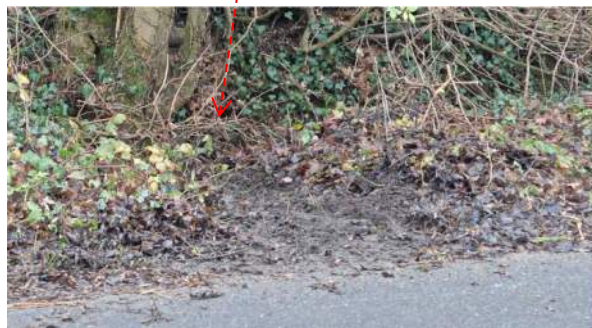
High St East
Cleared Run off

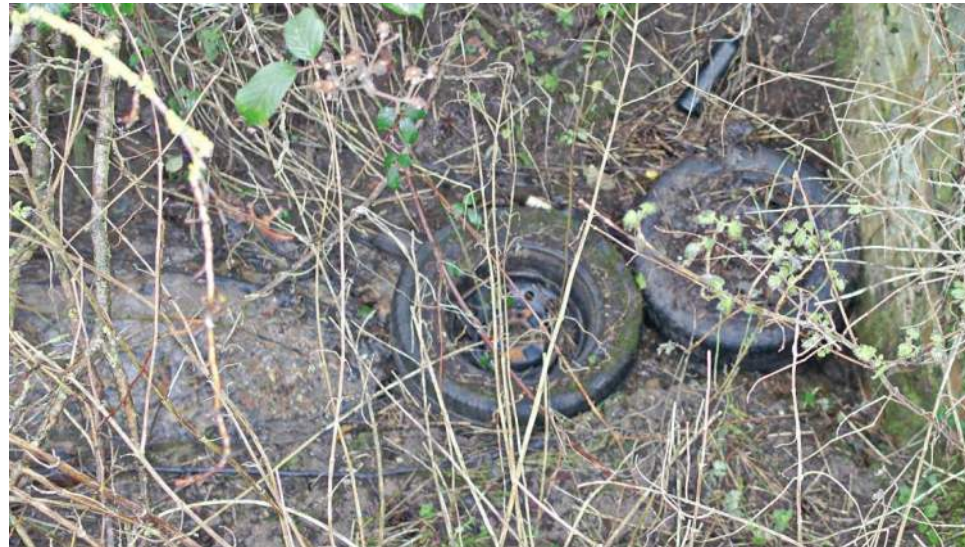
High St East
Tires blocking ditch

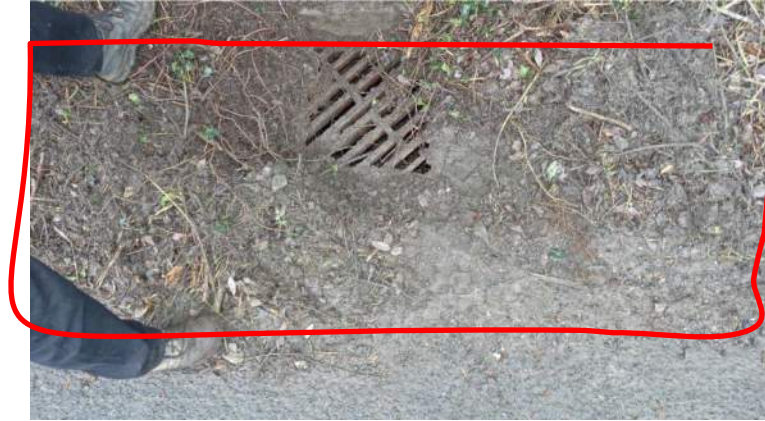
High St West
Recovered Kerbside
Recovered Road Drain
Overgrown Vegetation
