North Crawley Conservation Area Review

December 2021

Conservation & Archaeology

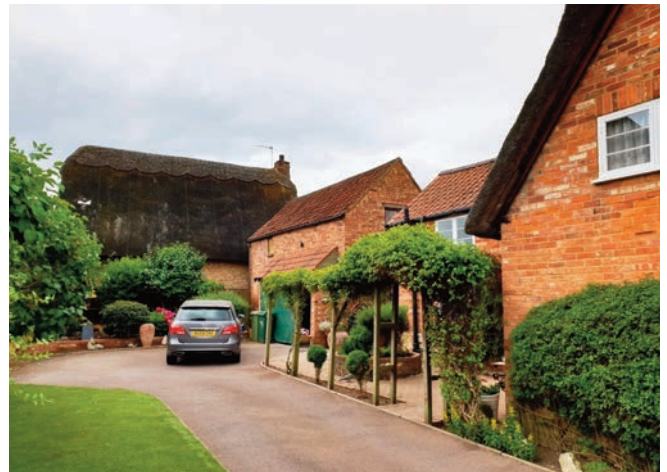
Thatch and clay tile roofs in North Crawley

Early roofing materials would have been long straw thatch or locally made plain clay tiles. Long stemmed straw for thatch was once available easily from the surrounding fields but the change to shorter stemmed wheat varieties and mechanised harvesting has led to its replacement in the latter part of the 20th century with reed thatch. This material has a much sharper clipped appearance compared to the shaggier and softer looking long straw variety traditional to the area. Long straw also lacks the pronounced ridge detailing found on reed thatches as it is flexible enough to wrap over the top of roofs.

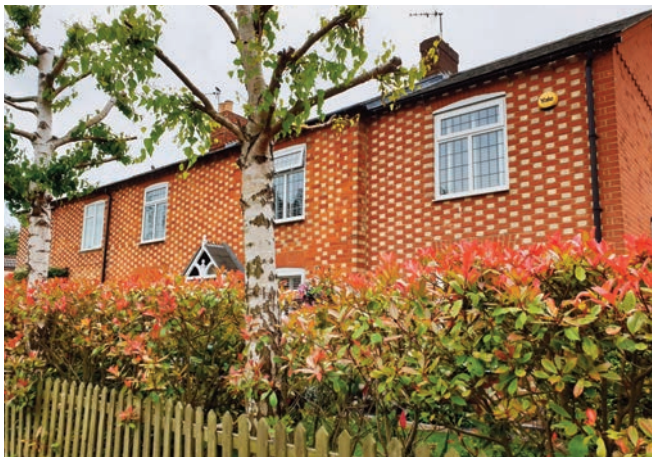
Decorative chequer board pattern made using Flemish bond, 32-34 High Street

Numbers 32-34 High Street are a striking example of this technique. Flemish bond and variations of it are used almost exclusively in the village, particularly an elongated version known as Flemish garden wall or Sussex bond where three stretchers and one header alternate to make the bricks go further. Often Flemish garden wall bond is used for the sides of buildings keeping the full Flemish bond to the front, but some house frontages make use of this stretched version and here and there it is used decoratively too.

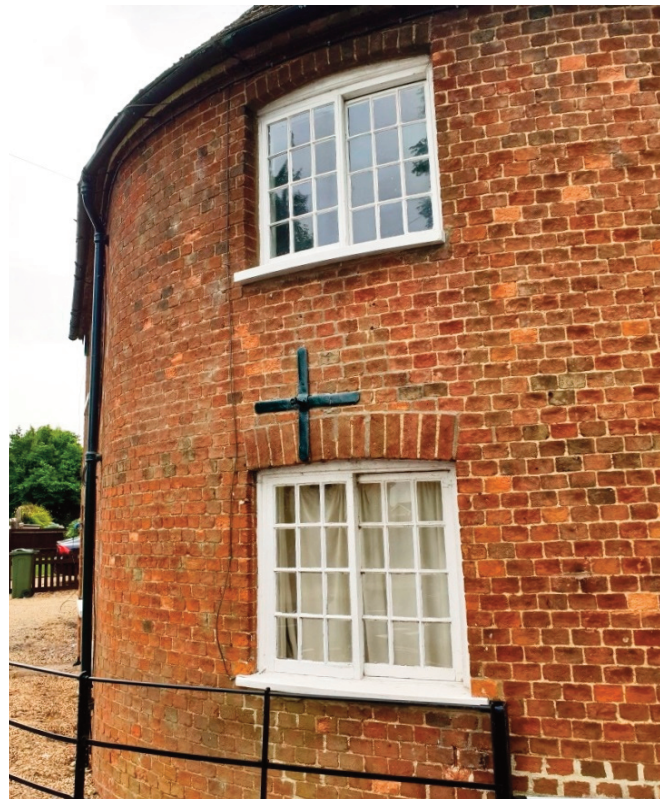
Brick 'headers' used skilfully create a curved wall. The windows are horizontal (Yorkshire) sliding sash that predate vertical sliding sashes. They are of small 12x12 pane puttied into structural (rather than applied) glazing bars under simple segmental brick arches. Some old glass survives and the impressions for a hinge that supported a shutter are still observable.

headers to create a curved wall on the corner of 1 High Street (Grade II listed) at the junction with Folly Lane.

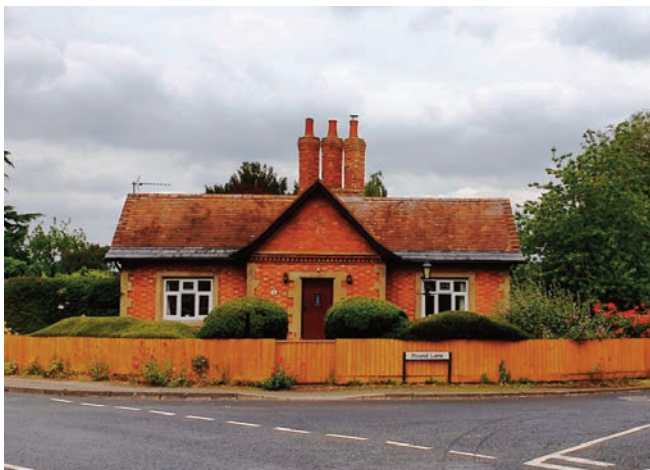
Stone dressings (left unpainted) used to enhance the presence of doors and windows, 29 High Street

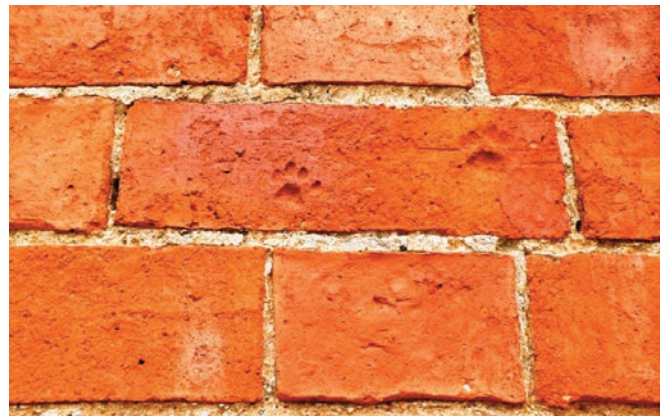
Orange brick with pawprints embedded, set in an offwhite lime and sand mortar with a little hearth grit to aid curing

The mortar for brick and stonework is white with small pebbles and/or black hearth grit evident. The whiteness comes from the slaked quicklime into which coarse and smooth sand and material considered to aid consistent curing of the mortar was added. Lime mortar in particular can be temperamental to use and inconsistent in inexperienced hands so, as a result, its use in general building has ceased. The porosity of the material and its suitability for use in softer handmade brick and porous limestones means that air curing lime mortar is more widely available for use again. In the slightly darker than usual orangebrown brickwork of North

Crawley the whiteness of the mortar creates more of a contrast. This acts to heighten the visibility of the coursing bond and thus any slight variations in the brick laying. Careless repointing or repointing in grey modern cements can have a disproportionately harmful impact on the appearance of brickwork as its careful setting out becomes blurred and, by preventing proper evaporation of water vapour from within a wall, can cause brickwork to fail prematurely.

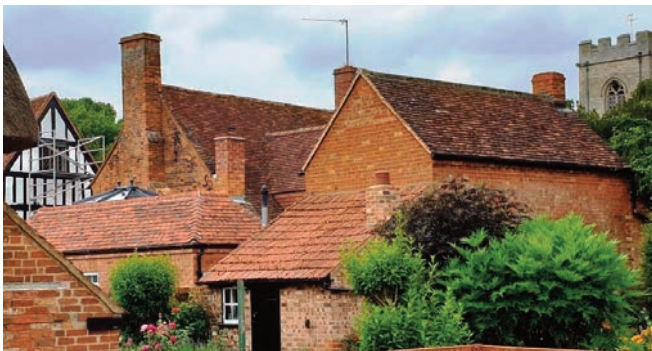
Clay tiles old and new (new, with cat sat on ridge) seen from Chequers Lane

Plain clay tiles often with a plain shallow curve that imparts a pleasing slightly jumbled look are now rare in the village. Here and there are ridged or curved pantiles which add characterful texture; they are mostly used on outbuildings. Later mass produced tiles from the late 19th century onwards tend to lie much flatter, are more uniform in colour than the handmade kind and now dominate the village.

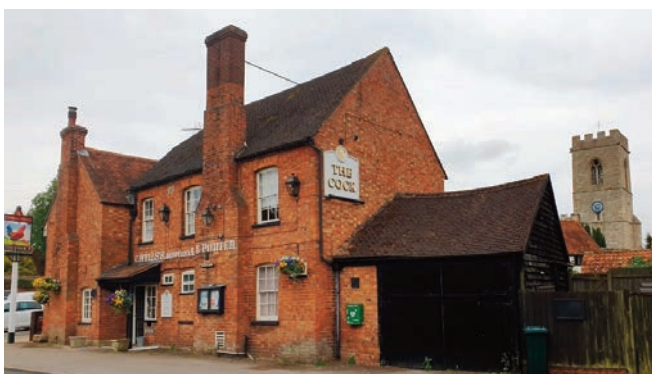
Weatherboard store standing on the west side of The Cock public house. Note the pantiled outbuilding beyond. The Cock's windows have flat head segmental arches and are set some 90mm into their opening

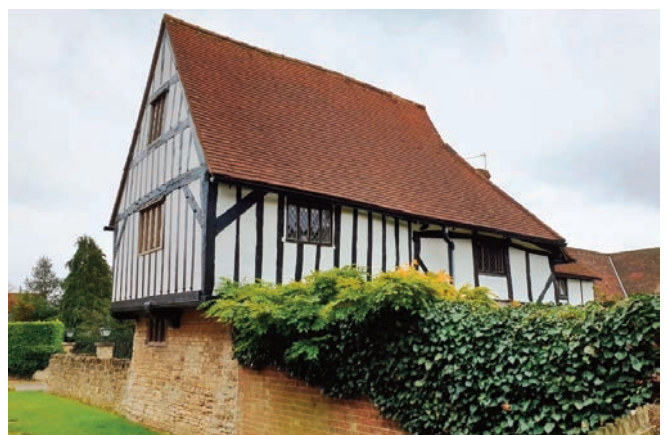
Church Farm early, cill-less, side hung, flush fitting, small pane with lead comes timber windows, set in a timber frame gable with a stone base and modern plain clay tile roof. The wall is Flemish garden wall bond

Early cottage windows (circa 17th century or earlier) tend to be side hung flush fitting casement type but few genuine examples now survive. At first they combined small pieces of glass held in place by lead 'comes' but evolved to have larger panes of glass fixed by putty into frames subdivided by wooden glazing bars. Cills tended to be absent and the windows placed almost flush with the external stonework or framing. During the 18th century vertically hung sliding sash windows became prevalent. At first these too were flush with external masonry but late 18th century laws aimed at reducing the risk of fire spreading pushed the windows into their openings by four inches. The shadow lines this creates adds expression to later Georgian and Victorian windows. Whilst modern windows are influenced by the configuration of historic casement and sash windows few correctly

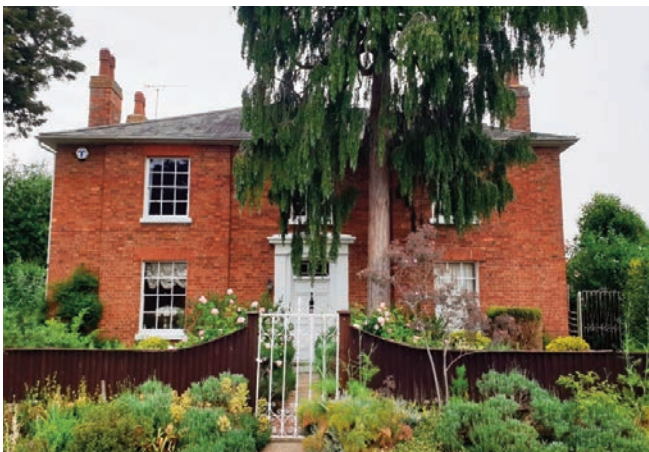
Timber doors and windows set in a symmetrical brickwork composition under a Welsh slate roof. The windows are 'six over six' timber vertically sliding sashes whilst the front door is of eight panels under a fanlight (or 'transom' light) and set within a restrained early Victorian door surround. Note the relatively small size of the door in the context of the ornamental treatment and the ornamental iron gate.

Doors come in a variety of designs from basic plank doors to ornate Victorian and Edwardian designs. In North Crawley some Victorian or Edwardian era doors survive. They typically comprise vertical stiles and horizontal rail frames further divided vertically by muntins into which wood panels or glazing is placed. Fanlights, where present, are invariably placed above doors and never incorporated into them. Polished brass knobs, rather than lever handles, were used to open doors. The doors are always painted smooth and woodgrain finish is absent. Georgian and Victorian doors, particularly on higher status buildings often have a door hood supported by brackets. These can be very plain to highly decorated and sometimes accompanied by an ornamental door surround.
