RESURFACING 2021

SITE 01
BRINKLOW RBOUT

SITE 01/OVERVIEW

OVERVIEW

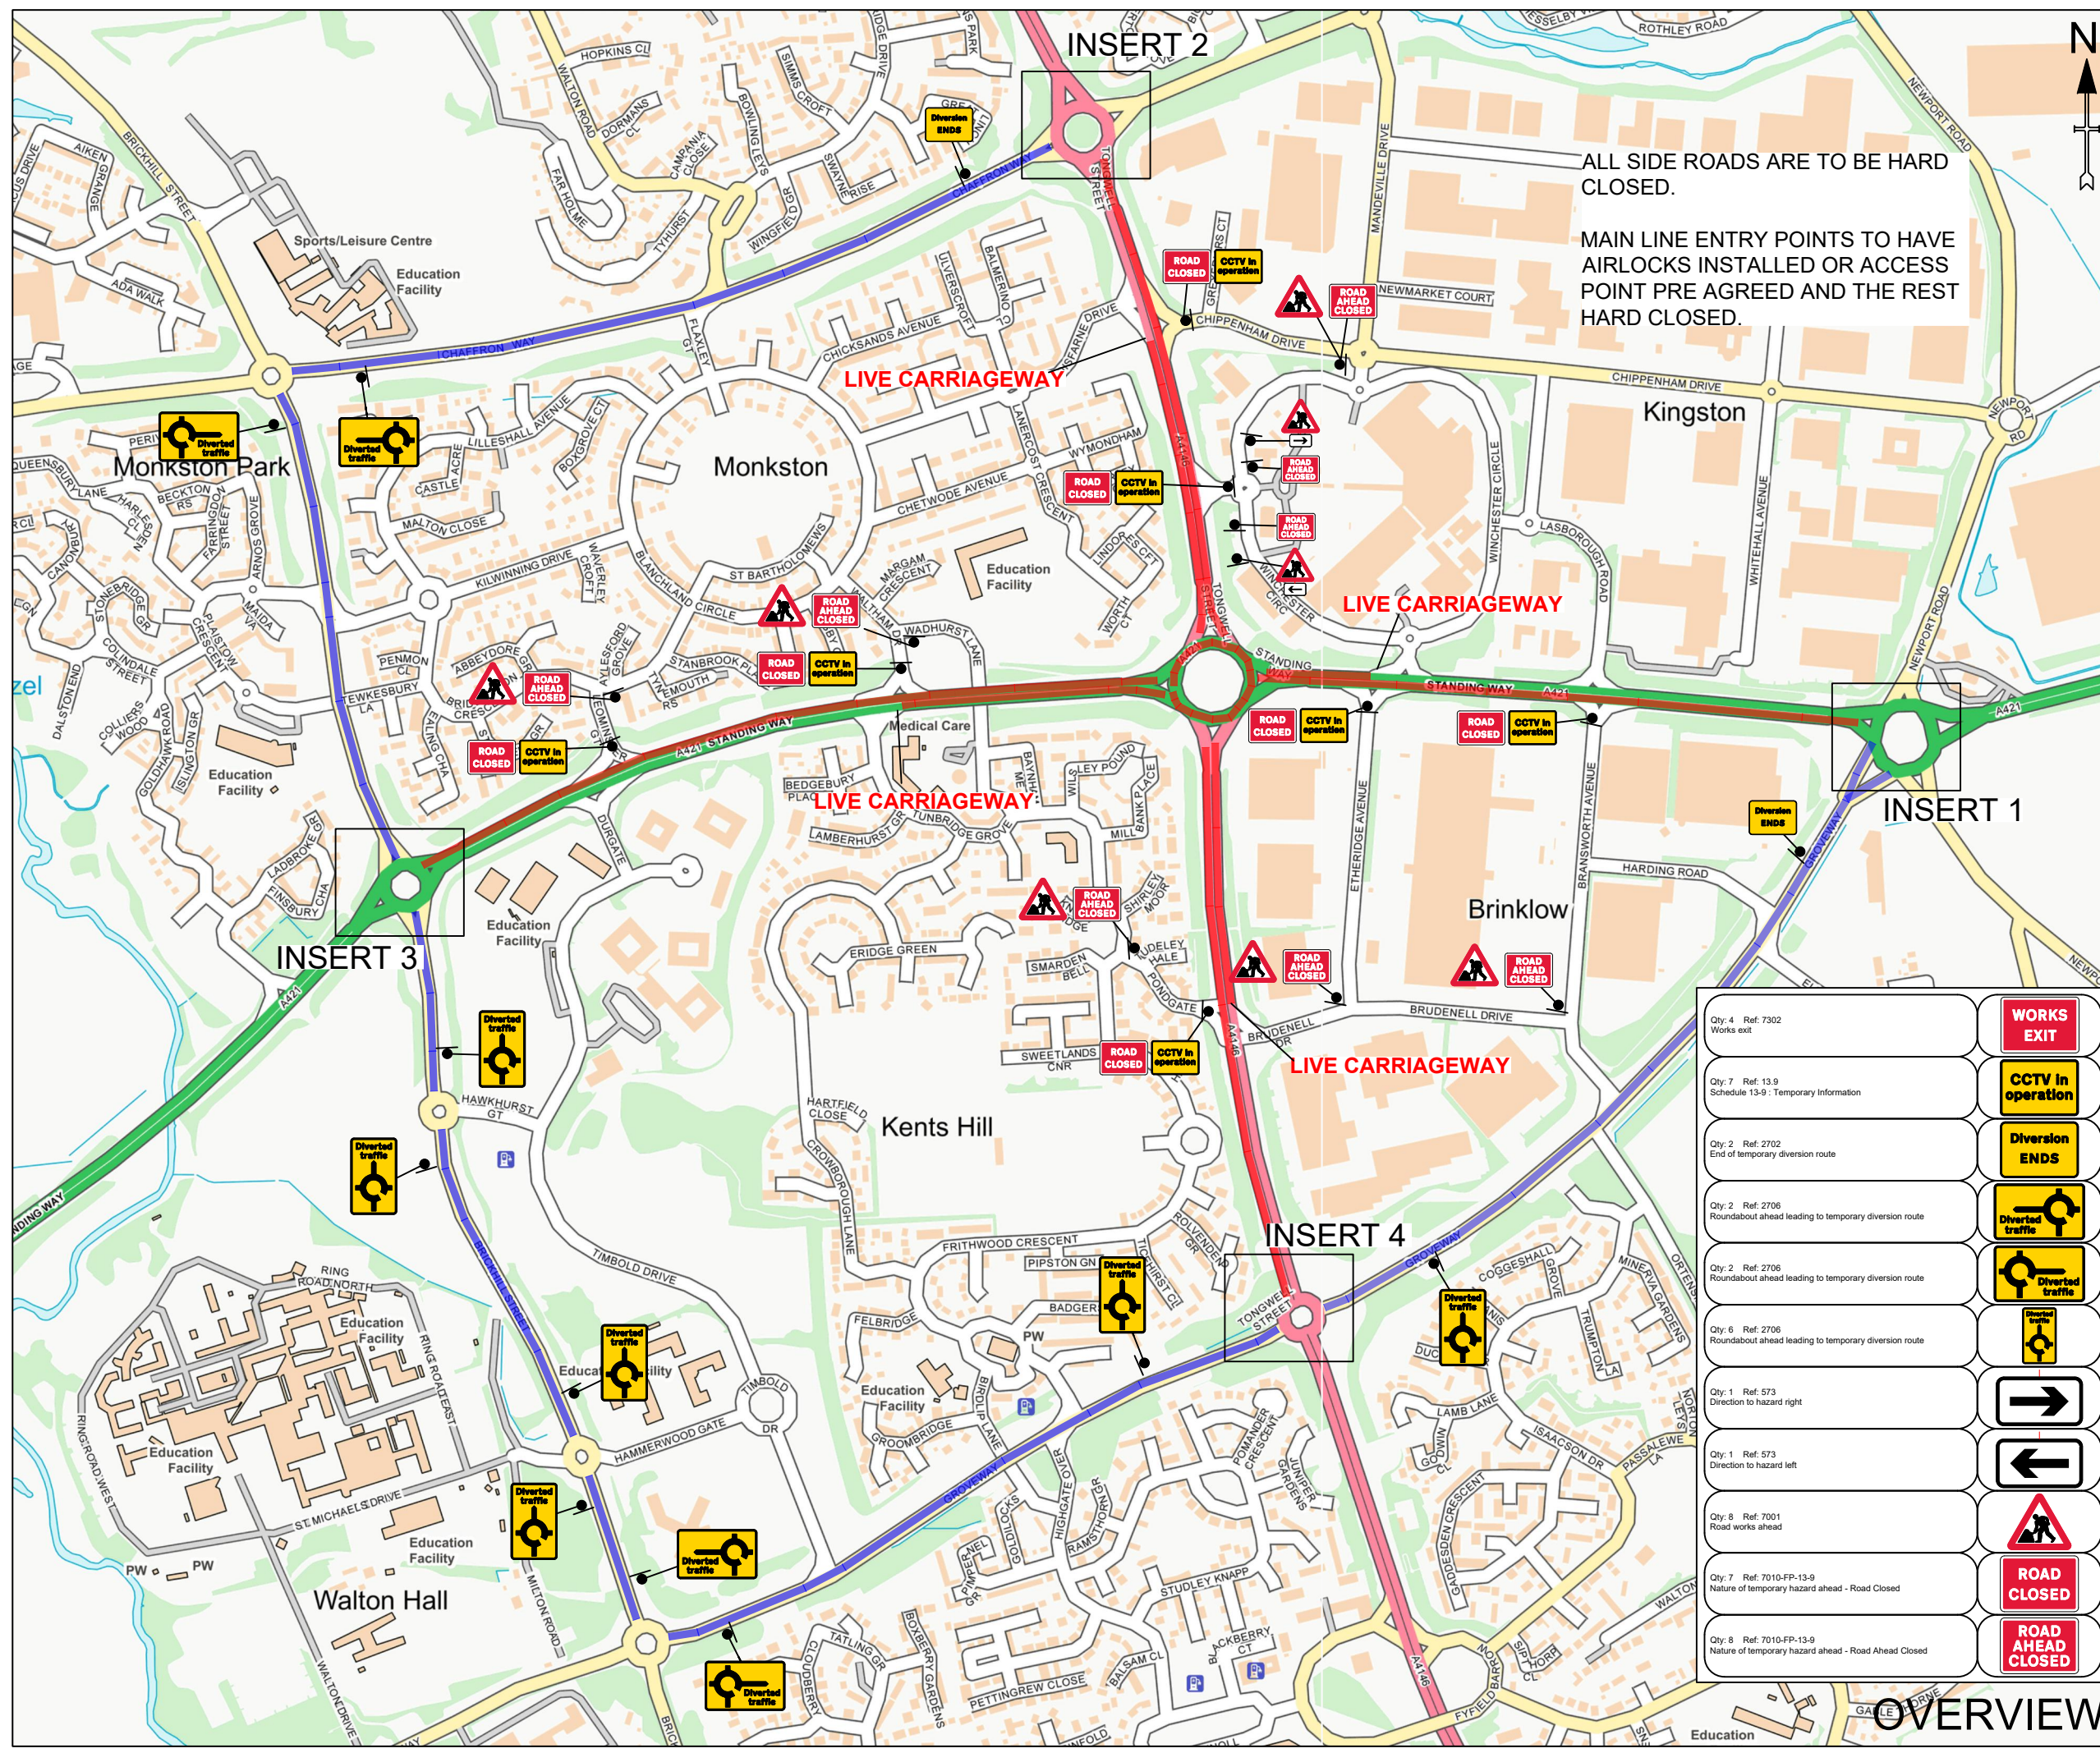
ALL SIDE ROADS ARE TO BE HARD CLOSED.

MAIN LINE ENTRY POINTS TO HAVE AIRLOCKS INSTALLED OR ACCESS POINT PRE AGREED AND THE REST HARD CLOSED.

LIVE CARRIAGEWAY/ END OF CLOSURE TO BE MARKED WITH CHICANE AND WORKS EXIT SIGN

Airlock installed where indicated. 2 sets of Nissen barrier must be installed.

AIRLOCKS TO BE INSTALLED WHERE REQUIRED TO RINGWAY SPEC.

NO PARKING CONES INSTALLED PM BEFORE START OF WORKS AS PER WALK TALK BUILDS.

CONES AND TAPE INSTALLED ALONG FOOTWAY WHERE REQUIRED AS PER RINGWAY SPEC.
